**RAMI**  
Property  
Inspections

## Property Inspection Report

# VILLA

Description	Client : Dubai 0000
Address :	Dubai
Generated on	- 10/12/2024
Stages	- Comprehensive Handover Snagging
Building trades	<ul style="list-style-type: none"><li>- About</li><li>- Air conditioning</li><li>- Aluminium joinery</li><li>- Bathroom Accessories, interiors and Fittings</li><li>- Electricity</li><li>- General Works</li><li>- Glass</li><li>- Gypsum &amp; Acoustic Ceiling</li><li>- Humidity</li><li>- Interior joinery</li><li>- Kitchen</li><li>- Noise Level</li><li>- Paint</li><li>- Paving</li><li>- Plaster</li><li>- Plumbing and heating</li><li>- Thermography</li><li>- Tiling, Wooden Floorings and stairs.</li><li>- Water Networks</li><li>- Water/ Moisture Intrusion</li></ul>
Stakeholders	
Drawings	- 2024-11-29 (Comprehensive Handover Snagging)

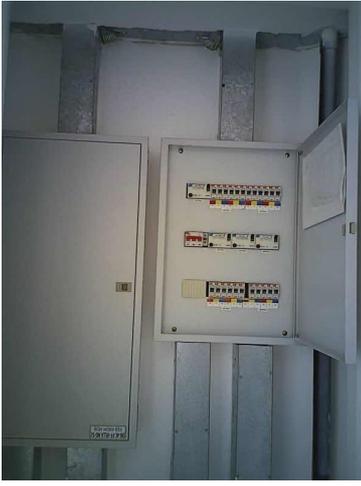
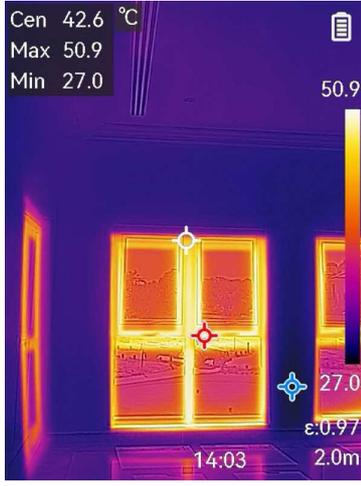
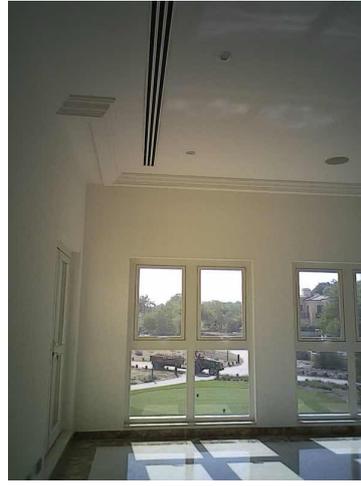
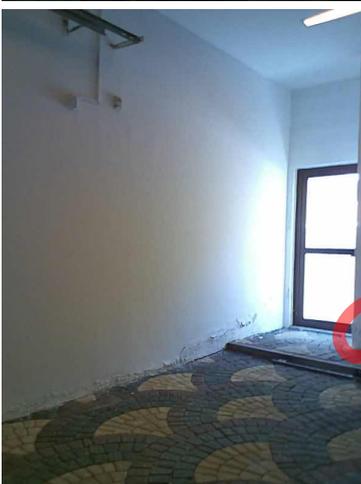
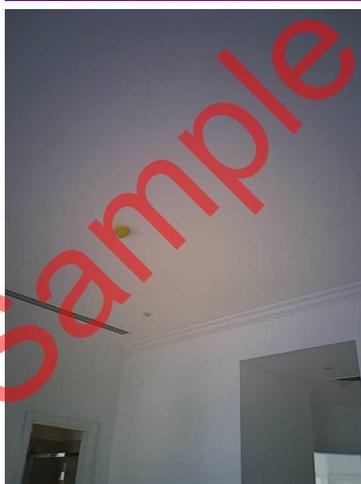
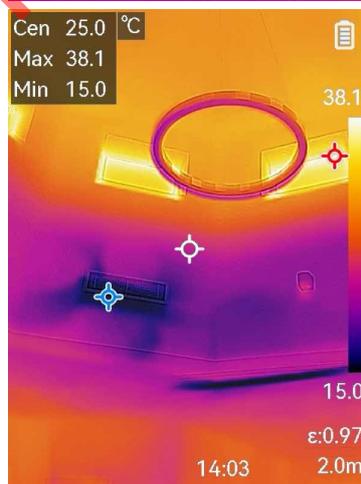
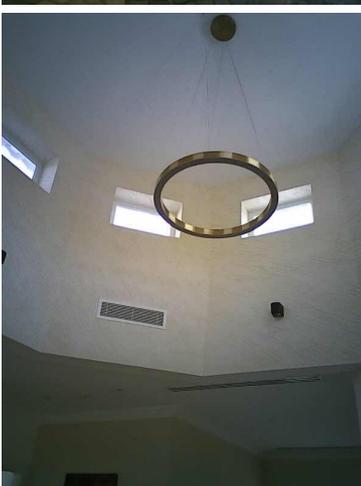
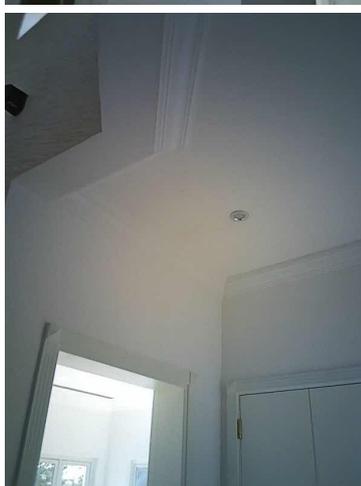
38 12/10/2024 Not attributed No deadline Not completed

The property has undergone a comprehensive thermal scan, which was conducted using advanced infrared thermography technology. This technique allows for the detection of temperature variations on surfaces, identifying areas of potential concern that may not be visible to the naked eye. The scan assessed the property's structural integrity, insulation efficiency, and overall thermal performance. Throughout the inspection, no significant anomalies were detected. Specifically, there were no indications of moisture ingress, air leaks, or thermal bridging that could suggest insulation deficiencies or compromised building materials. All temperature variations were within normal ranges, confirming that the property is thermally efficient and does not exhibit any issues related to energy loss, dampness, or structural irregularities. This thorough examination ensures that the property is in optimal condition from a thermal performance perspective.

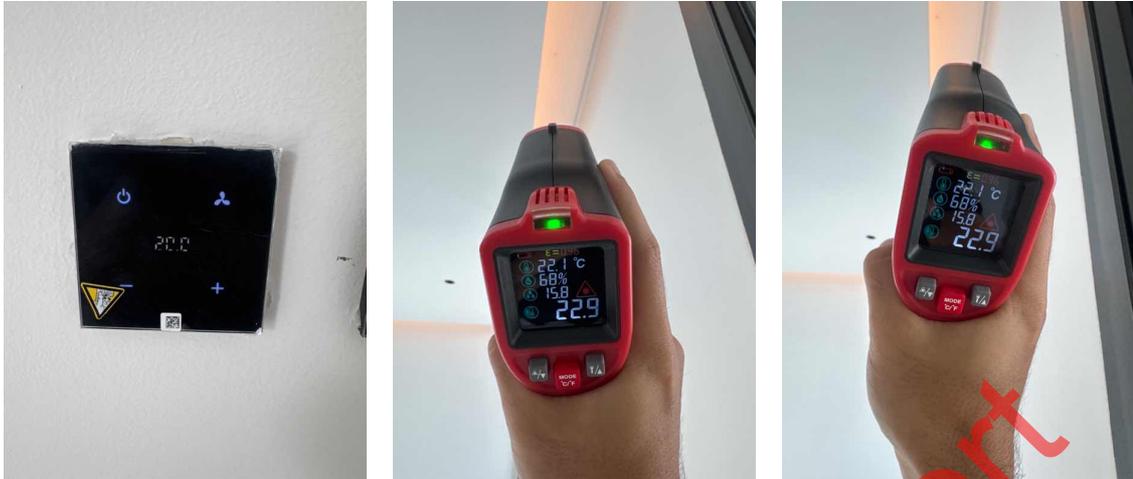
25 + 29/11/2024 Not attributed No deadline Not completed

The temperature readings at the air vents are elevated, exceeding acceptable levels, and should ideally be no higher than 12°C, given that the thermostat is set to 20°C. This discrepancy suggests potential inefficiencies in the HVAC system. A comprehensive diagnostic should be performed to investigate the underlying causes, starting with a thorough inspection of the chilled water supply, ductwork, and piping for potential leaks, blockages, or insulation issues. Additionally, the performance of the compressor units should be assessed to ensure they are functioning optimally and maintaining the correct refrigerant pressure and airflow. Any faults in these areas could be contributing to the system's inability to regulate the interior temperature effectively.

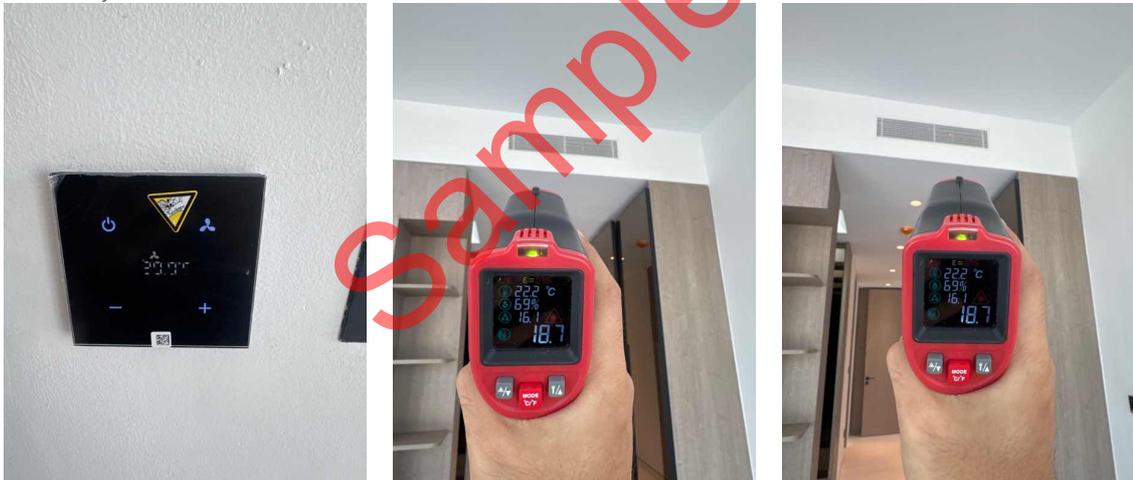
27 + 29/11/2024 Not attributed No deadline Not completed

The temperature readings at the air vents are elevated, exceeding acceptable levels, and should ideally be no higher than 12°C, given that the thermostat is set to 20°C. This discrepancy suggests potential inefficiencies in the HVAC system. A comprehensive diagnostic should be performed to investigate the underlying causes, starting with a thorough inspection of the chilled water supply, ductwork, and piping for potential leaks, blockages, or insulation issues. Additionally, the performance of the compressor units should be assessed to ensure they are functioning optimally and maintaining the correct refrigerant pressure and airflow. Any faults in these areas could be contributing to the system's inability to regulate the interior temperature effectively.

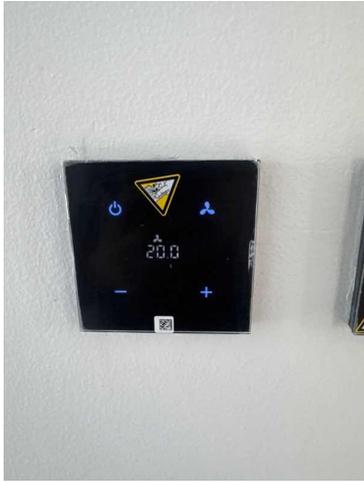
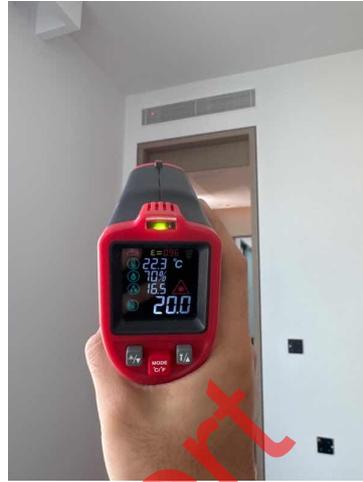
29 + 29/11/2024 Not attributed No deadline Not completed

The temperature readings at the air vents are elevated, exceeding acceptable levels, and should ideally be no higher than 12°C, given that the thermostat is set to 20°C. This discrepancy suggests potential inefficiencies in the HVAC system. A comprehensive diagnostic should be performed to investigate the underlying causes, starting with a thorough inspection of the chilled water supply, ductwork, and piping for potential leaks, blockages, or insulation issues. Additionally, the performance of the compressor units should be assessed to ensure they are functioning optimally and maintaining the correct refrigerant pressure and airflow. Any faults in these areas could be contributing to the system's inability to regulate the interior temperature effectively.

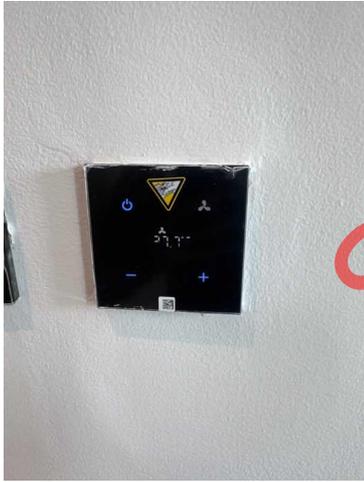
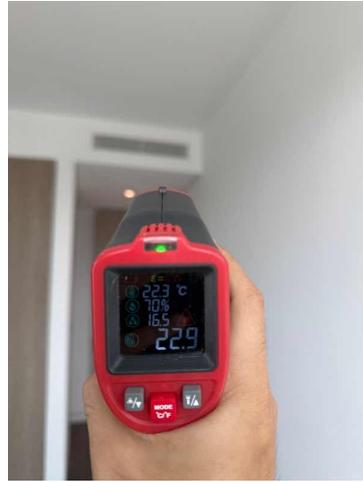
30 + 29/11/2024 Not attributed No deadline Not completed

The temperature readings at the air vents are elevated, exceeding acceptable levels, and should ideally be no higher than 12°C, given that the thermostat is set to 20°C. This discrepancy suggests potential inefficiencies in the HVAC system. A comprehensive diagnostic should be performed to investigate the underlying causes, starting with a thorough inspection of the chilled water supply, ductwork, and piping for potential leaks, blockages, or insulation issues. Additionally, the performance of the compressor units should be assessed to ensure they are functioning optimally and maintaining the correct refrigerant pressure and airflow. Any faults in these areas could be contributing to the system's inability to regulate the interior temperature effectively.

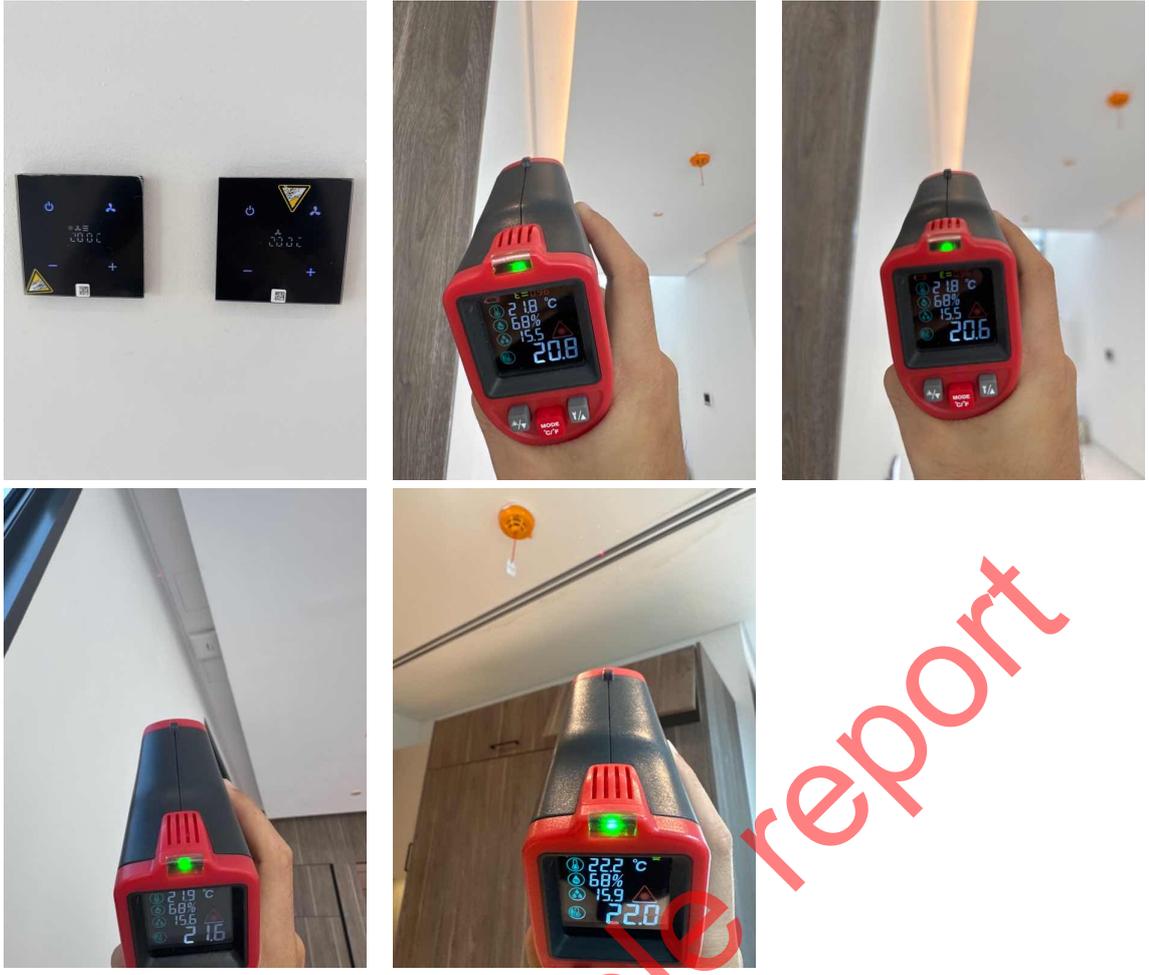
89 + 29/11/2024 Not attributed No deadline Not completed

Temperature recordings are within the acceptable levels and as per British standard.

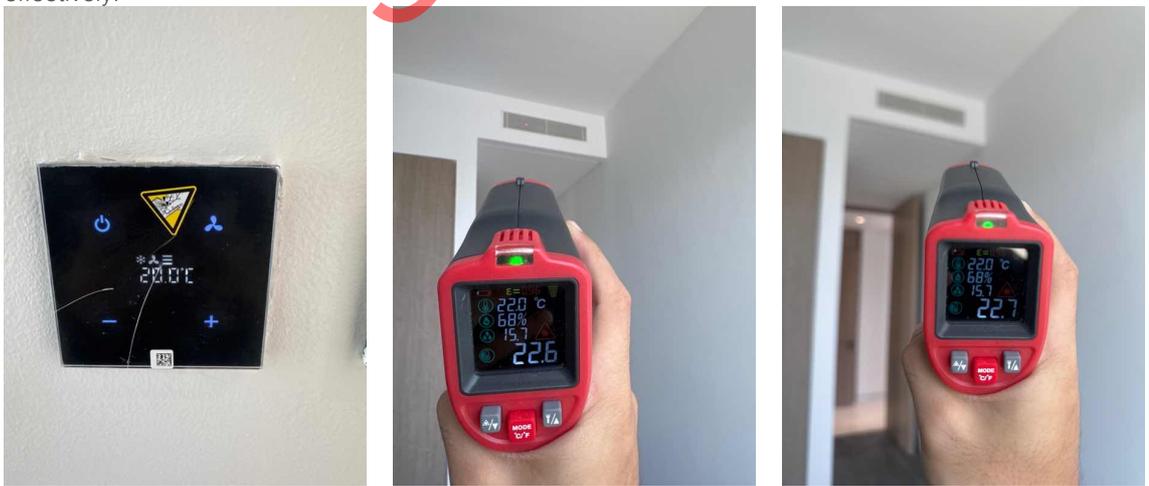
91 + 29/11/2024 Not attributed No deadline Not completed

The temperature readings at the air vents are elevated, exceeding acceptable levels, and should ideally be no higher than 12°C, given that the thermostat is set to 20°C. This discrepancy suggests potential inefficiencies in the HVAC system. A comprehensive diagnostic should be performed to investigate the underlying causes, starting with a thorough inspection of the chilled water supply, ductwork, and piping for potential leaks, blockages, or insulation issues. Additionally, the performance of the compressor units should be assessed to ensure they are functioning optimally and maintaining the correct refrigerant pressure and airflow. Any faults in these areas could be contributing to the system's inability to regulate the interior temperature effectively.

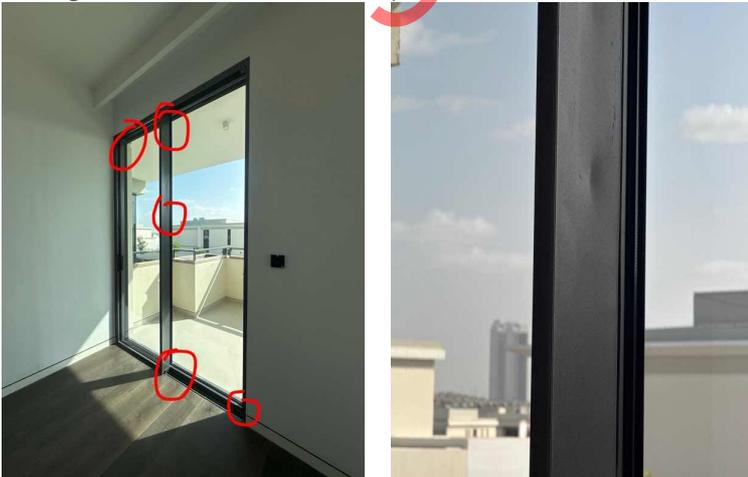
41 + 29/11/2024 Not attributed No deadline Not completed

Damaged aluminum frames to be replaced at all areas.

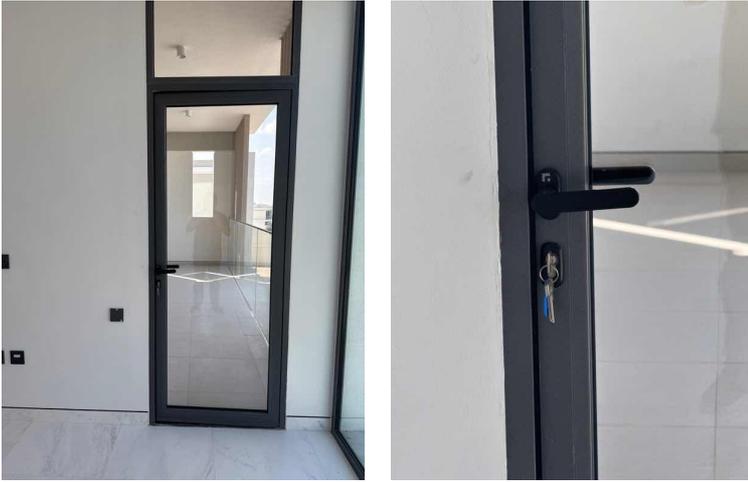
67 + 29/11/2024 Not attributed No deadline Not completed

Issue with the door lock to be replaced

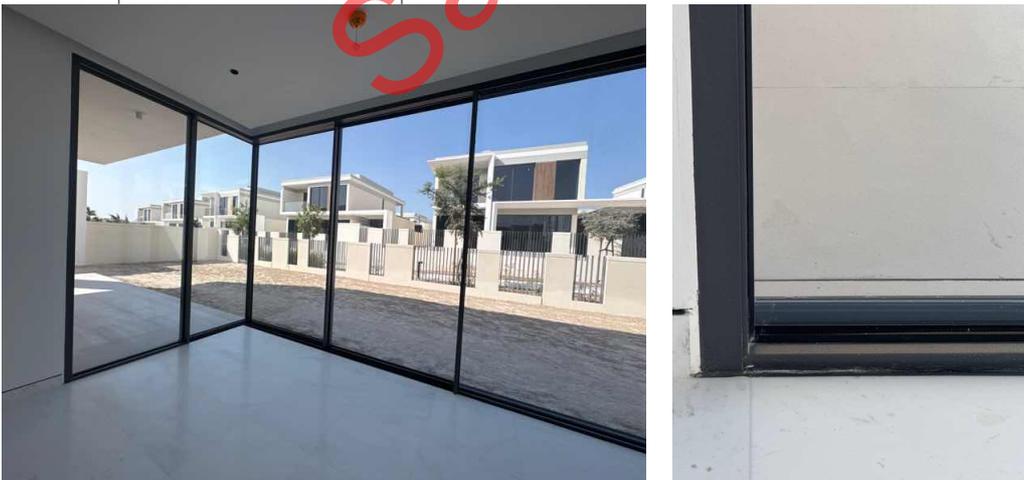
100 + 29/11/2024 Not attributed No deadline Not completed

Aluminum panels to be cleaned and polished.

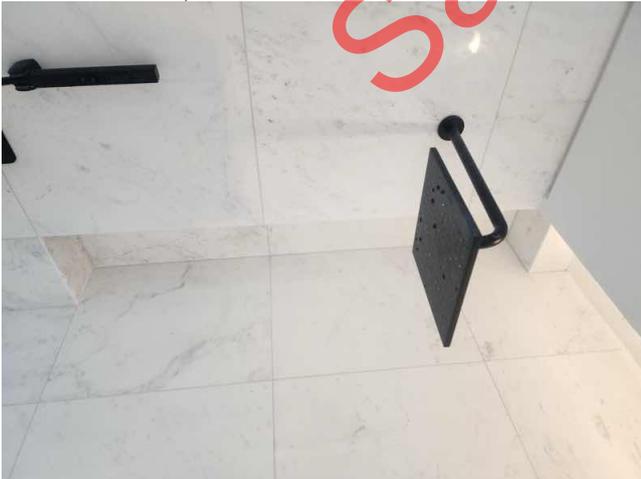
149 + 05/12/2024 Not attributed No deadline Not completed

Water shower cap in master bedroom bathroom not fixed well. Wobbly

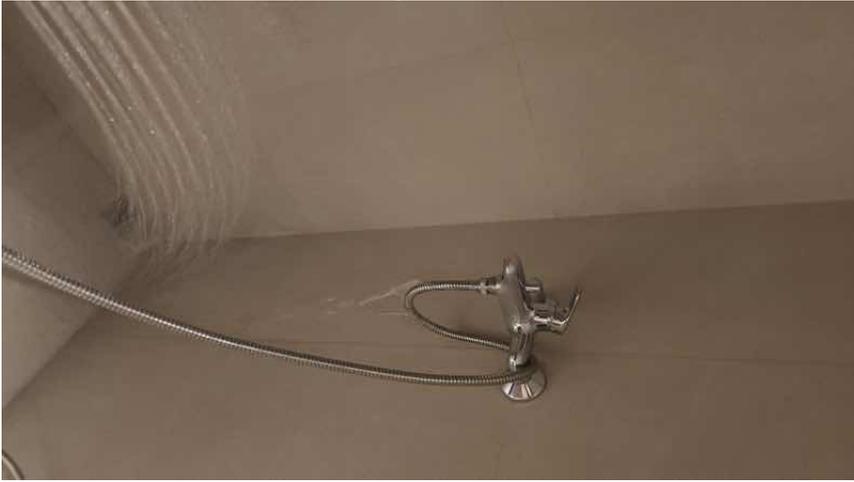
171 + 05/12/2024 Not attributed No deadline Not completed

Annex-Maid Room Shower is Leaking

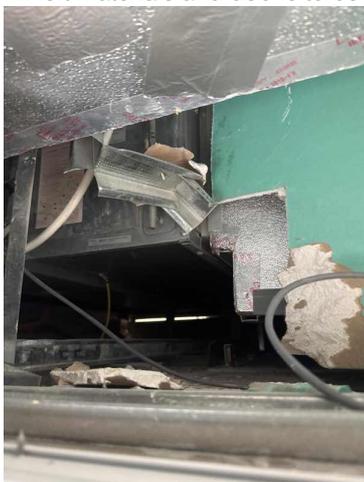
6 + 29/11/2024 Not attributed No deadline Not completed

All left materials and debris to be removed .

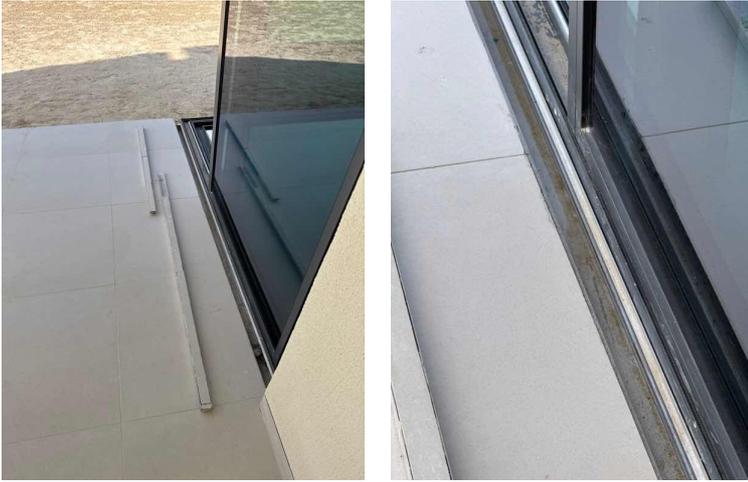
141 + 29/11/2024 Not attributed No deadline Not completed

Cover to be replaced.

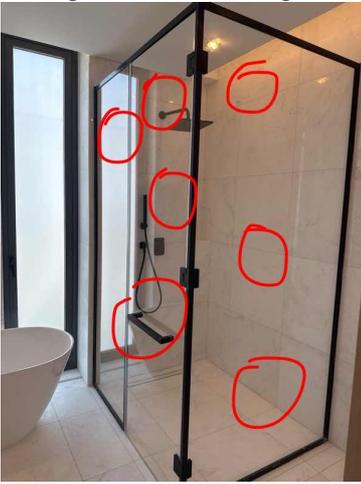
15 + 29/11/2024 Not attributed No deadline Not completed

Damaged and scratched glass to be replaced.

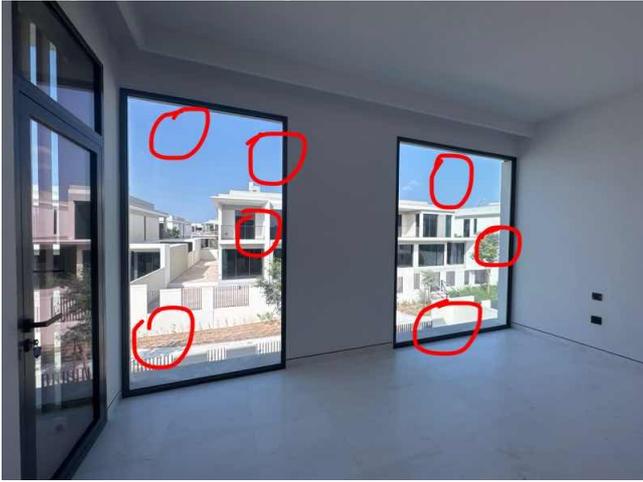
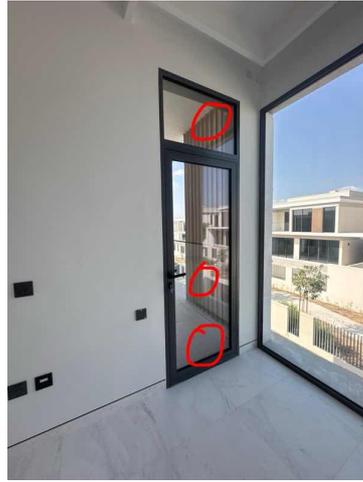
62 + 29/11/2024 Not attributed No deadline Not completed

Damaged and scratched glass to be replaced.

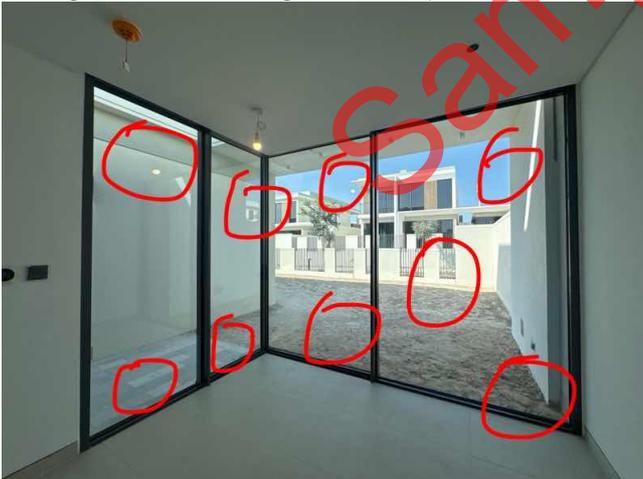
83 + 29/11/2024 Not attributed No deadline Not completed

Damaged and scratched glass to be replaced.

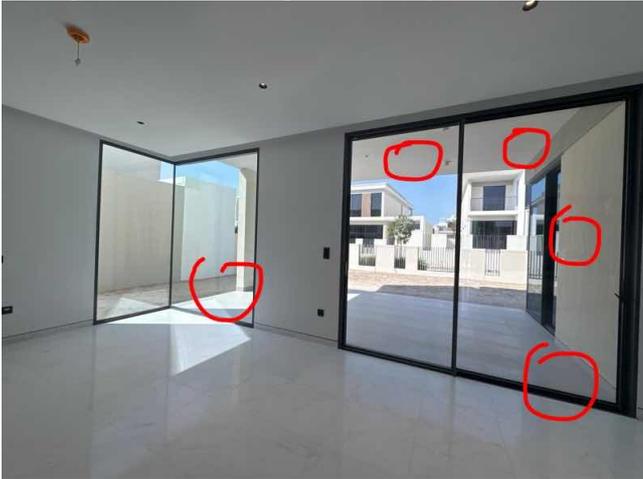
98 + 29/11/2024 Not attributed No deadline Not completed

Damaged and scratched glass to be replaced.

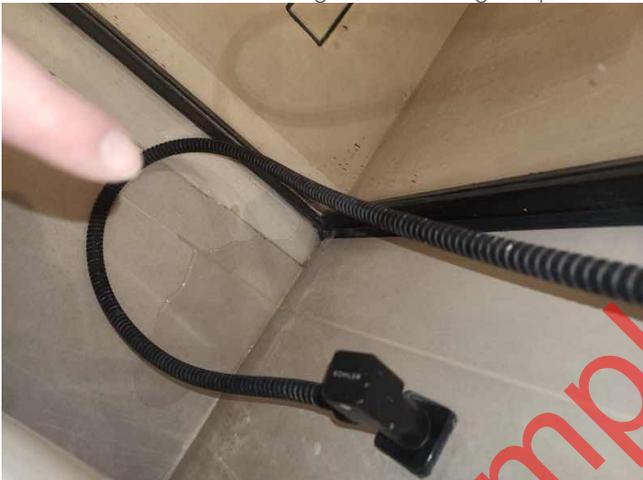
156 + 05/12/2024 Not attributed No deadline Not completed

Guest bedroom: water leaking between the glass partition frame and wall joint. No silicone insulation applied

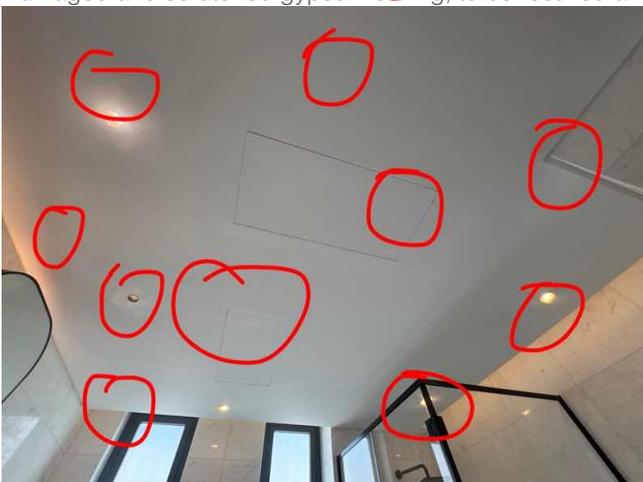
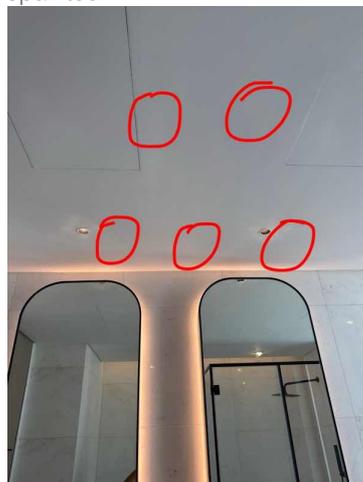
3 + 29/11/2024 Not attributed No deadline Not completed

Damaged and scratched gypsum ceiling, to be rectified and repainted.

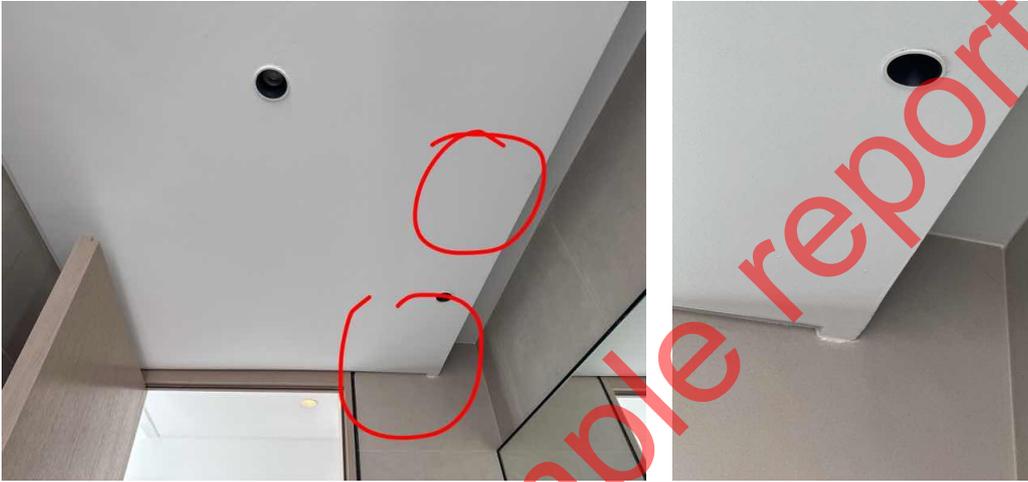
50 + 29/11/2024 Not attributed No deadline Not completed

Damaged and scratched gypsum ceiling, to be rectified and repainted.

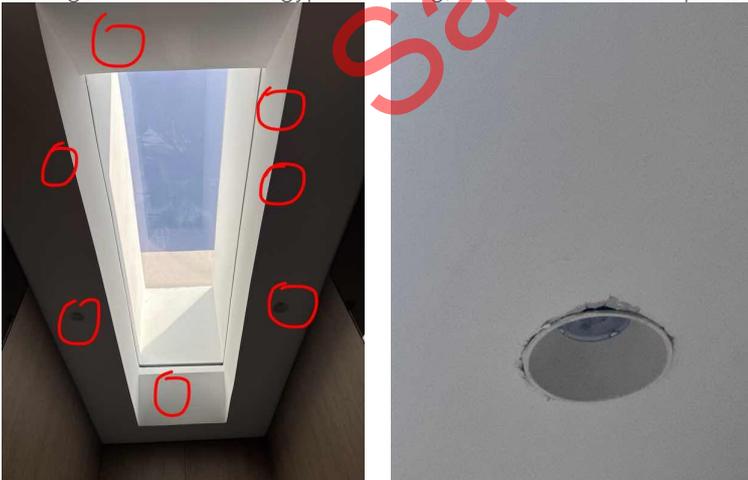
58 + 29/11/2024 Not attributed No deadline Not completed

Damaged and scratched gypsum ceiling, to be rectified and repainted.

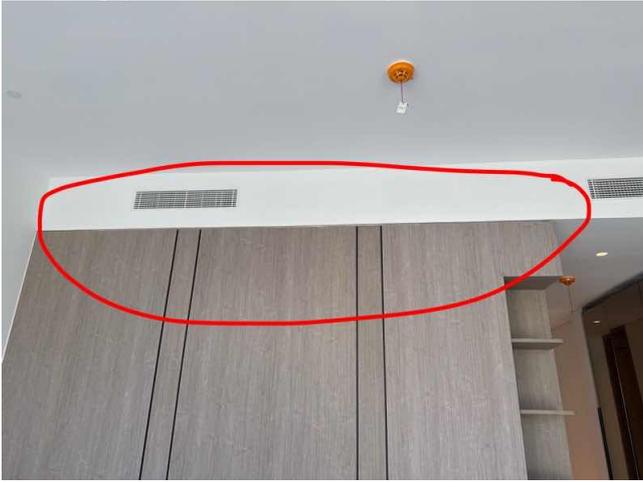
69 + 29/11/2024 Not attributed No deadline Not completed

Shadow gap trim to be redone and painted.

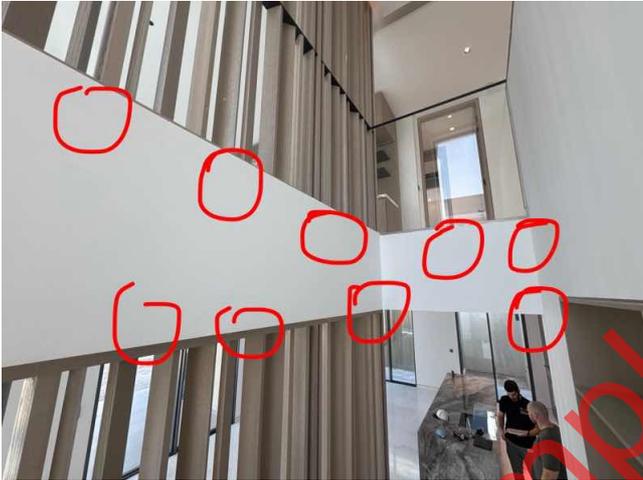
71 + 29/11/2024 Not attributed No deadline Not completed

Damaged and scratched gypsum ceiling, to be rectified and repainted.

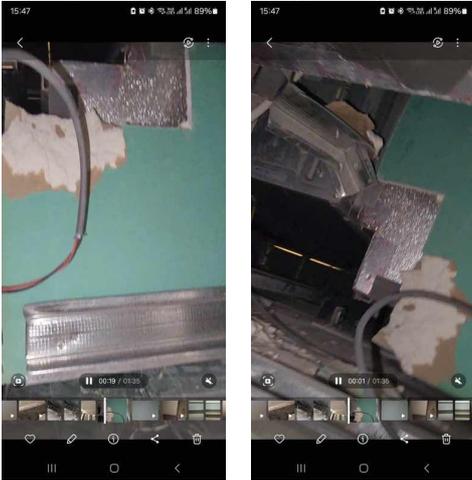
146 + 05/12/2024 Not attributed No deadline Not completed

Damaged and scratched gypsum partitions to be replaced in above bathroom ceiling.

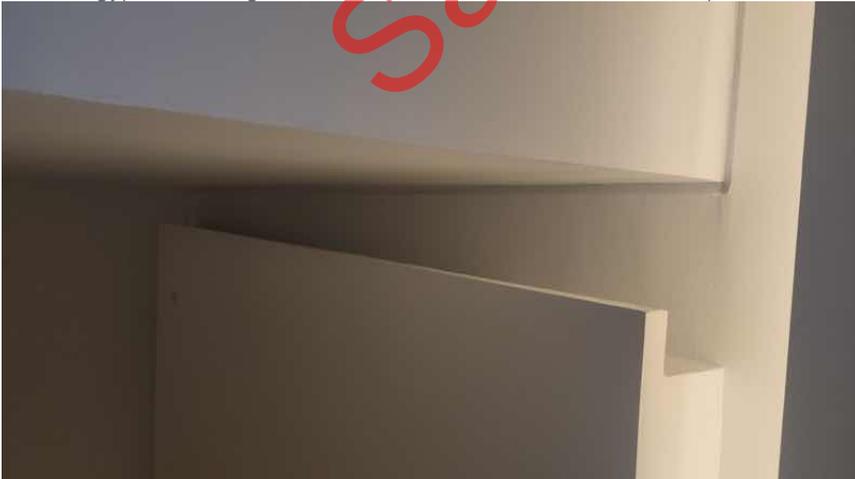
151 + 05/12/2024 Not attributed No deadline Not completed

1st floor gypsum ceiling above staircase: uneven corner, uneven paint

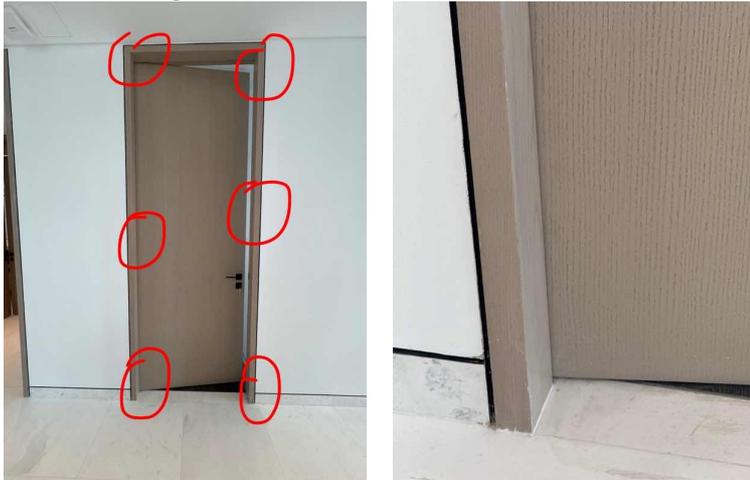
53 + 29/11/2024 Not attributed No deadline Not completed

Damaged and scratched wood frames, to be replaced and rectified at all areas, damages been observed at all doors and cabinets at a higher rate.

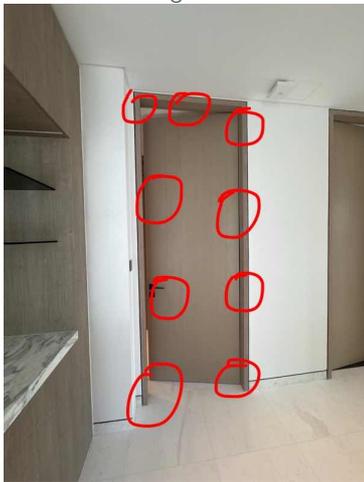
54 + 29/11/2024 Not attributed No deadline Not completed

Damaged and scratched wood frames, to be replaced and rectified at all areas, damages been observed at all doors and cabinets at a higher rate.

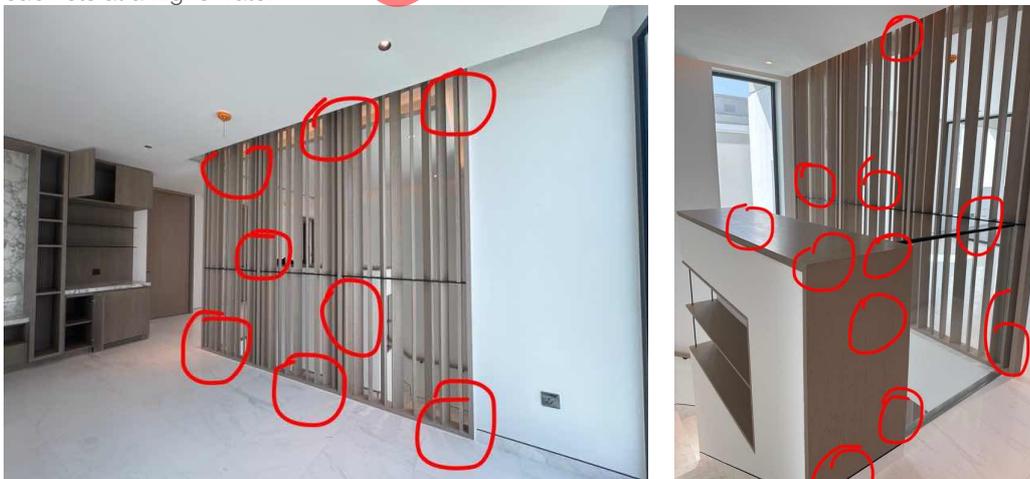
55 + 29/11/2024 Not attributed No deadline Not completed

Damaged and scratched wood frames, to be replaced and rectified at all areas, damages been observed at all doors and cabinets at a higher rate.

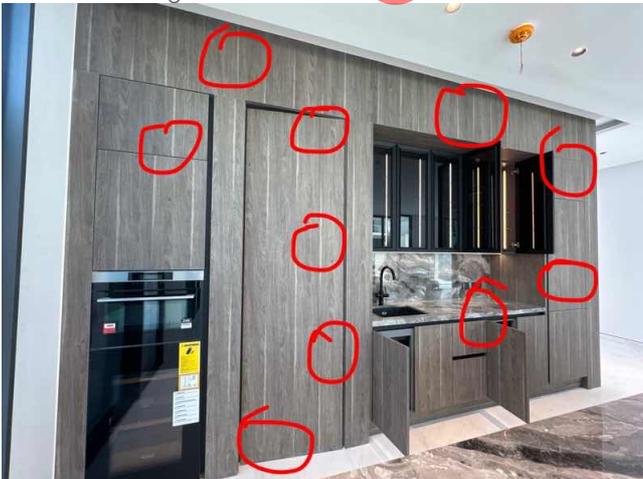
110 + 29/11/2024 Not attributed No deadline Not completed

Damaged and scratched wood frames, to be replaced and rectified at all areas, damages been observed at all doors and cabinets at a higher rate.

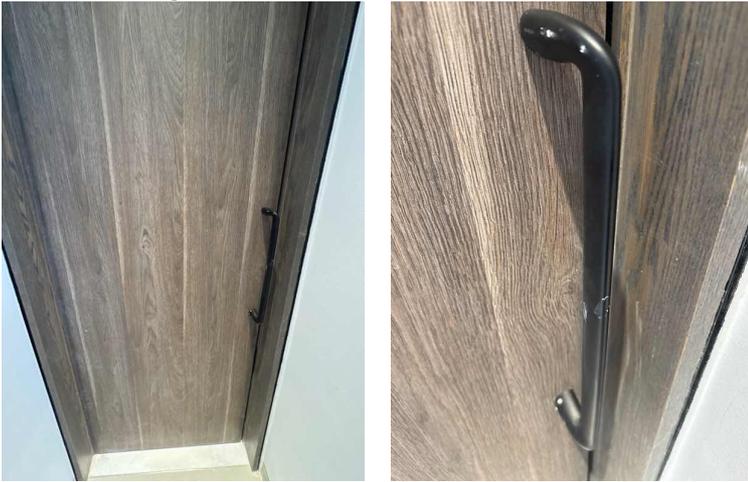
117 + 29/11/2024 Not attributed No deadline Not completed

Damaged and scratched wood frames, to be replaced and rectified at all areas, damages been observed at all doors and cabinets at a higher rate.

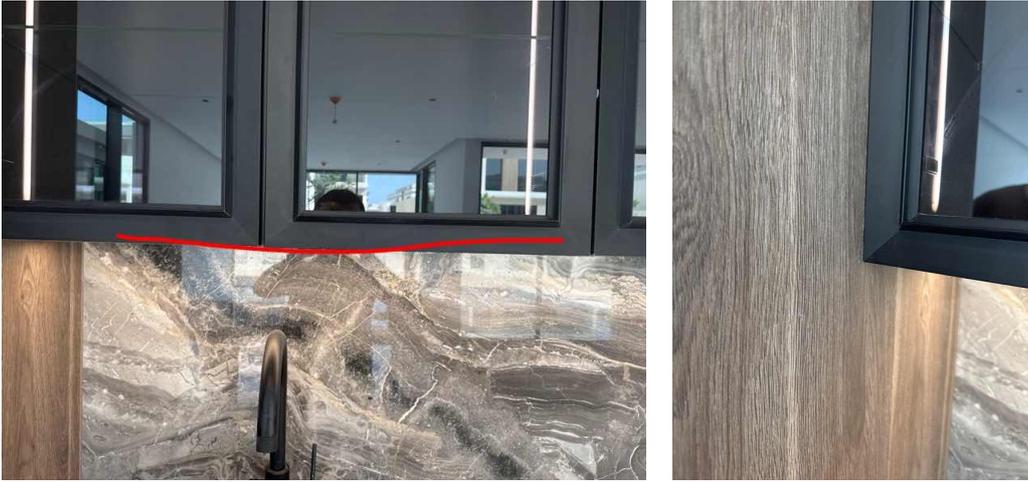
Frame alignment to be rectified all of the cabinets hinges are loose and touching other elements when opening

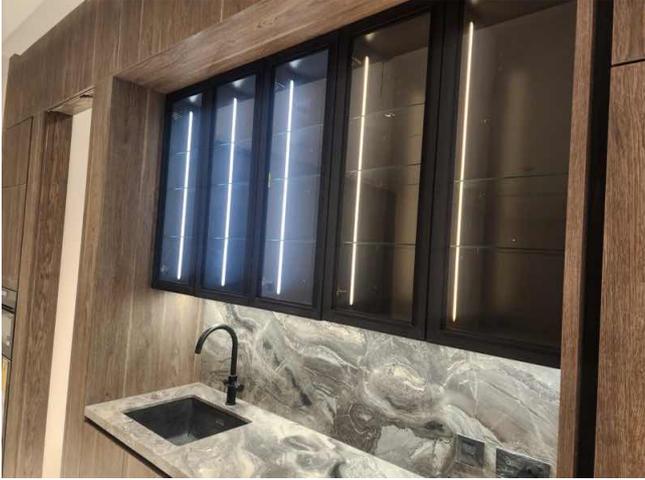
Showkitchen: different temperature and color tone LED Strips

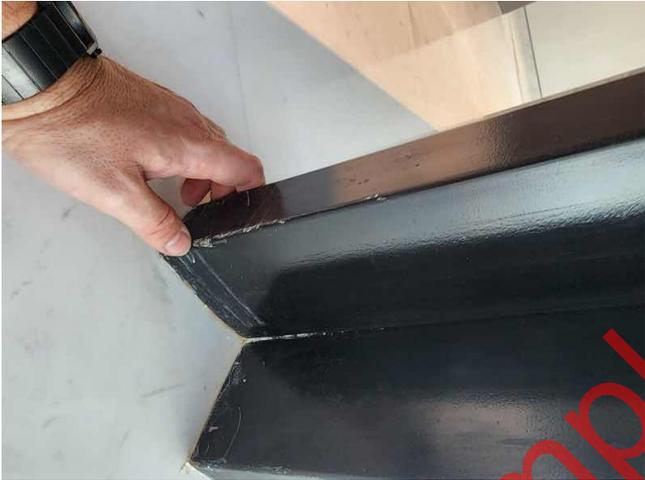
162 + 05/12/2024 Not attributed No deadline Not completed

Scratched and damaged front kitchen island leg

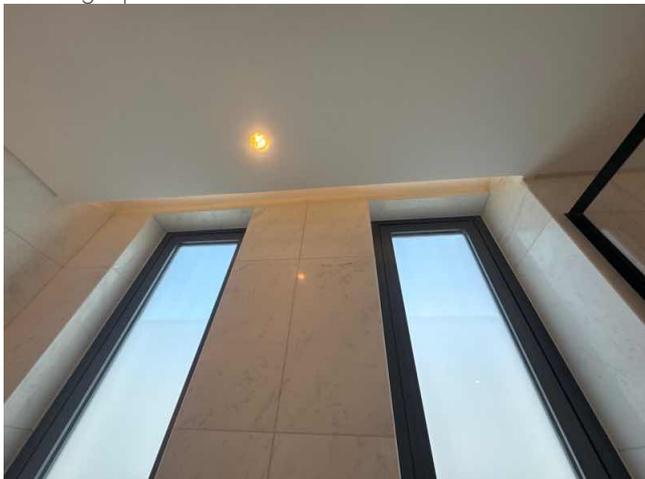
Masking tape to be removed from all areas

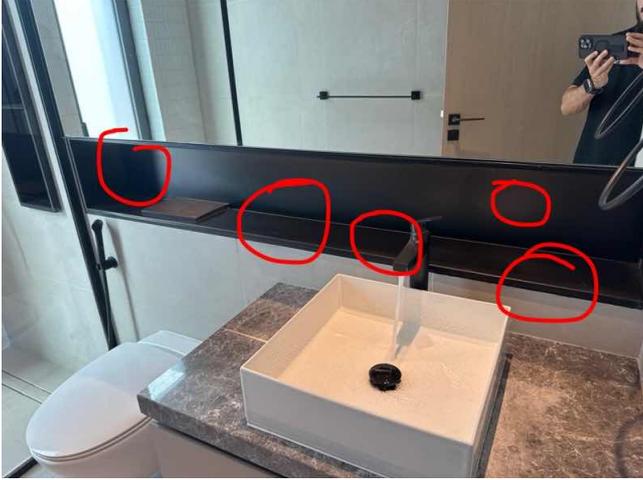
43 + 29/11/2024 Not attributed No deadline Not completed

Damages on the wall, a final layer of paint to be applied.

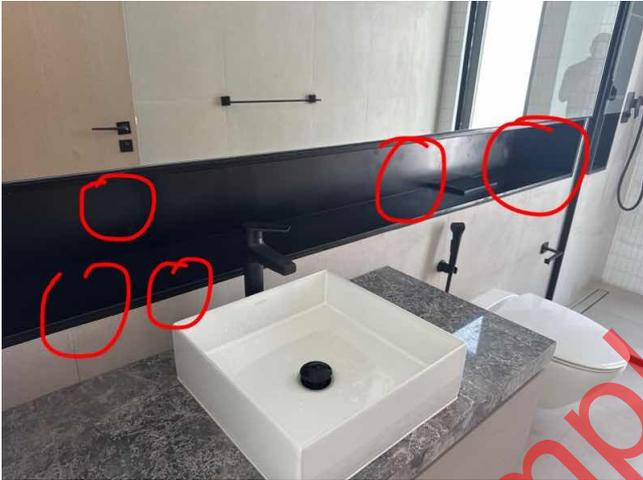
48 + 29/11/2024 Not attributed No deadline Not completed

Damages on the wall, a final layer of paint to be applied.

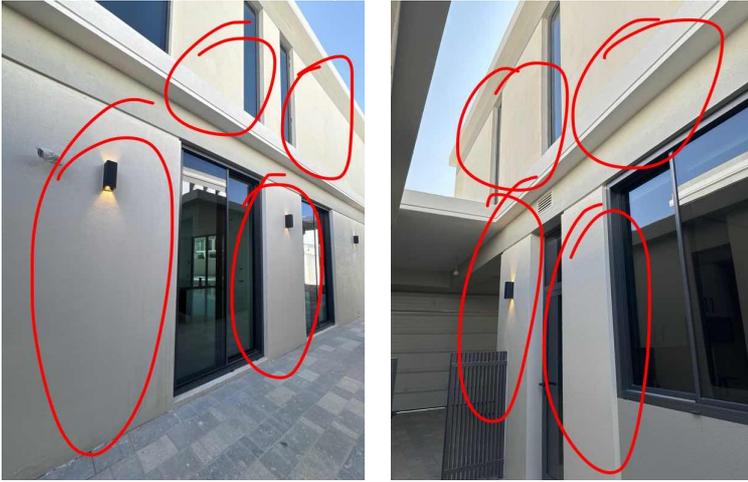
Damages on the wall, a final layer of paint to be applied.

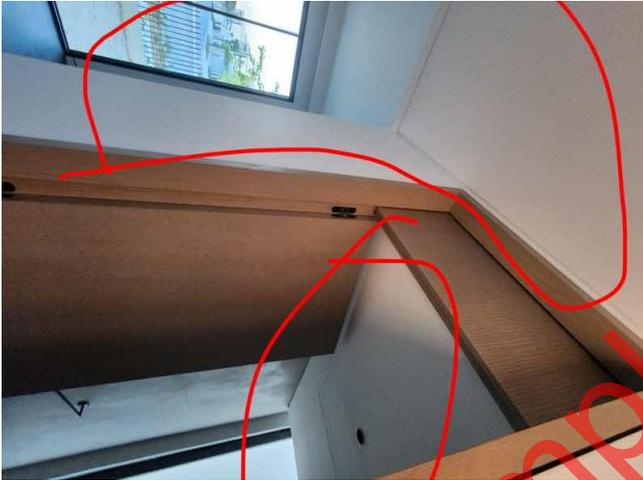
Damages on the wall, a final layer of paint to be applied.

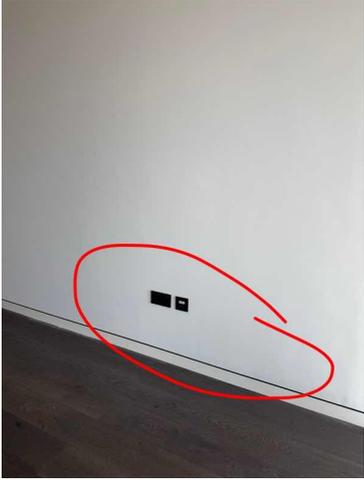
Damages and scratches, to be replastered and a final layer of paint to be applied.

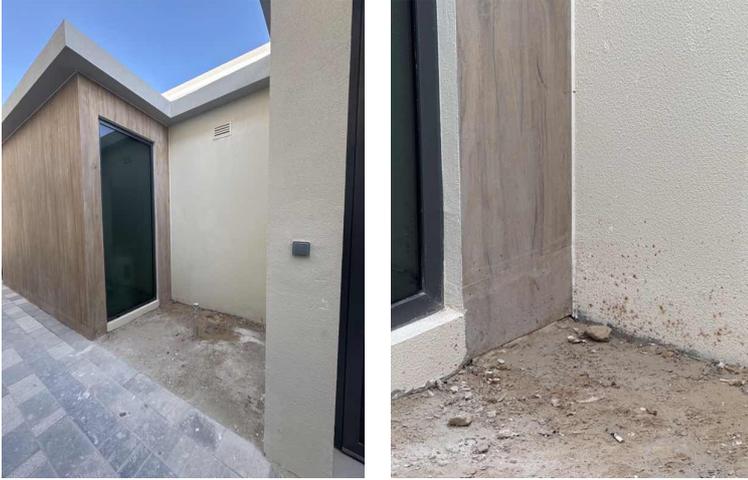
For finishing and termination to be rectified

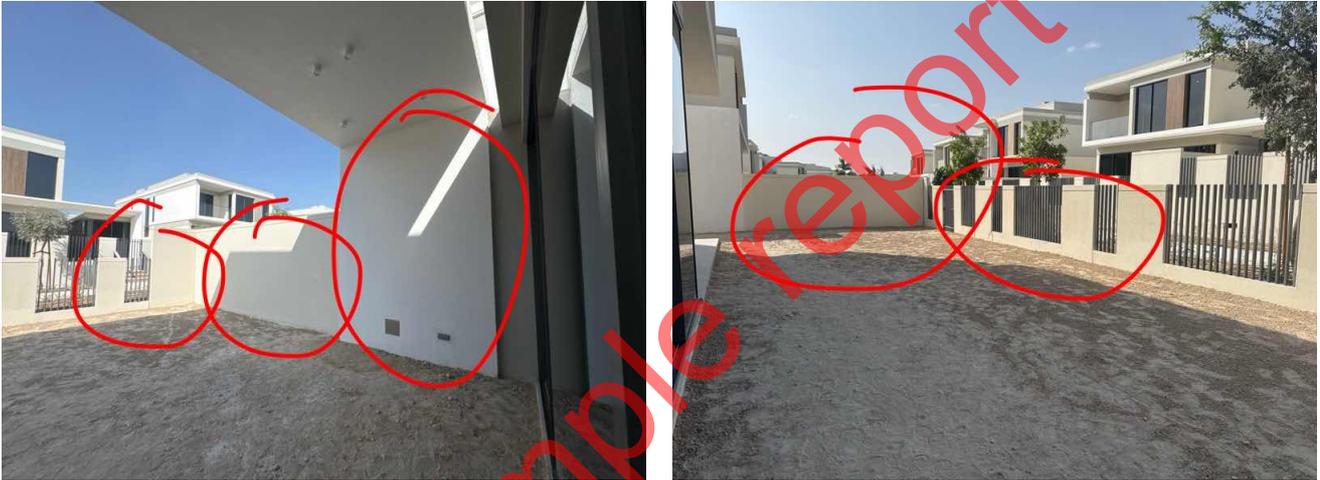
85 + 29/11/2024 Not attributed No deadline Not completed

Damages and scratches, to be replastered and a final layer of paint to be applied.

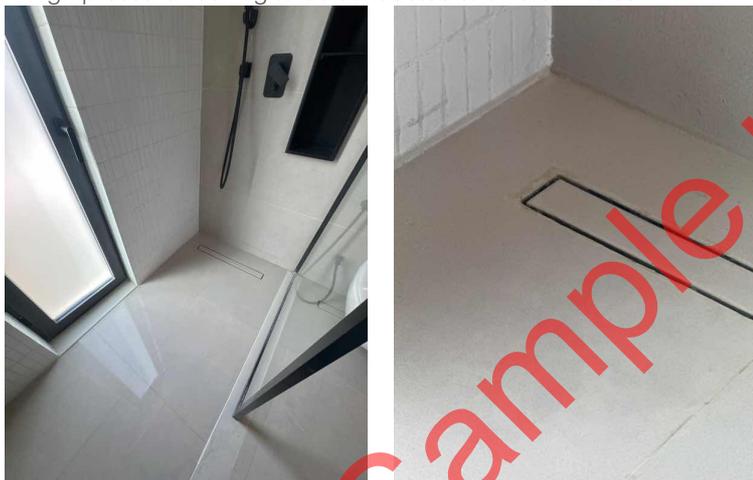
Water not draining, to be checked for blockage.  
A high pressure flushing to be conducted to all drain holes.

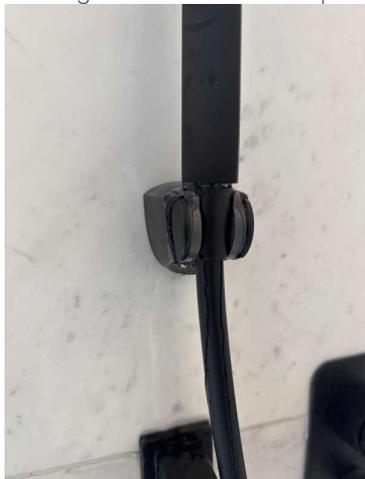
21 + 29/11/2024 Not attributed No deadline Not completed

Leaking showerhead to be replaced

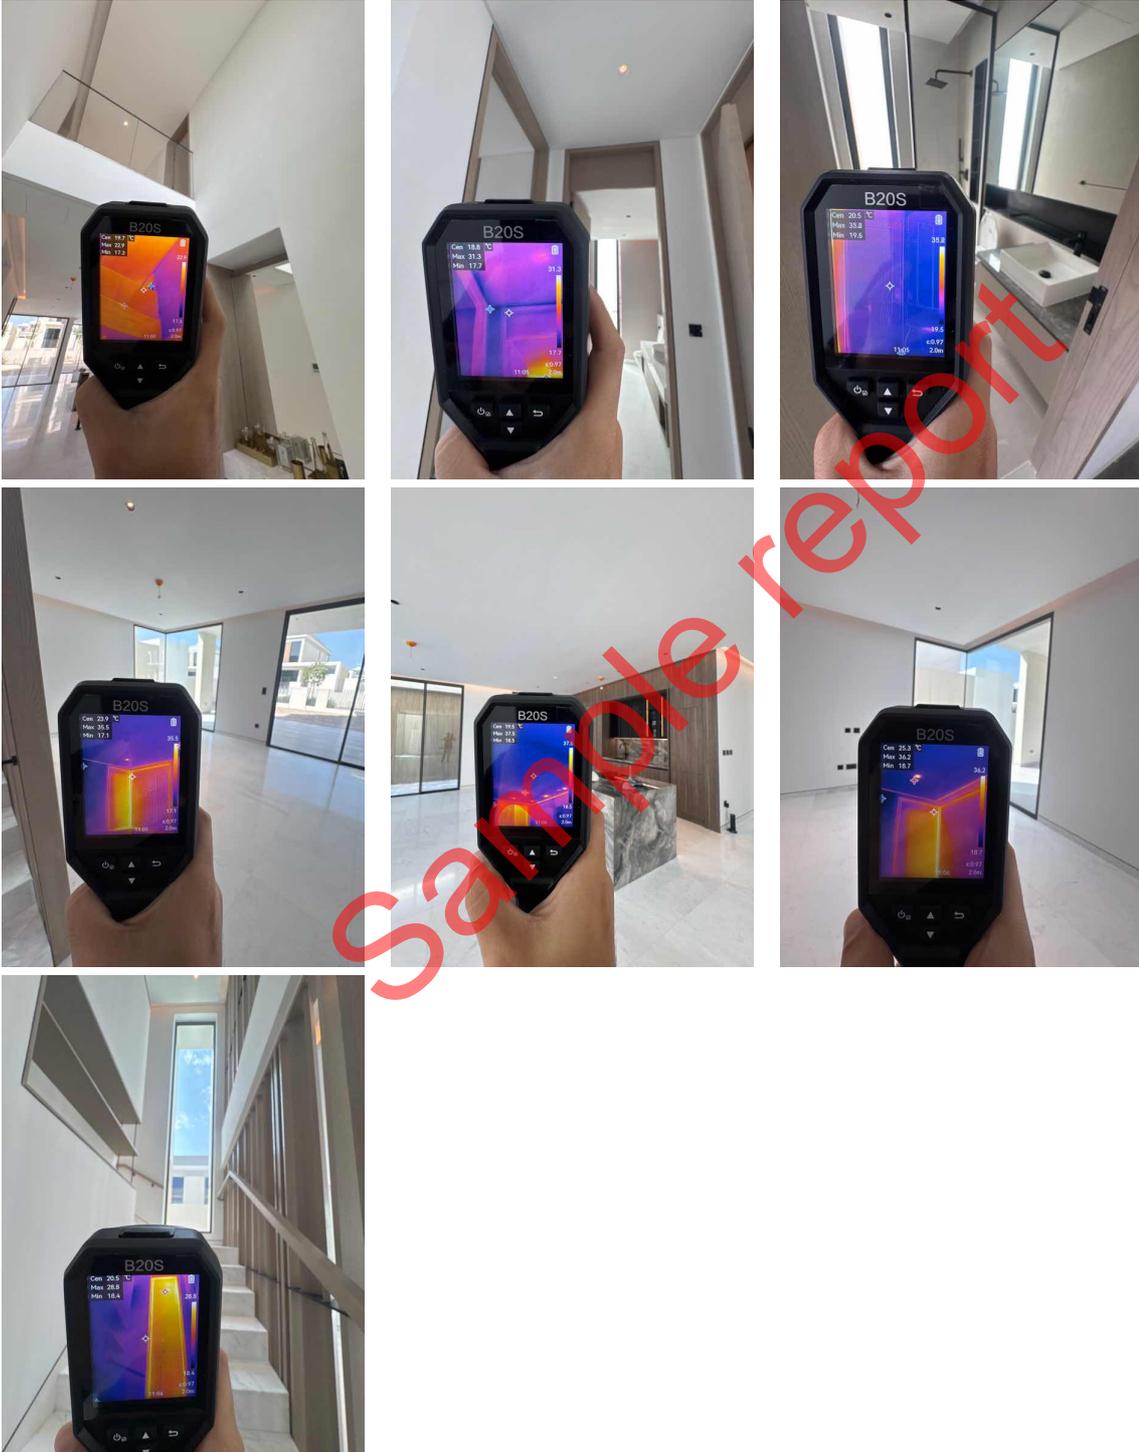
The property has undergone a comprehensive thermal scan, which was conducted using advanced infrared thermography technology. This technique allows for the detection of temperature variations on surfaces, identifying areas of potential concern that may not be visible to the naked eye. The scan assessed the property's structural integrity, insulation efficiency, and overall thermal performance. Throughout the inspection, no significant anomalies were detected. Specifically, there were no indications of moisture ingress, air leaks, or thermal bridging that could suggest insulation deficiencies or compromised building materials. All temperature variations were within normal ranges, confirming that the property is thermally efficient and does not exhibit any issues related to energy loss, dampness, or structural irregularities. This thorough examination ensures that the property is in optimal condition from a thermal performance perspective.

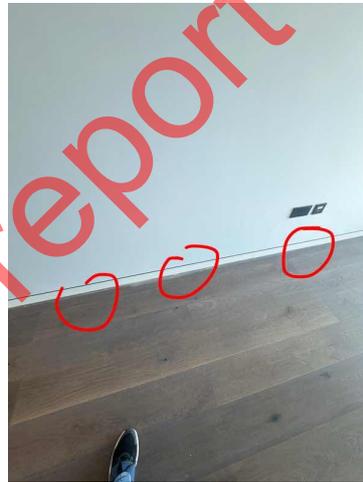
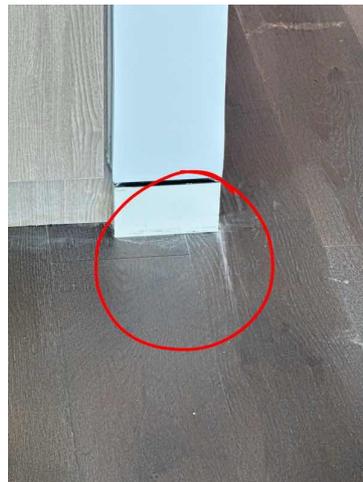
Damaged tile , to be replaced.
