**RAMI**  
Property  
Inspections

## Property Inspection Report

# VILLA

Description	Client : Dubai 0000
Address :	Dubai
Generated on	- 10/12/2024
Stages	- Comprehensive Handover Snagging
Building trades	<ul style="list-style-type: none"><li>- About</li><li>- Air conditioning</li><li>- Aluminium joinery</li><li>- Bathroom Accessories, interiors and Fittings</li><li>- Electricity</li><li>- General Works</li><li>- Glass</li><li>- Gypsum &amp; Acoustic Ceiling</li><li>- Humidity</li><li>- Interior joinery</li><li>- Kitchen</li><li>- Noise Level</li><li>- Paint</li><li>- Paving</li><li>- Plaster</li><li>- Plumbing and heating</li><li>- Thermography</li><li>- Tiling, Wooden Floorings and stairs.</li><li>- Water Networks</li><li>- Water/ Moisture Intrusion</li></ul>
Stakeholders	
Drawings	- 2024-11-29 (Comprehensive Handover Snagging)

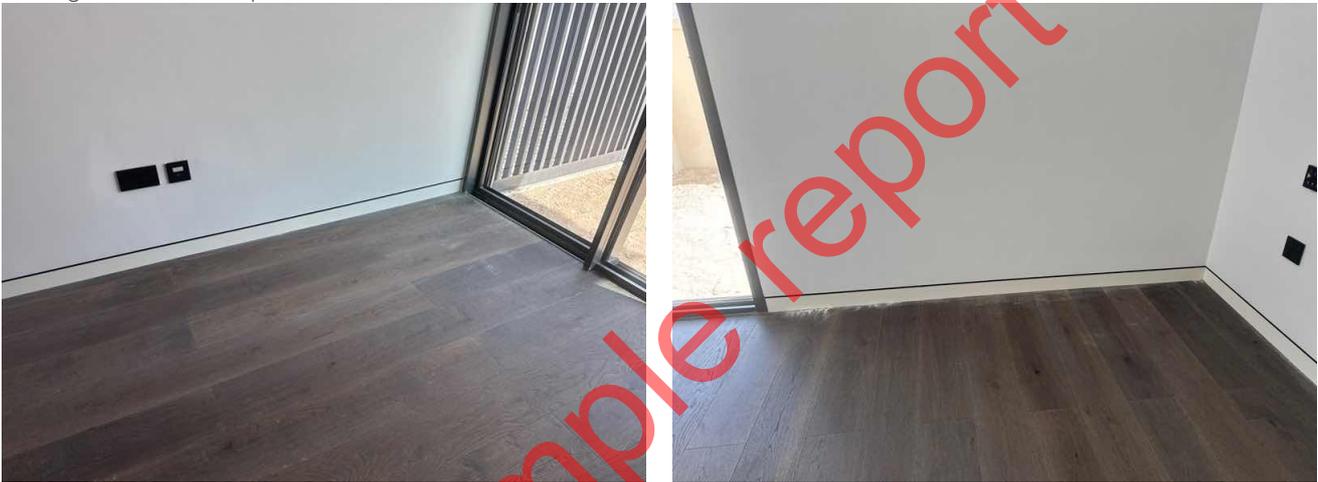
Damaged tile , to be replaced.

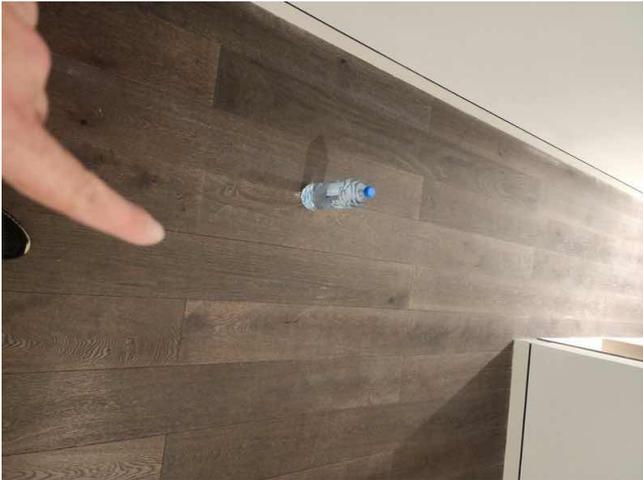
Bedroom 1st floor street side left hand side (when facing street) - uneven floor in front of the bathroom door, Exactly where the bottle is

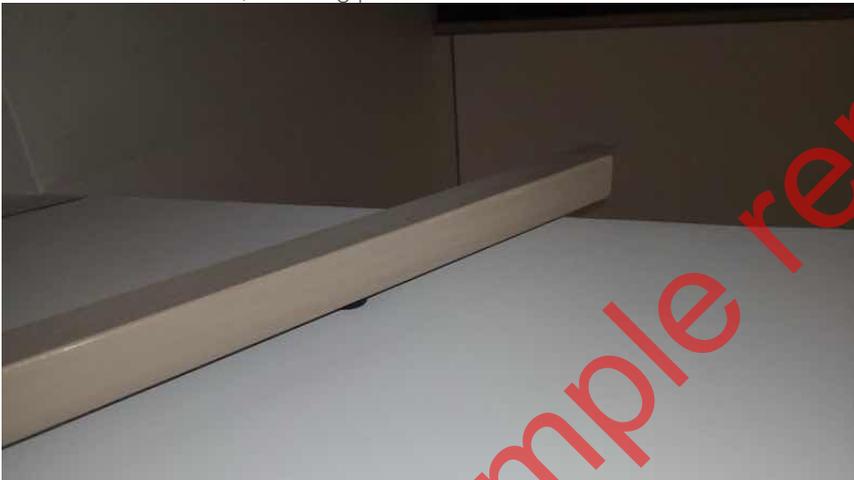
152 + 05/12/2024 Not attributed No deadline Not completed

Staircase rail: 1st floor, 1st fixing point not fixed well. Wobble noted.

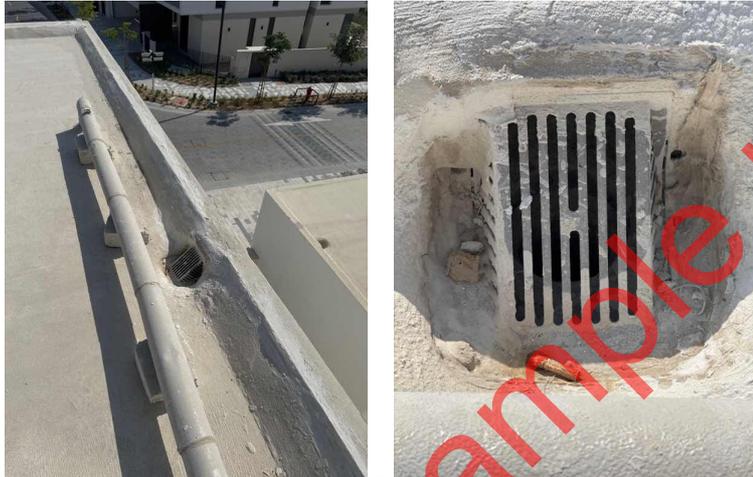
External drainage points to be tested for blockage, debris have been observed which raises the possibility.

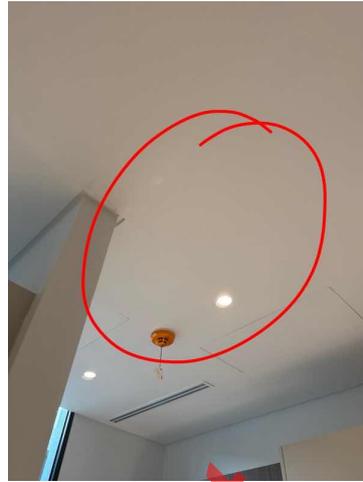
72    + 29/11/2024    Not attributed    No deadline    Not completed

Damp patches due to penetrating damps , all surrounding faulty gaps and cracks to be closed, walls and ceiling to be painted with damp proof paint and exterior areas to be properly coated.
