**RAMI**  
Property  
Inspections

## Property Inspection Report

# VILLA

Description	Client : Dubai 0000
Address :	Dubai
Generated on	- 10/12/2024
Stages	- Comprehensive Handover Snagging
Building trades	<ul style="list-style-type: none"><li>- About</li><li>- Air conditioning</li><li>- Aluminium joinery</li><li>- Bathroom Accessories, interiors and Fittings</li><li>- Electricity</li><li>- General Works</li><li>- Glass</li><li>- Gypsum &amp; Acoustic Ceiling</li><li>- Humidity</li><li>- Interior joinery</li><li>- Kitchen</li><li>- Noise Level</li><li>- Paint</li><li>- Paving</li><li>- Plaster</li><li>- Plumbing and heating</li><li>- Thermography</li><li>- Tiling, Wooden Floorings and stairs.</li><li>- Water Networks</li><li>- Water/ Moisture Intrusion</li></ul>
Stakeholders	
Drawings	- 2024-11-29 (Comprehensive Handover Snagging)

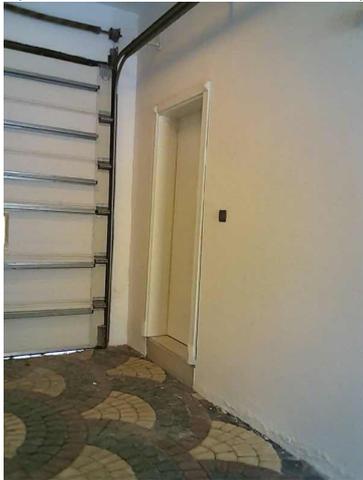
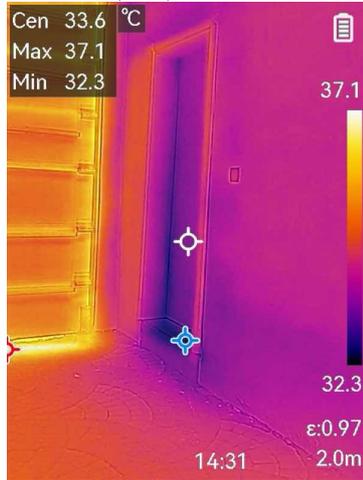
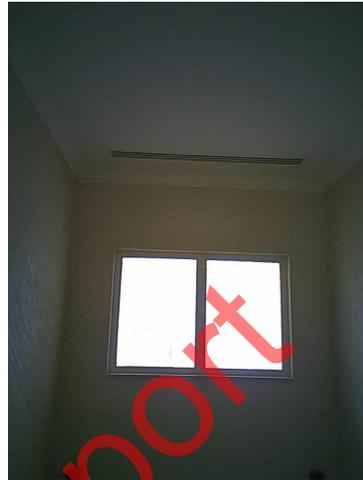
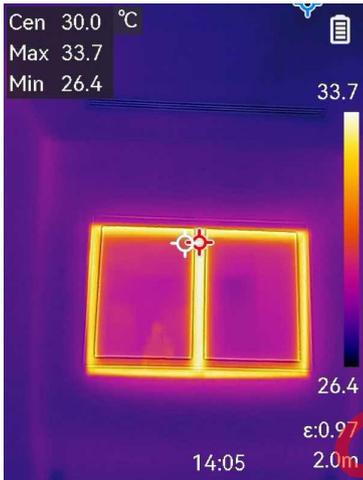
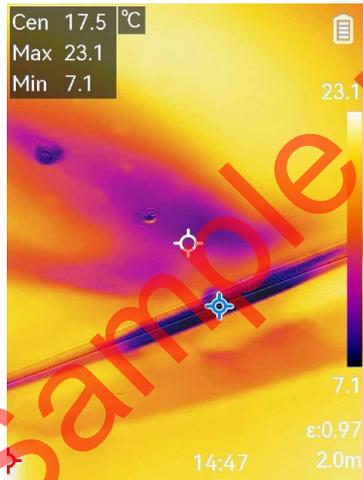
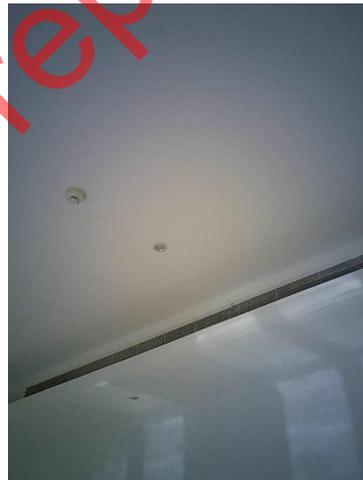
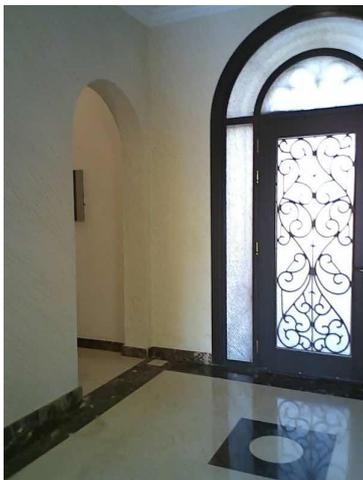
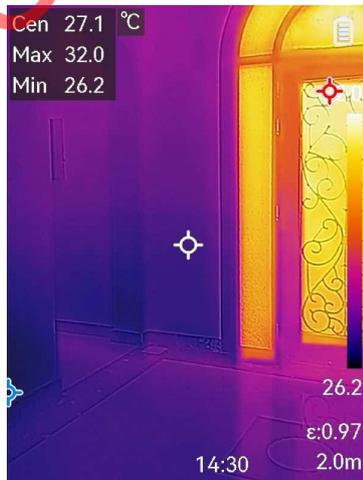
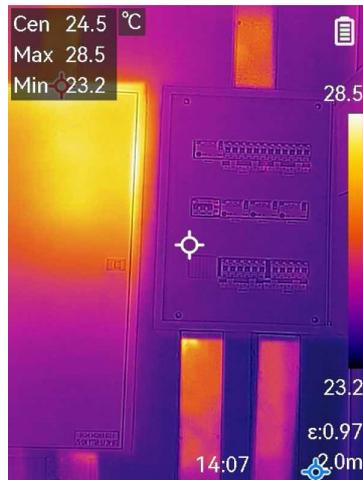
38 12/10/2024 Not attributed No deadline Not completed

The property has undergone a comprehensive thermal scan, which was conducted using advanced infrared thermography technology. This technique allows for the detection of temperature variations on surfaces, identifying areas of potential concern that may not be visible to the naked eye. The scan assessed the property's structural integrity, insulation efficiency, and overall thermal performance. Throughout the inspection, no significant anomalies were detected. Specifically, there were no indications of moisture ingress, air leaks, or thermal bridging that could suggest insulation deficiencies or compromised building materials. All temperature variations were within normal ranges, confirming that the property is thermally efficient and does not exhibit any issues related to energy loss, dampness, or structural irregularities. This thorough examination ensures that the property is in optimal condition from a thermal performance perspective.

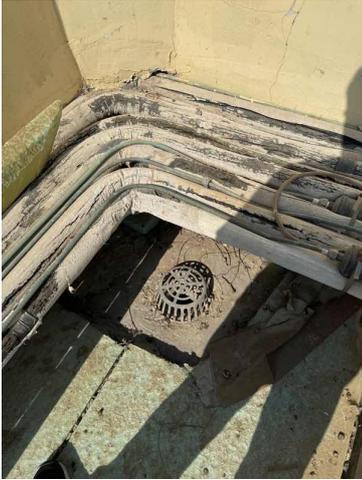
33    11/10/2024    Not attributed    No deadline    Not completed

External drainage points to be tested for blockage, debris have been observed which raises the possibility.

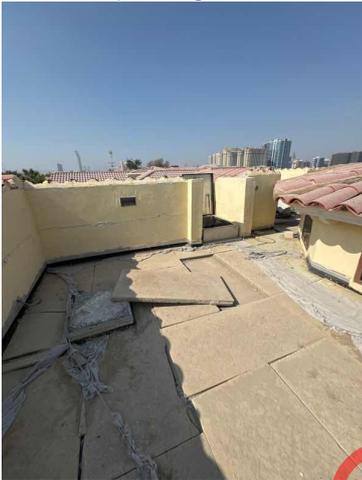
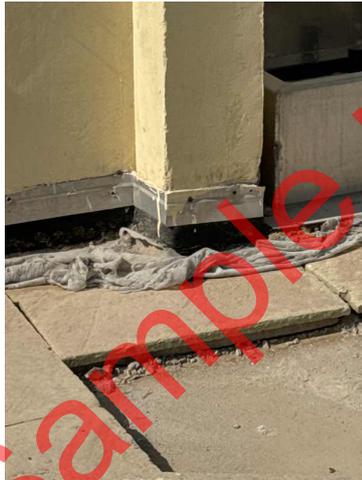
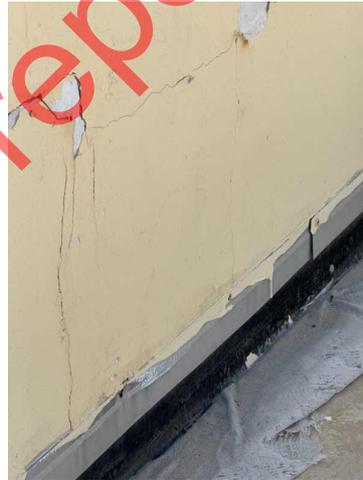
28    11/10/2024    Not attributed    No deadline    Not completed

New waterproofing to be installed on the roof. Current installation is not sufficient to protect from water leakage.

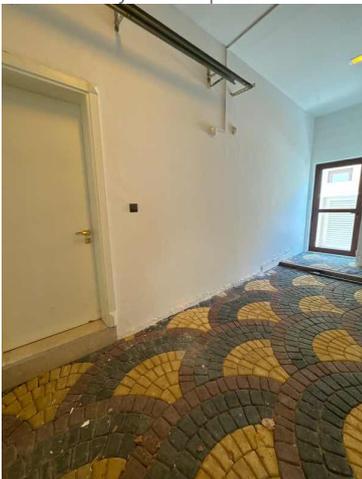
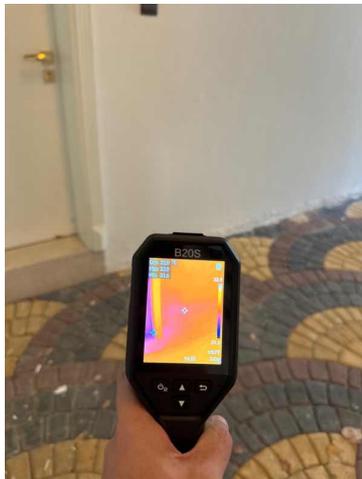
37    11/10/2024    Not attributed    No deadline    Not completed

Damp surface as per the Moisture meter ( Reading above 18% is considered damp).

Excess moisture coming in due to condensation, leaks, insufficient exhaust at bathrooms and inadequate drainage, all to be checked by developer.

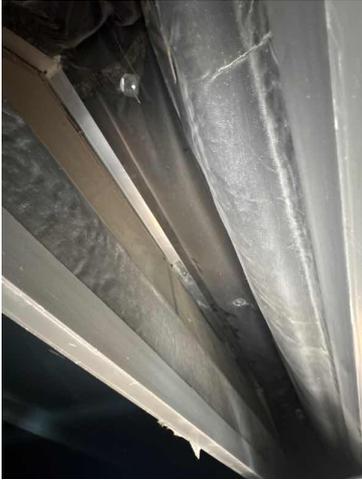
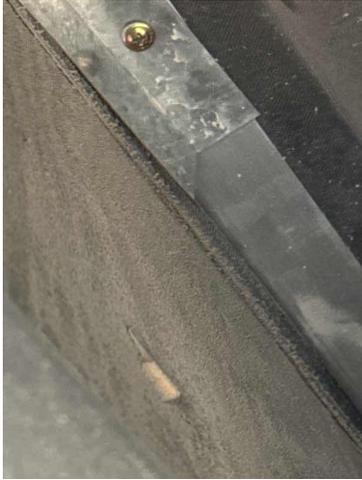
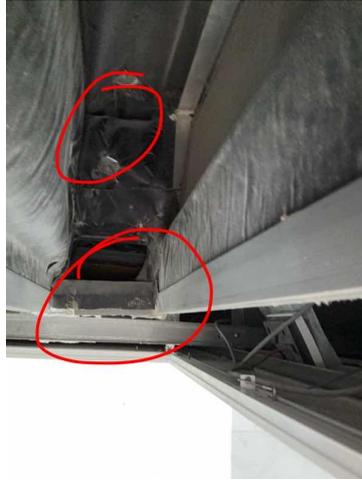
5    29/11/2024    Not attributed    No deadline    Not completed

AC filters are dusty to be cleaned at all units, this helps in avoiding high DEWA bills and mechanical problems down the road.

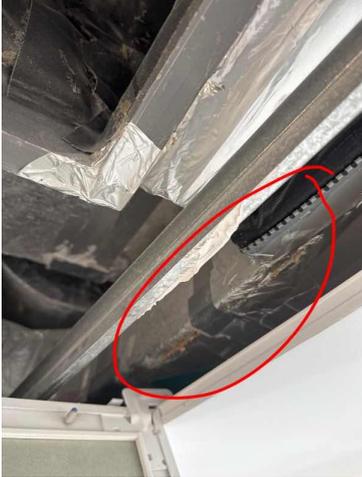
7    29/11/2024    Not attributed    No deadline    Not completed

Damage ducting to be replaced

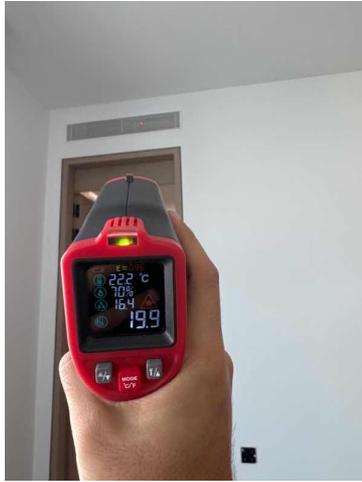
29 + 29/11/2024 Not attributed No deadline Not completed

The temperature readings at the air vents are elevated, exceeding acceptable levels, and should ideally be no higher than 12°C, given that the thermostat is set to 20°C. This discrepancy suggests potential inefficiencies in the HVAC system. A comprehensive diagnostic should be performed to investigate the underlying causes, starting with a thorough inspection of the chilled water supply, ductwork, and piping for potential leaks, blockages, or insulation issues. Additionally, the performance of the compressor units should be assessed to ensure they are functioning optimally and maintaining the correct refrigerant pressure and airflow. Any faults in these areas could be contributing to the system's inability to regulate the interior temperature effectively.

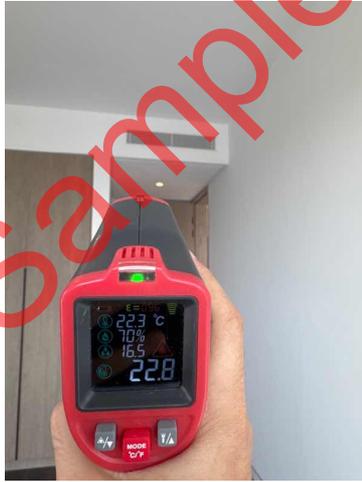
30 + 29/11/2024 Not attributed No deadline Not completed

The temperature readings at the air vents are elevated, exceeding acceptable levels, and should ideally be no higher than 12°C, given that the thermostat is set to 20°C. This discrepancy suggests potential inefficiencies in the HVAC system. A comprehensive diagnostic should be performed to investigate the underlying causes, starting with a thorough inspection of the chilled water supply, ductwork, and piping for potential leaks, blockages, or insulation issues. Additionally, the performance of the compressor units should be assessed to ensure they are functioning optimally and maintaining the correct refrigerant pressure and airflow. Any faults in these areas could be contributing to the system's inability to regulate the interior temperature effectively.

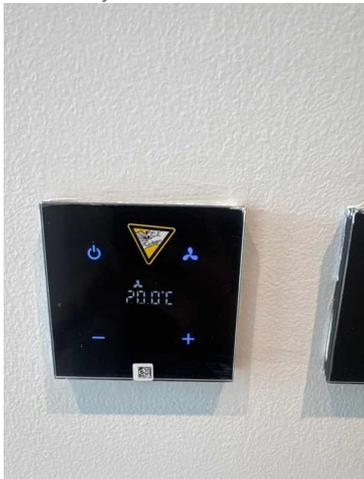
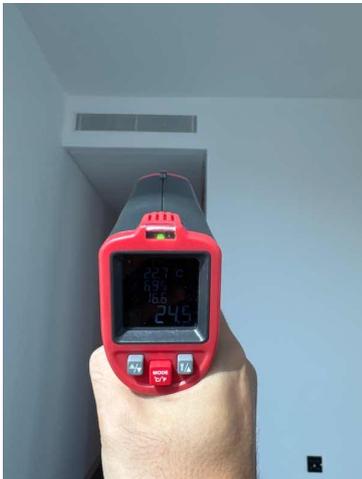
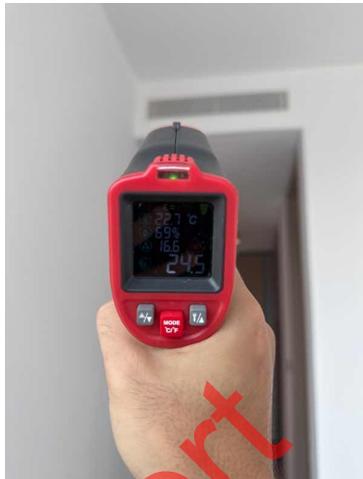
31 29/11/2024 Not attributed No deadline Not completed

The temperature readings at the air vents are elevated, exceeding acceptable levels, and should ideally be no higher than 12°C, given that the thermostat is set to 20°C. This discrepancy suggests potential inefficiencies in the HVAC system. A comprehensive diagnostic should be performed to investigate the underlying causes, starting with a thorough inspection of the chilled water supply, ductwork, and piping for potential leaks, blockages, or insulation issues. Additionally, the performance of the compressor units should be assessed to ensure they are functioning optimally and maintaining the correct refrigerant pressure and airflow. Any faults in these areas could be contributing to the system's inability to regulate the interior temperature effectively.

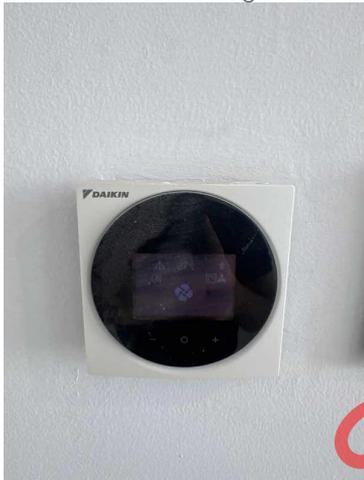
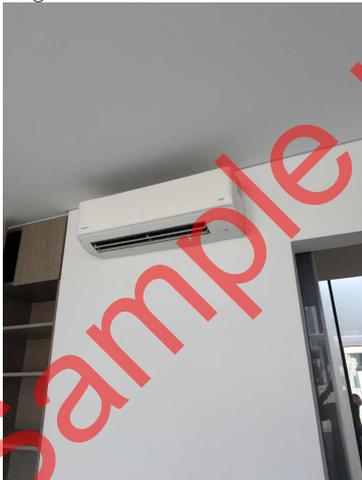
84 29/11/2024 Not attributed No deadline Not completed

I see with error message and not calling to be checked

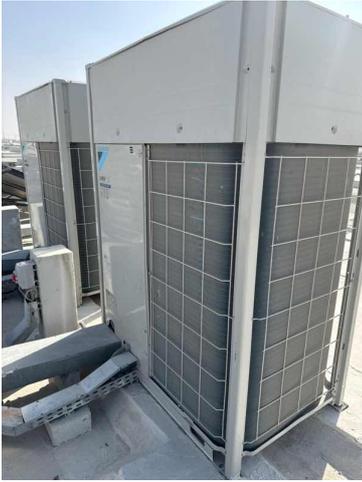
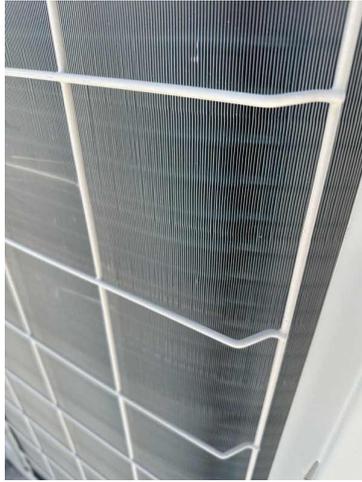
130 + 29/11/2024 Not attributed No deadline Not completed

Complete cleaning for AC external units to be conducted, construction debris have been observed inside all units.

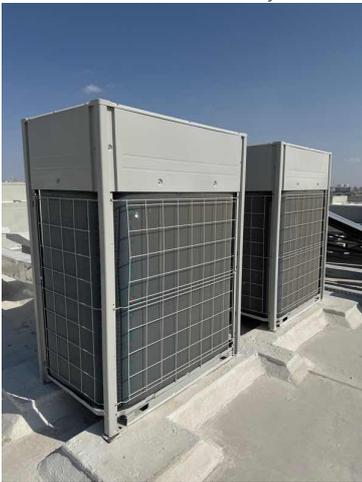
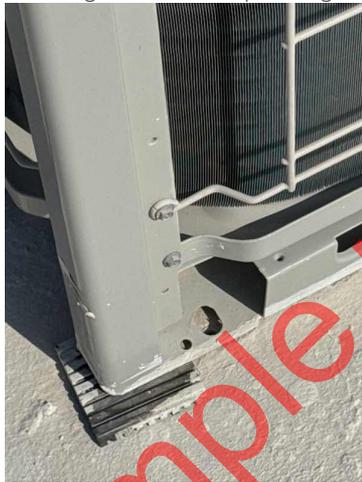
131 + 29/11/2024 Not attributed No deadline Not completed

AC units not fixed directly to the slab making noise while operating to be rectified

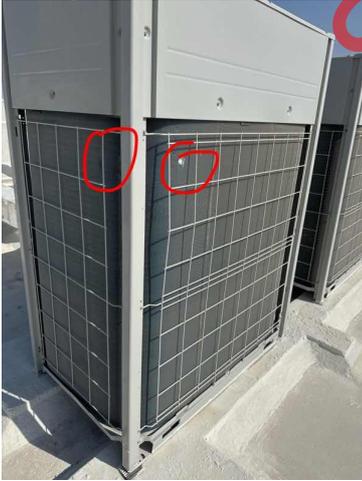
137 + 29/11/2024 Not attributed No deadline Not completed

Damaged Covers of AC external units to be replaced.

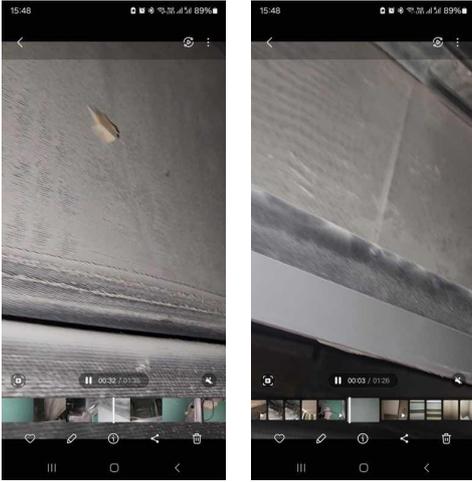
145 + 05/12/2024 Not attributed No deadline Not completed

All AC filters inside the unit needs to be cleaned with no exceptions

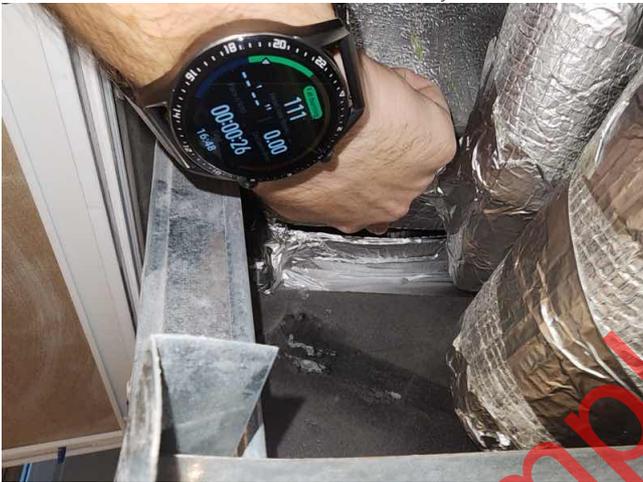
165 + 05/12/2024 Not attributed No deadline Not completed

AC Duct not Insulated Above the Laundry Room

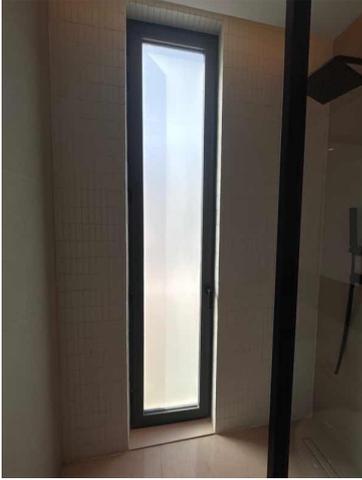
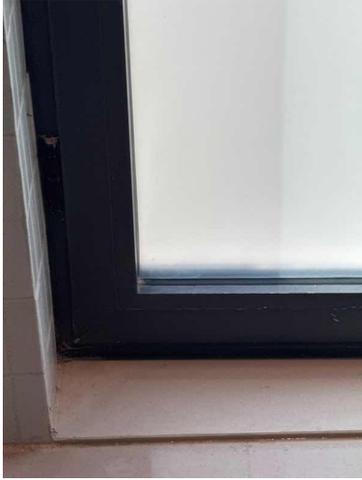
44 + 29/11/2024 Not attributed No deadline Not completed

Damaged aluminum frames to be replaced at all areas.

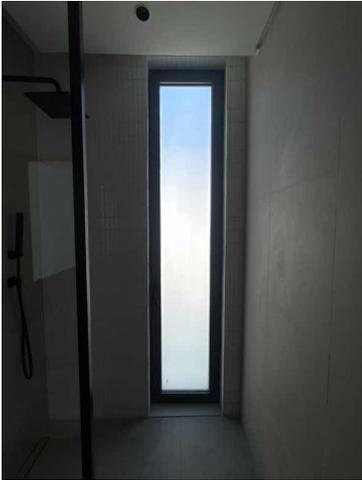
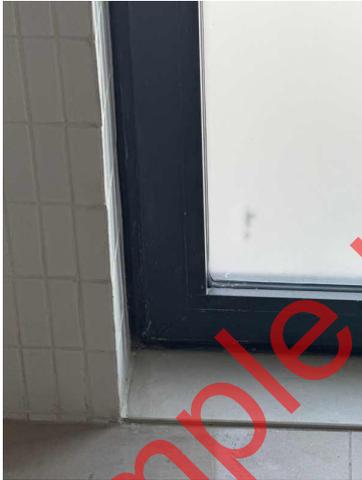
49 + 29/11/2024 Not attributed No deadline Not completed

Aluminum panels to be cleaned and polished.

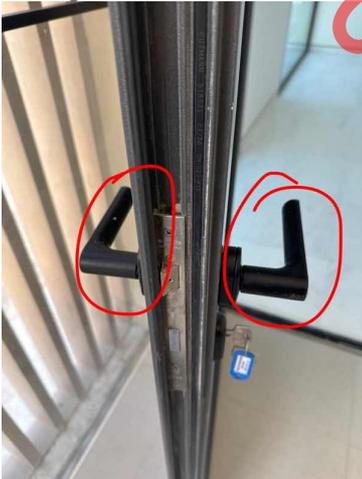
66 + 29/11/2024 Not attributed No deadline Not completed

Damaged aluminum frames to be replaced at all areas.

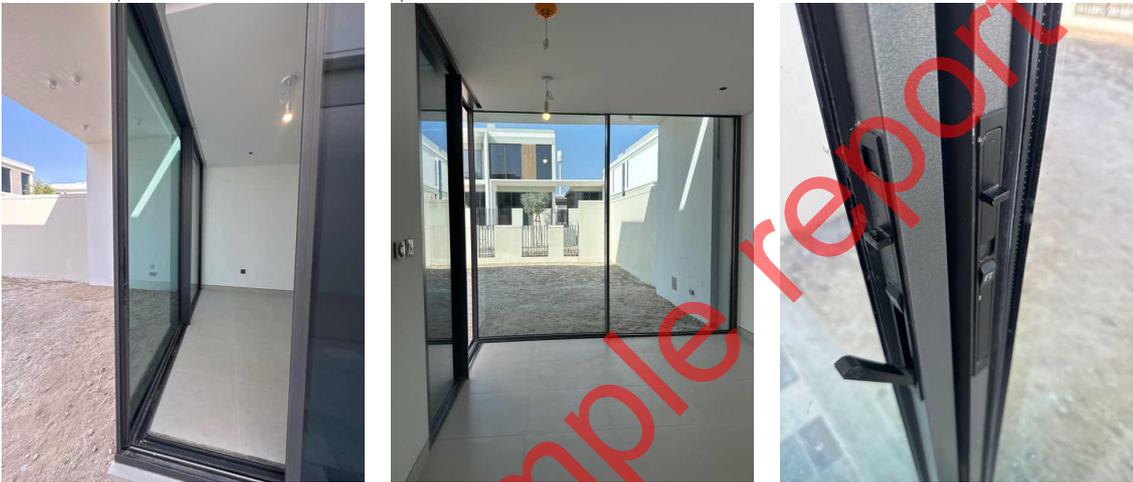
80 + 29/11/2024 Not attributed No deadline Not completed

Aluminum panels to be cleaned and polished.

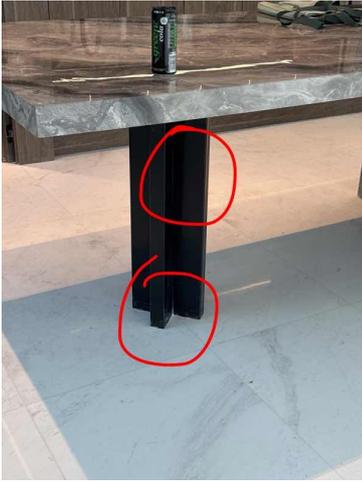
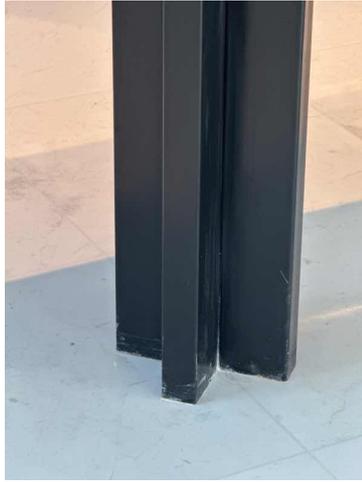
101 + 29/11/2024 Not attributed No deadline Not completed

Damaged aluminum frames to be replaced at all areas.

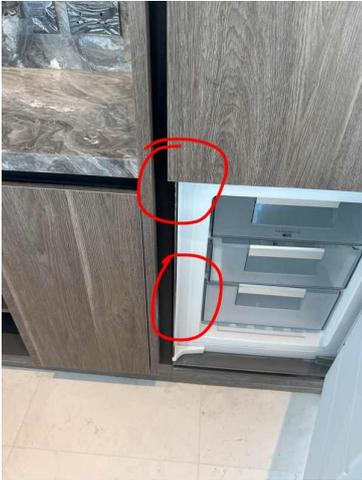
106 + 29/11/2024 Not attributed No deadline Not completed

Damaged aluminum frames to be replaced at all areas.

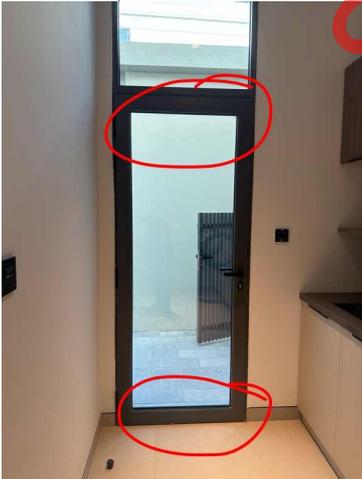
116 + 29/11/2024 Not attributed No deadline Not completed

Aluminum panels to be cleaned and polished.

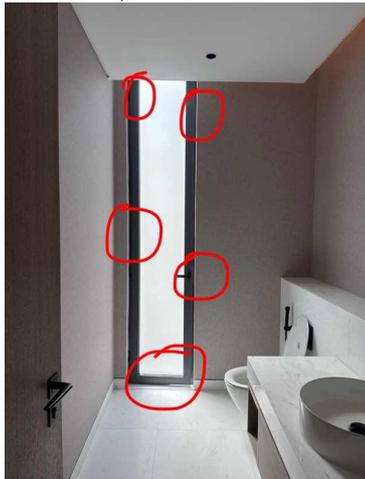
126 + 29/11/2024 Not attributed No deadline Not completed

Aluminum panels to be cleaned and polished.

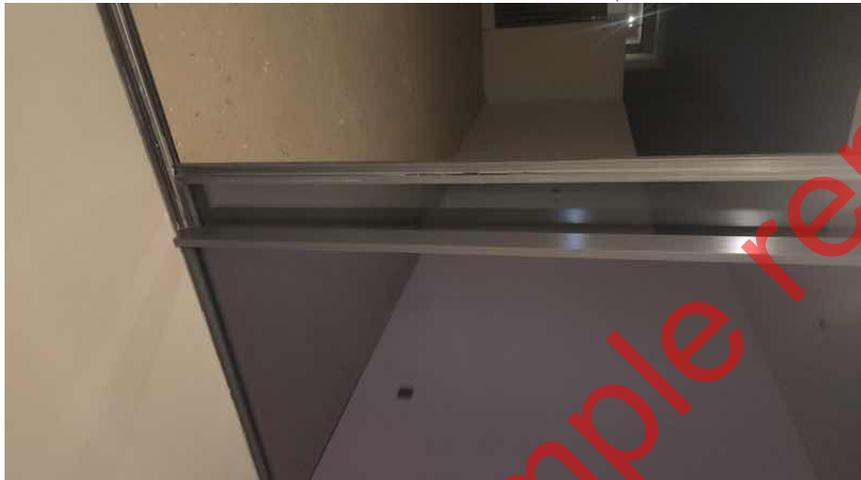
153 + 05/12/2024 Not attributed No deadline Not completed

Annex Main Room Garden Access Door: Left Side Door (from the side of the villa 130) does not close until the end

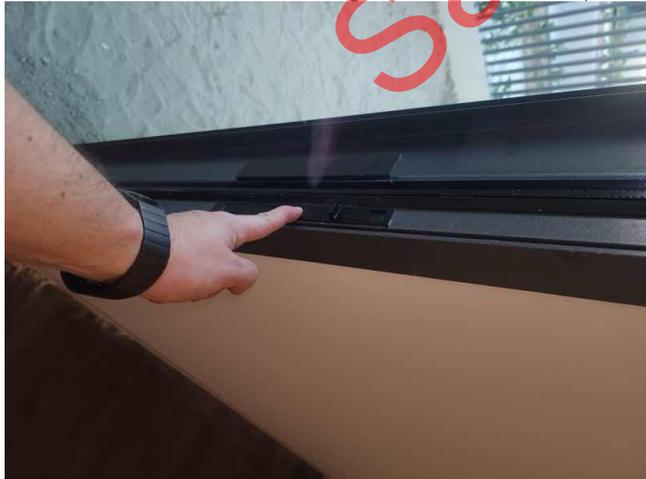
155 + 05/12/2024 Not attributed No deadline Not completed

Guest bedroom: terrace door, right side handle and opening mechanism not working

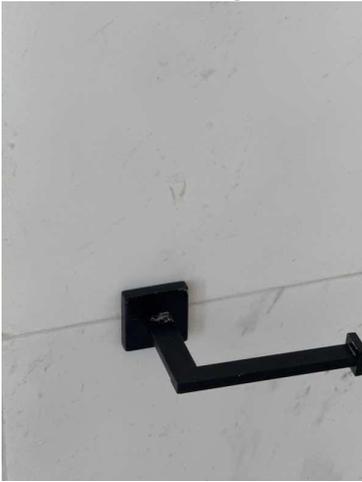
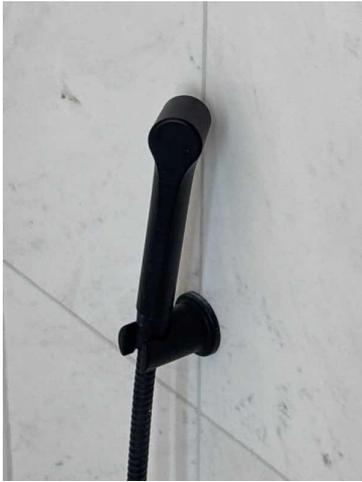
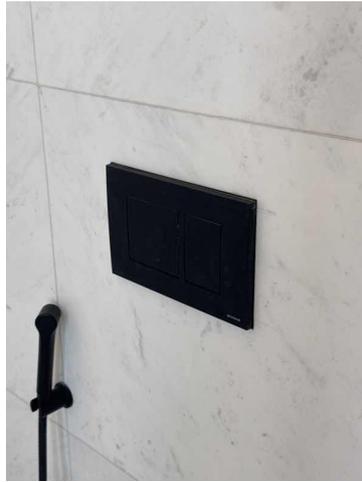
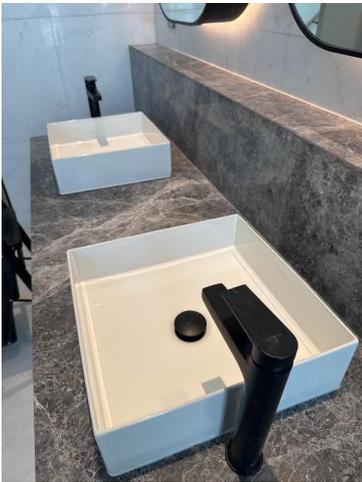
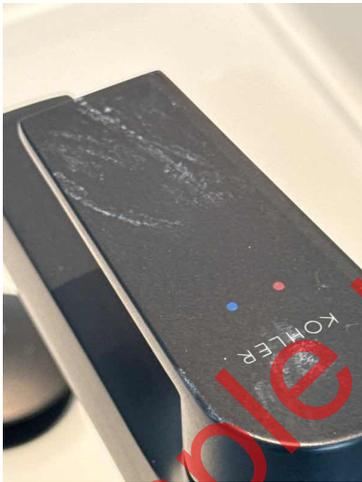
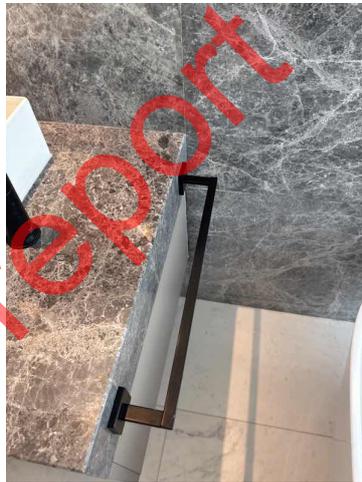
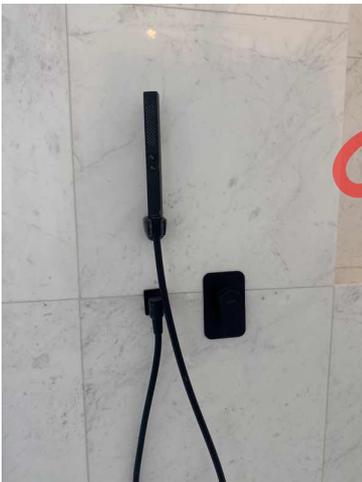
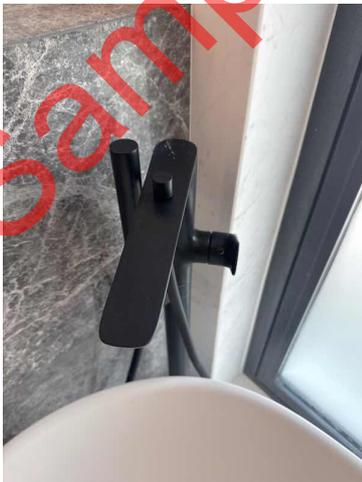
17 29/11/2024 Not attributed No deadline Not completed

Scratched and damaged fixtures to be replaced.

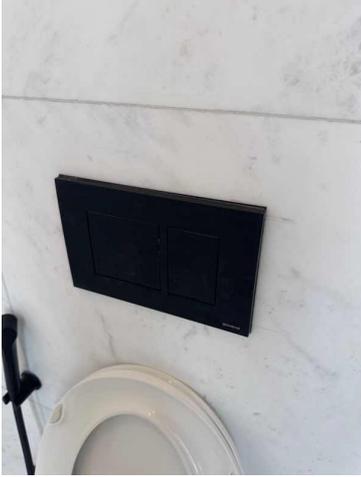
20 + 29/11/2024 Not attributed No deadline Not completed

Damaged pushed to flush mechanism to be replaced

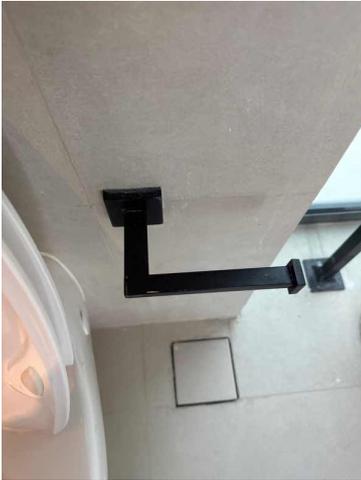
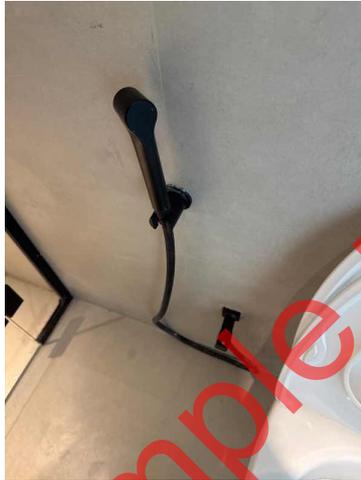
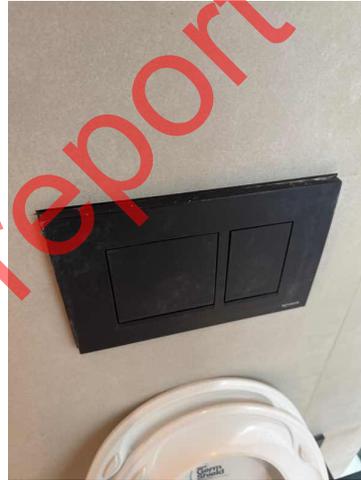
82 + 29/11/2024 Not attributed No deadline Not completed

Scratched and damaged fixtures to be replaced.

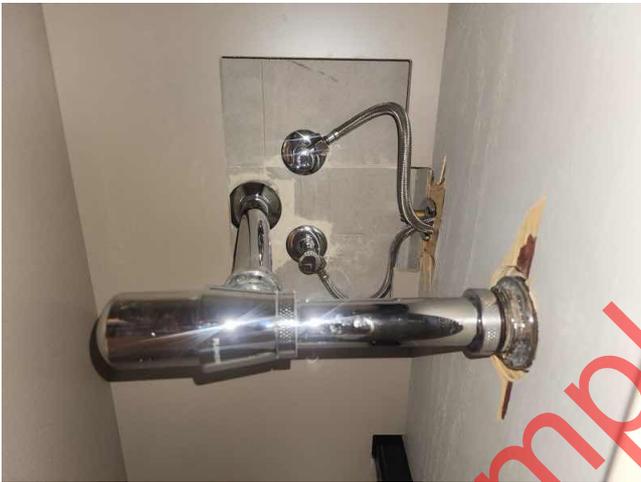
172 + 05/12/2024 Not attributed No deadline Not completed

In many bathrooms (i.e. in this picture this is the guest bedroom), just wood ply was used instead of water proof MDF under the sinks.

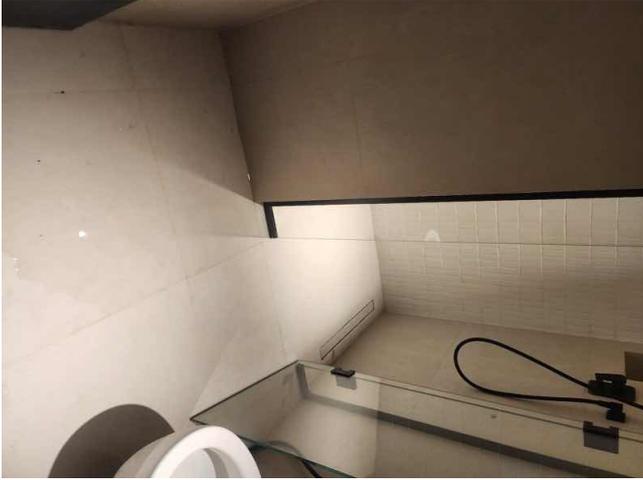
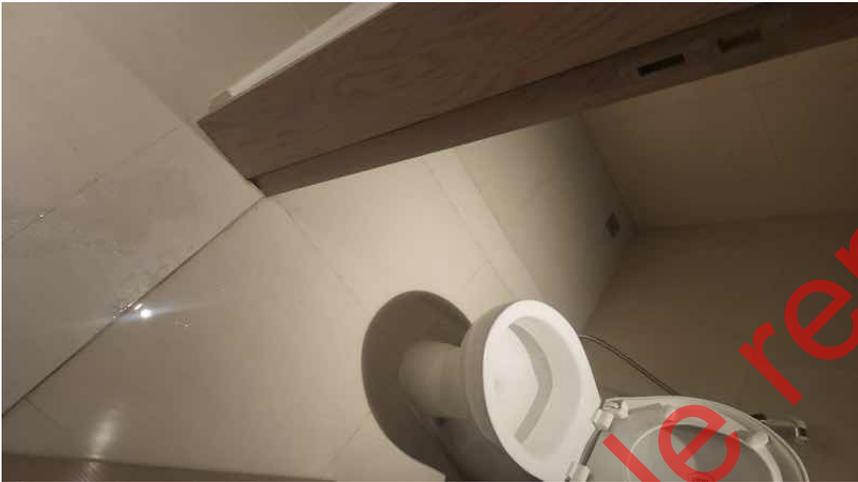
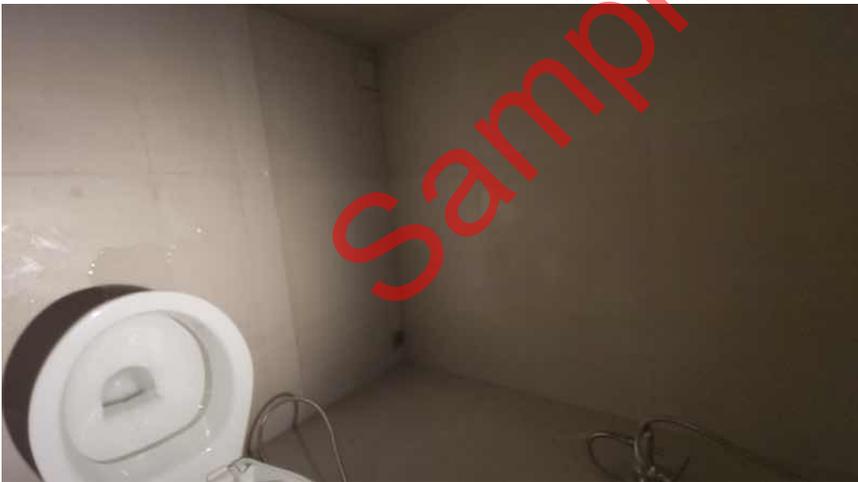
173 05/12/2024 Not attributed No deadline Not completed

Annex - Maid Room Shower No Slope led to Water Cumulation after 3 mins of running shower

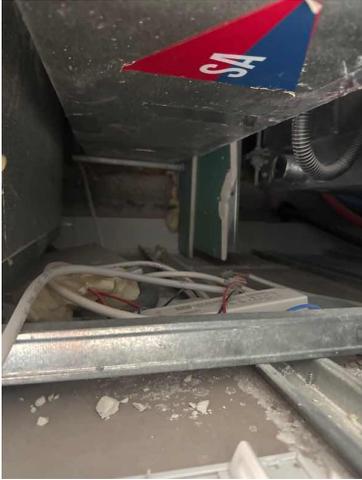
8 + 29/11/2024 Not attributed No deadline Not completed  
Damaged wiring to be replaced, any exposed to be checked and connected through a connector not tape, DEWA regulations for electrical installation to be followed ( 2017 edition).

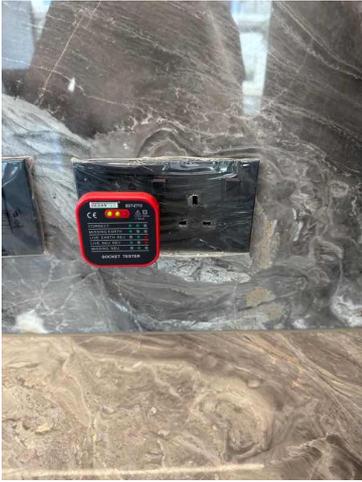
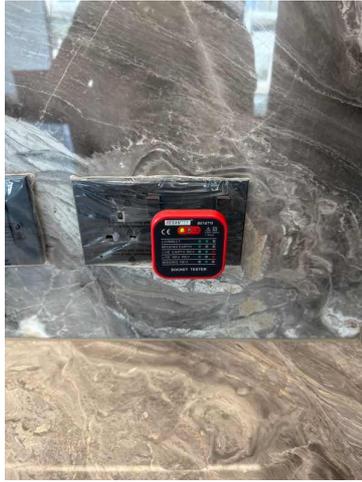
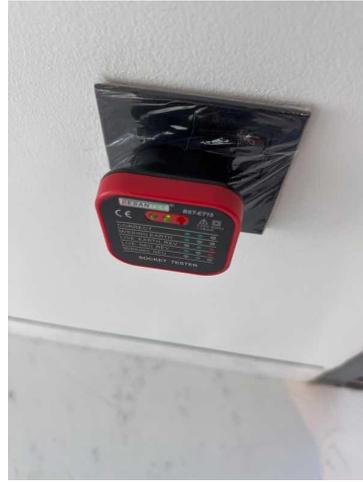
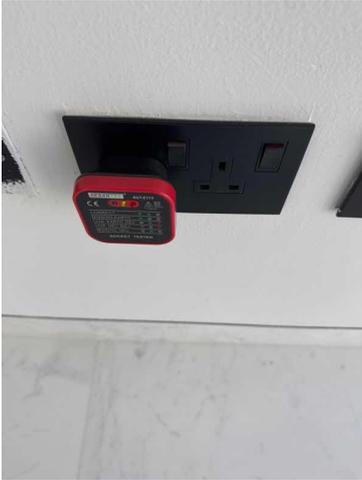
95 + 29/11/2024 Not attributed No deadline ✓ Not completed

All sockets have been tested in the room and shows no issues.

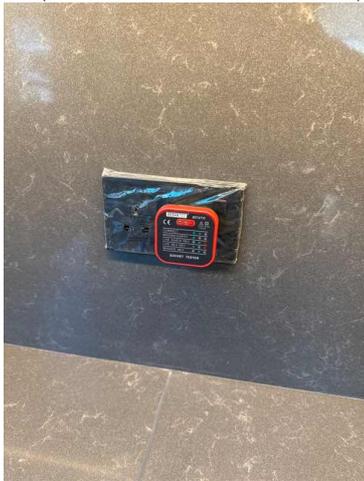
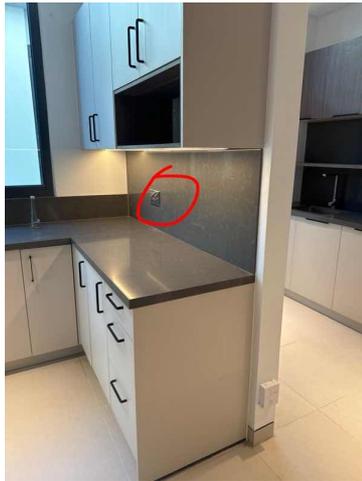
97 + 29/11/2024 Not attributed No deadline Not completed

No power in electrical socket as per the shown location

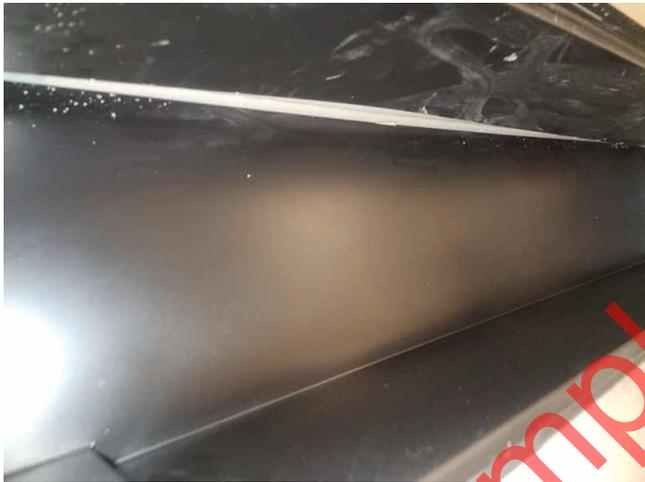
148 + 05/12/2024 Not attributed No deadline Not completed

LED Stripe in the Bathroom from Bedroom 1st Floor Front Right Street Side (when facing the street) - led strip channel is bulging and curved. Not fixed well

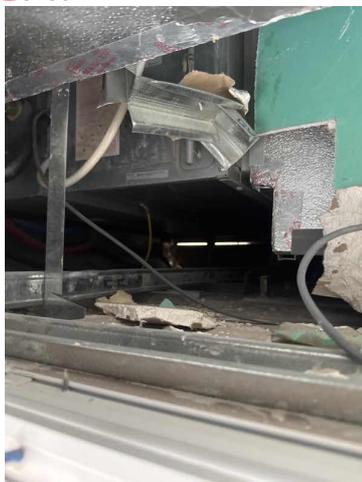
6 + 29/11/2024 Not attributed No deadline Not completed

All left materials and debris to be removed .

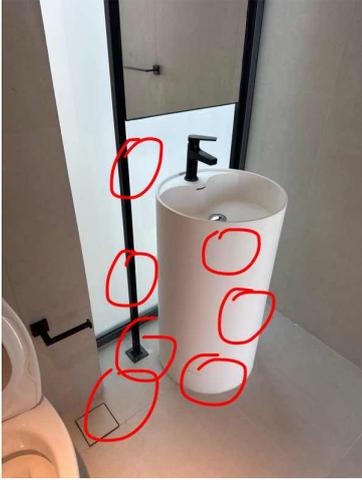
81 + 29/11/2024 Not attributed No deadline Not completed

For finishing with damages, excessive paint and scratches to be rectified and replaced material with applicable

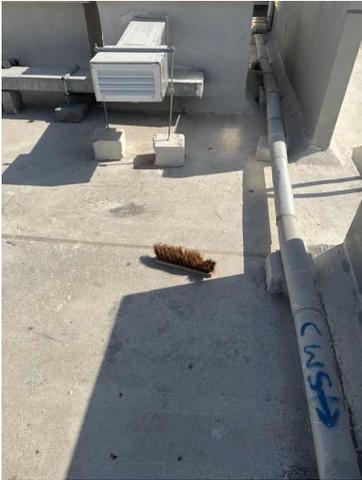
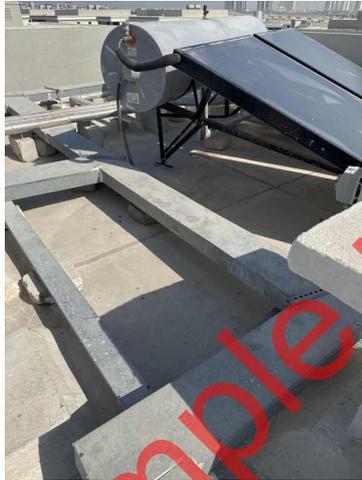
132 + 29/11/2024 Not attributed No deadline Not completed

All left materials and debris to be removed .

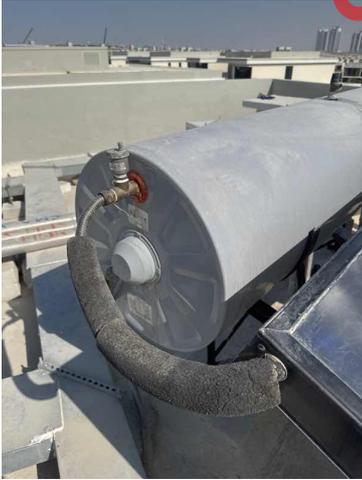
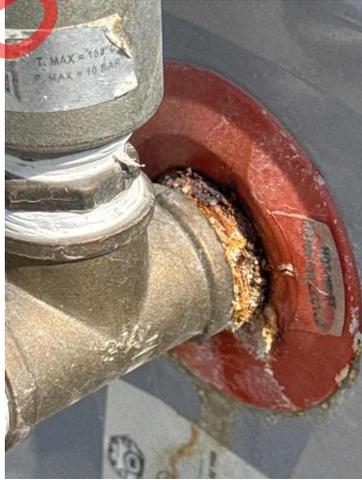
135 + 29/11/2024 Not attributed No deadline Not completed

Corrosion was noted on different locations with different levels of severity. All affected parts to be treated with rust inhibitors ( WD-40) before repainting.

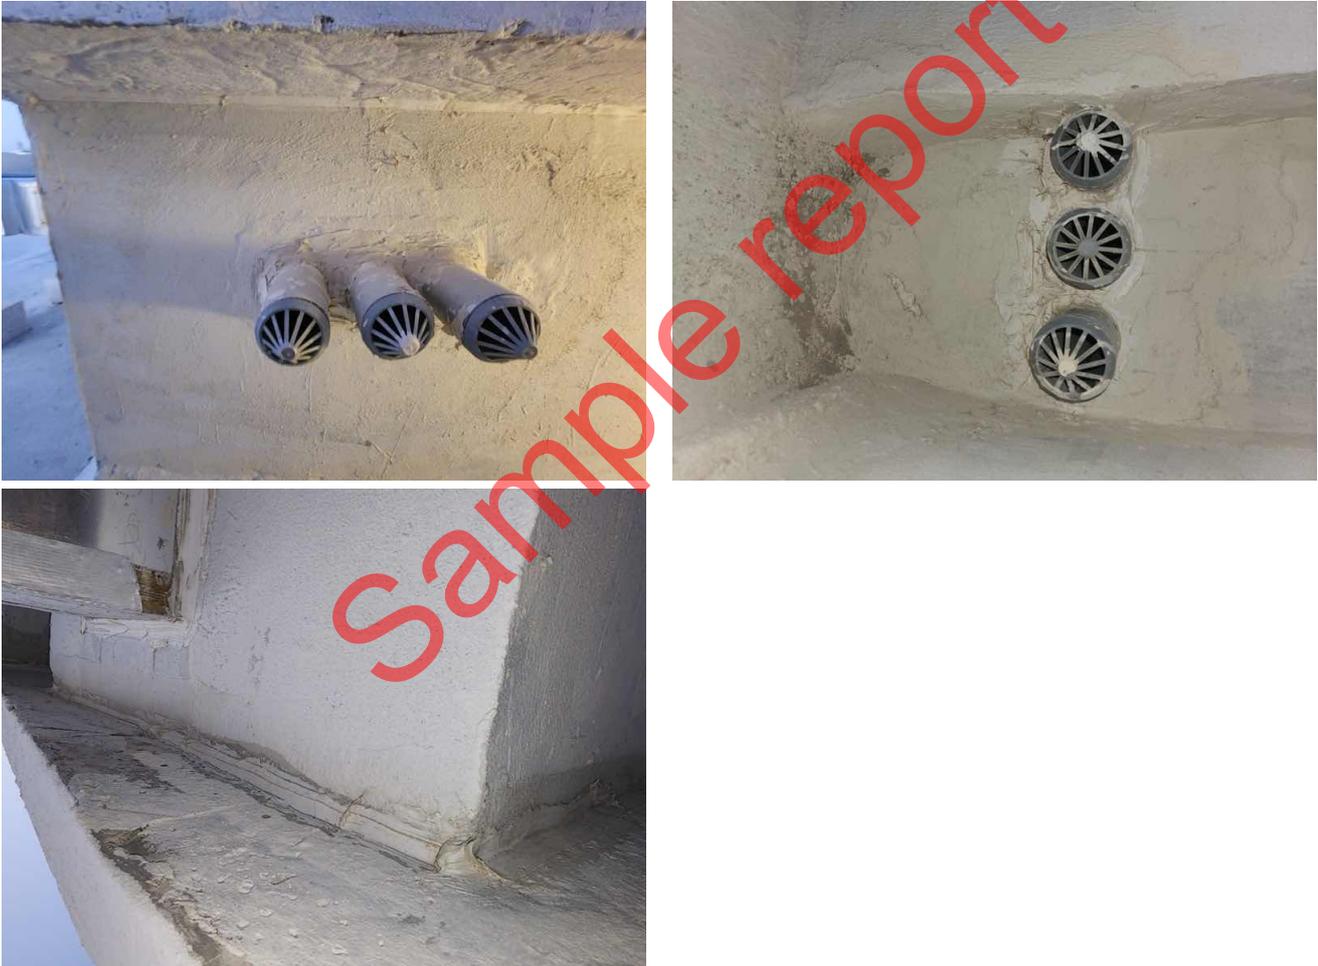
161 + 05/12/2024 Not attributed No deadline Not completed

Rooftop - piping ends and ventilation covers insulated unevenly with very thick layer of silicone instead of concrete and silicon.

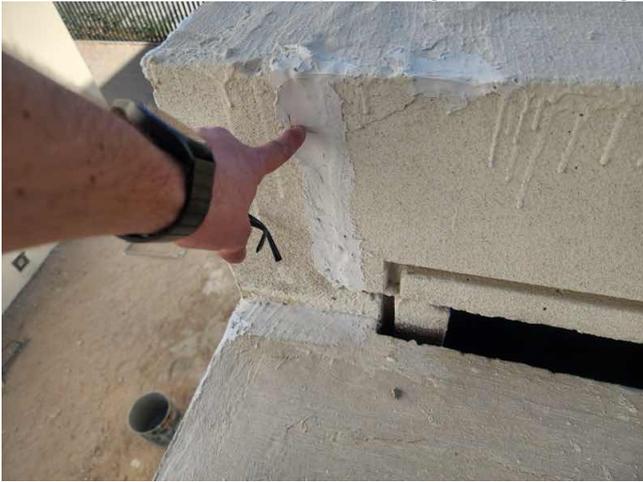
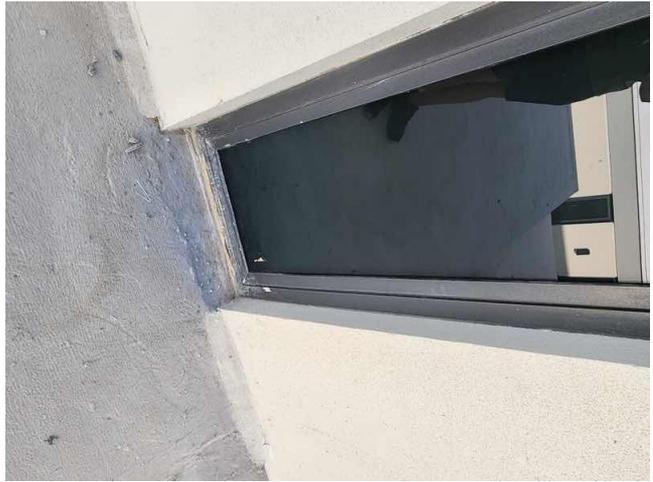
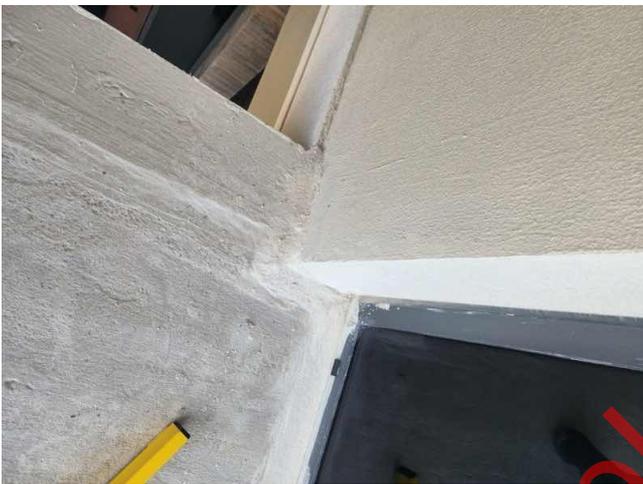
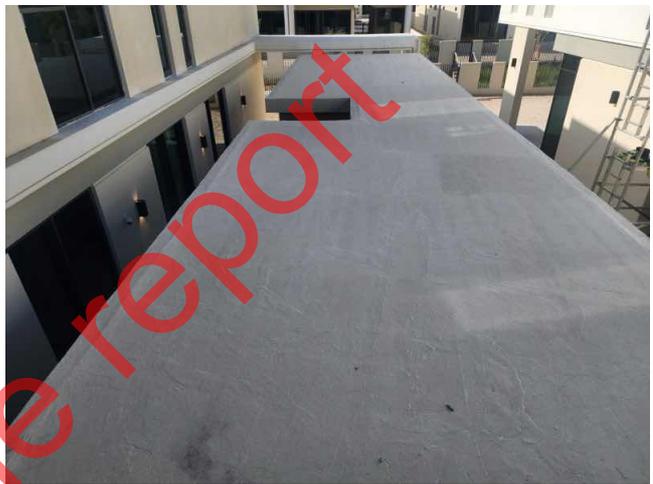
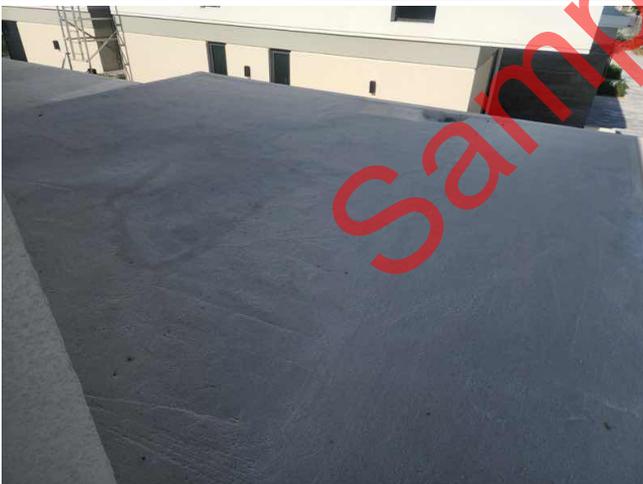
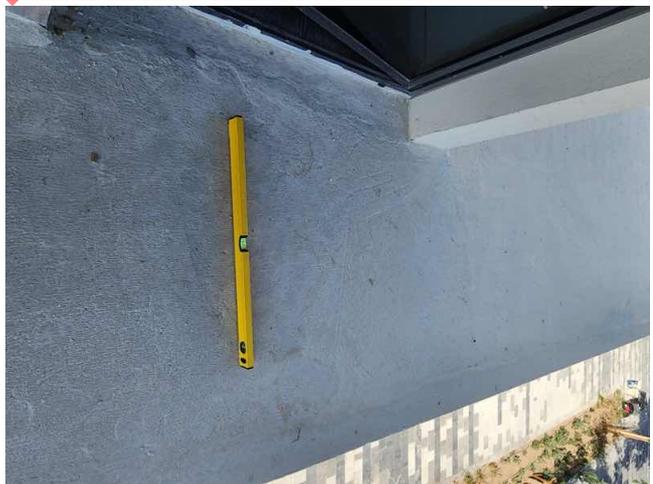
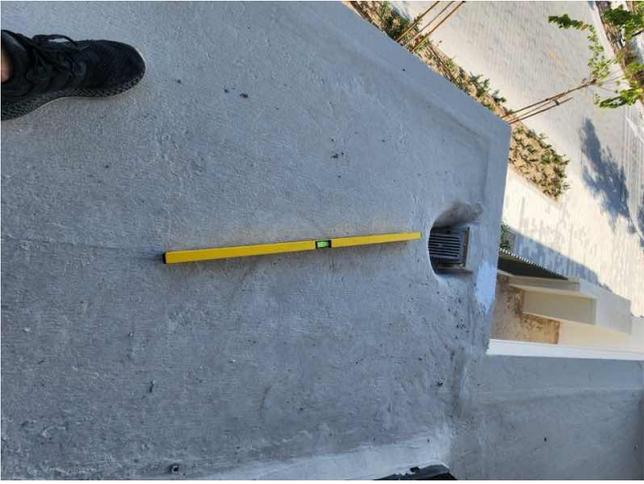
169 + 05/12/2024 Not attributed No deadline Not completed

Garage, Annex and Entrance Roof Surface is Not Even and Leveled. There is no Slope for Draining the Water that may lead to water cumulations and water penetrating the house through the windows

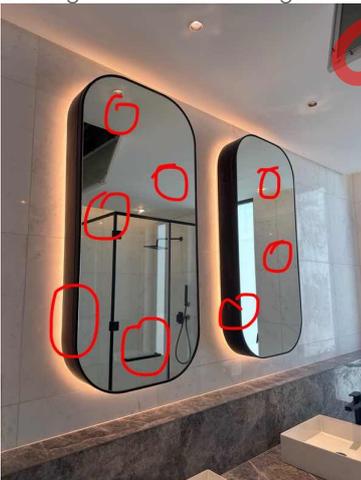
16 + 29/11/2024 Not attributed No deadline Not completed

Damaged and scratched glass to be replaced.

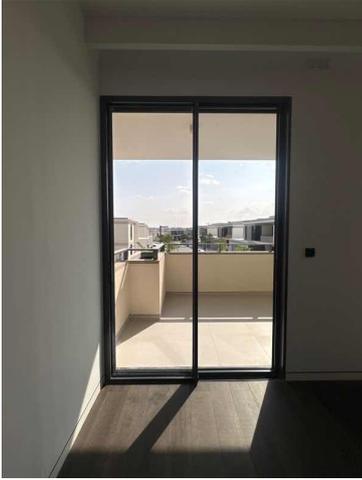
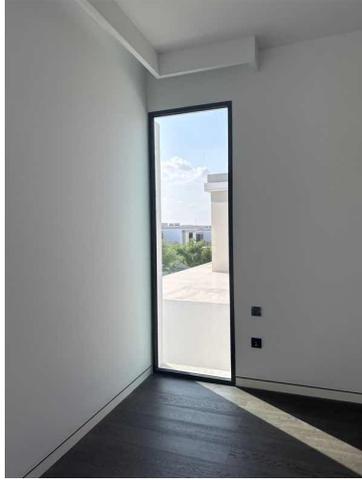
42 + 29/11/2024 Not attributed No deadline Not completed

Damaged and scratched glass to be replaced.

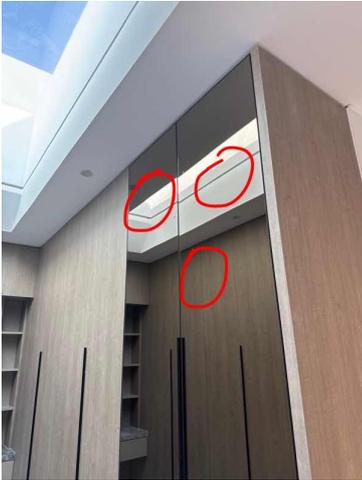
57 + 29/11/2024 Not attributed No deadline Not completed

Damaged and scratched glass to be replaced.

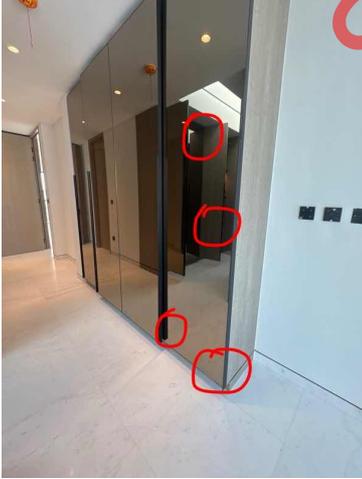
60 + 29/11/2024 Not attributed No deadline Not completed

Damaged and scratched glass to be replaced.

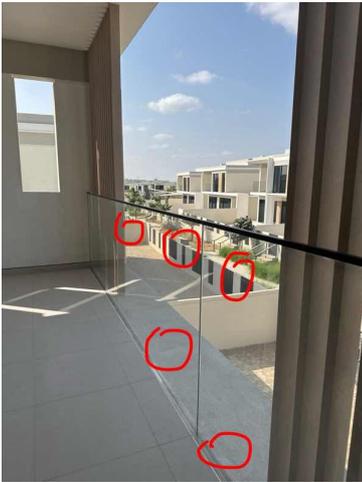
62 + 29/11/2024 Not attributed No deadline Not completed

Damaged and scratched glass to be replaced.

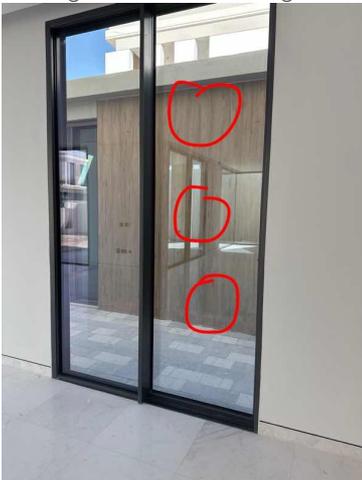
103 + 29/11/2024 Not attributed No deadline Not completed

Damaged and scratched glass to be replaced.

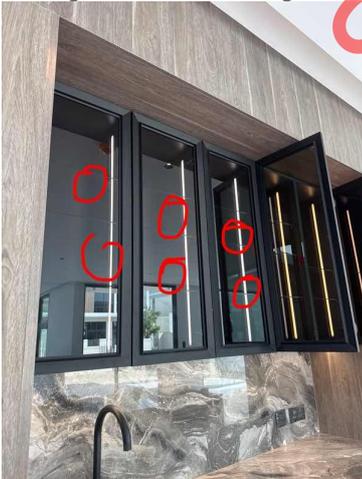
107 + 29/11/2024 Not attributed No deadline Not completed

Damaged and scratched glass to be replaced.

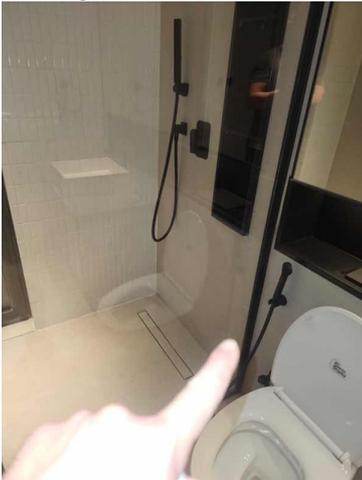
143 + 05/12/2024 Not attributed No deadline Not completed

Bedroom 1st floor street facig right side when facing street-bathroom water leaking behind the glass partition and the wall and entering the bathroom area
