**RAMI**  
Property  
Inspections

## Property Inspection Report

# VILLA

Description	Client : Dubai 0000
Address :	Dubai
Generated on	- 10/12/2024
Stages	- Comprehensive Handover Snagging
Building trades	<ul style="list-style-type: none"><li>- About</li><li>- Air conditioning</li><li>- Aluminium joinery</li><li>- Bathroom Accessories, interiors and Fittings</li><li>- Electricity</li><li>- General Works</li><li>- Glass</li><li>- Gypsum &amp; Acoustic Ceiling</li><li>- Humidity</li><li>- Interior joinery</li><li>- Kitchen</li><li>- Noise Level</li><li>- Paint</li><li>- Paving</li><li>- Plaster</li><li>- Plumbing and heating</li><li>- Thermography</li><li>- Tiling, Wooden Floorings and stairs.</li><li>- Water Networks</li><li>- Water/ Moisture Intrusion</li></ul>
Stakeholders	
Drawings	- 2024-11-29 (Comprehensive Handover Snagging)

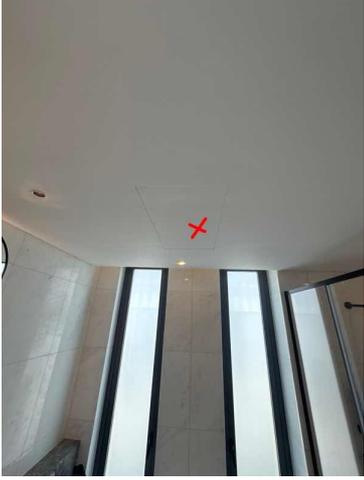
9 + 29/11/2024 Not attributed No deadline Not completed

Damaged and scratched gypsum ceiling, to be rectified and repainted.

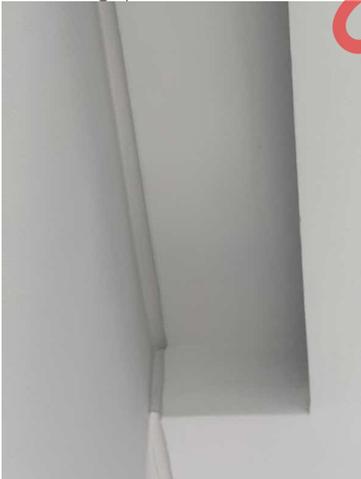
120 + 29/11/2024 Not attributed No deadline Not completed

Shadow gap trim to be redone and painted.

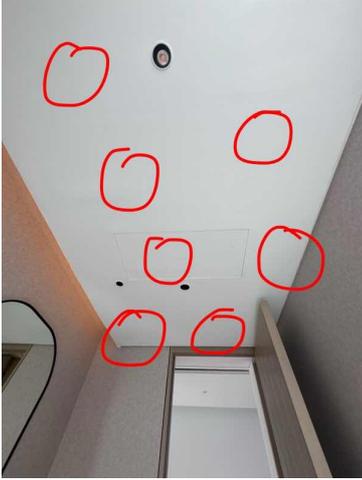
127 + 29/11/2024 Not attributed No deadline Not completed

Damaged and scratched gypsum ceiling, to be rectified and repainted.

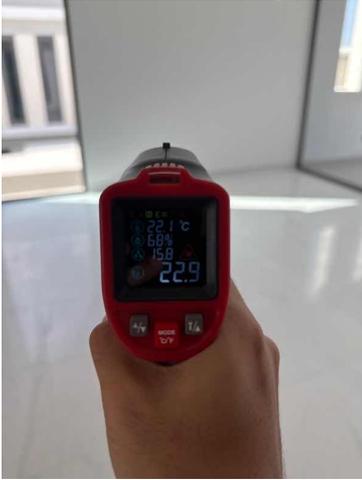
26 + 29/11/2024 Not attributed No deadline Not completed

Levels of Ambient humidity values are below 70% across the property, figures recorded are ideal for comfortable environment and prevention of mould growth.

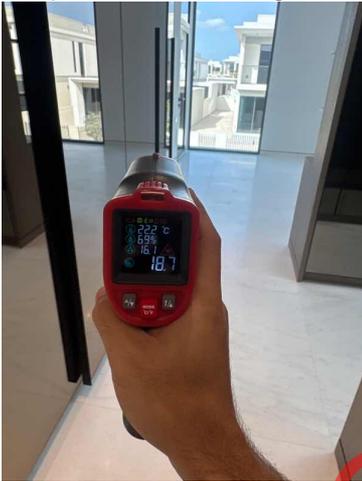
28 + 29/11/2024 Not attributed No deadline Not completed

Levels of Ambient humidity values are below 70% across the property, figures recorded are ideal for comfortable environment and prevention of mould growth.

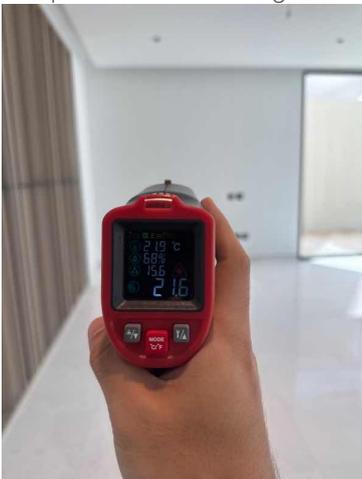
90 + 29/11/2024 Not attributed No deadline Not completed

Levels of Ambient humidity values are below 70% across the property, figures recorded are ideal for comfortable environment and prevention of mould growth.

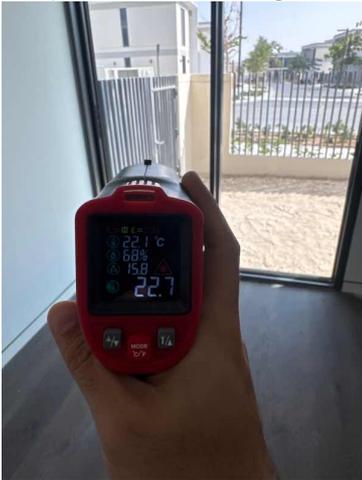
93 + 29/11/2024 Not attributed No deadline Not completed

Levels of Ambient humidity values are below 70% across the property, figures recorded are ideal for comfortable environment and prevention of mould growth.

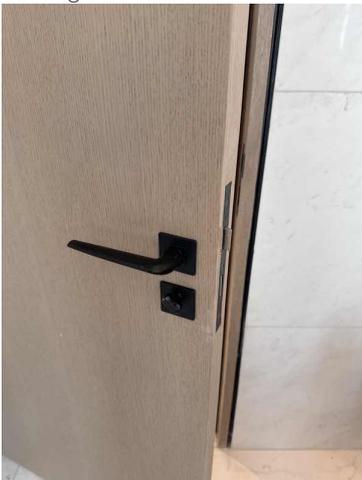
10 + 29/11/2024 Not attributed No deadline Not completed

Damaged and scratched door handle, to be replaced.

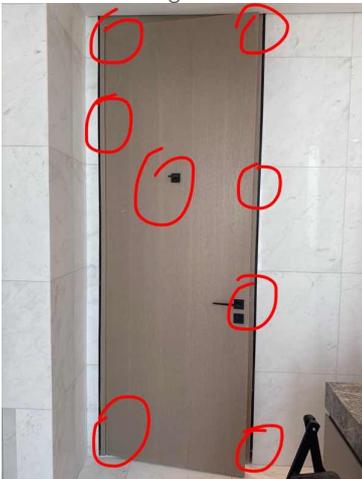
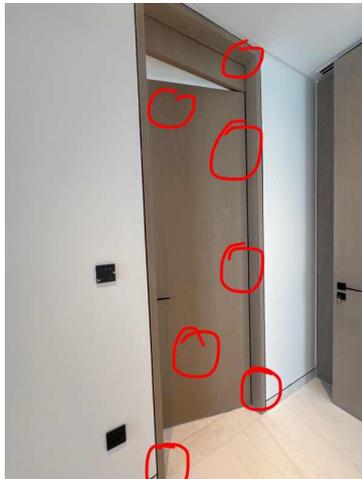
11 + 29/11/2024 Not attributed No deadline Not completed

Damaged and scratched wood frames, to be replaced and rectified at all areas, damages been observed at all doors and cabinets at a higher rate.

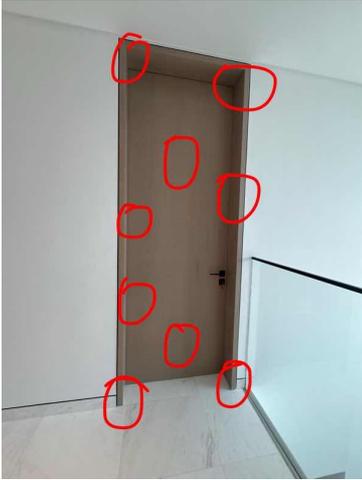
37 + 29/11/2024 Not attributed No deadline Not completed

Damaged and scratched wood frames, to be replaced and rectified at all areas, damages been observed at all doors and cabinets at a higher rate.

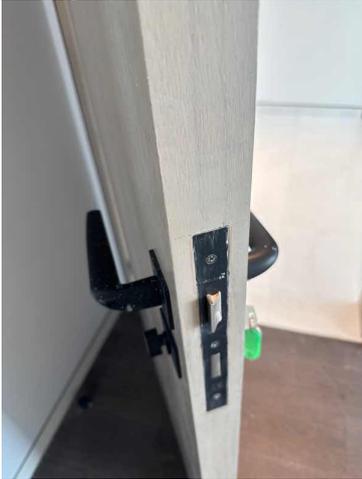
47 + 29/11/2024 Not attributed No deadline Not completed

Damaged and scratched door handle, to be replaced.

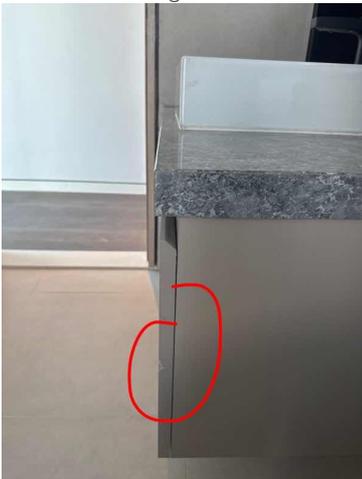
51 + 29/11/2024 Not attributed No deadline Not completed

Damaged and scratched wood frames, to be replaced and rectified at all areas, damages been observed at all doors and cabinets at a higher rate.

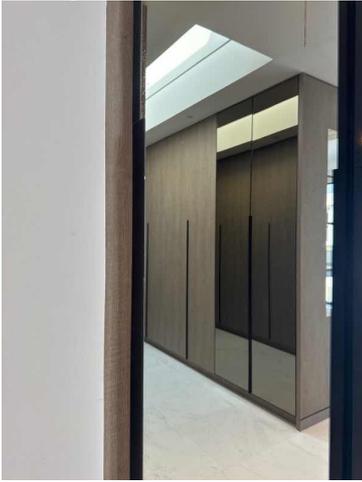
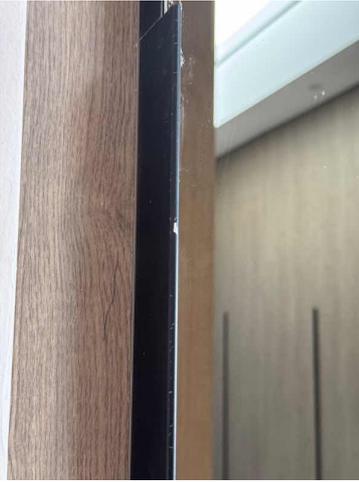
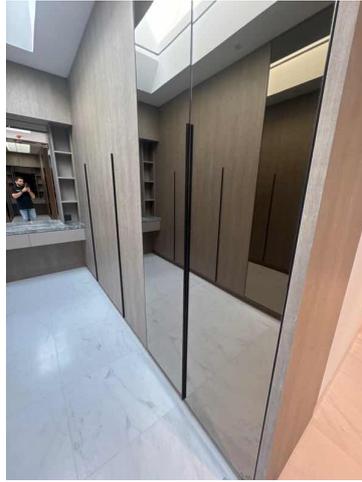
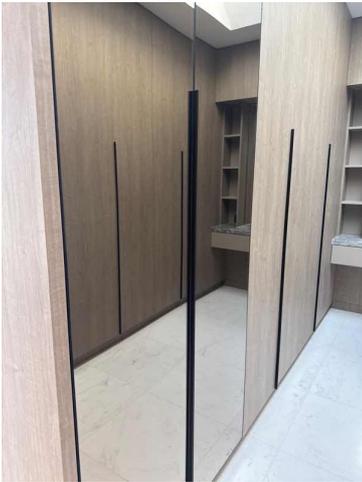
56 + 29/11/2024 Not attributed No deadline Not completed

Damaged and scratched door handle, to be replaced.

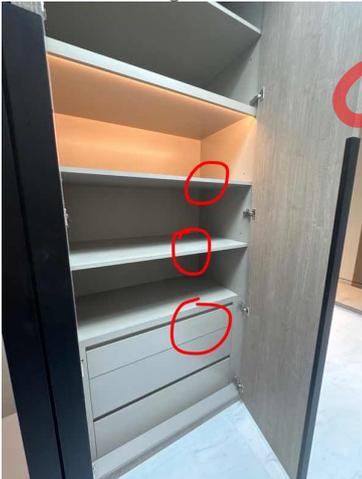
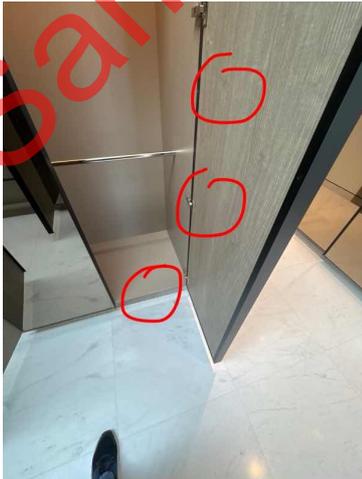
59 + 29/11/2024 Not attributed No deadline Not completed

Damaged and scratched wood frames, to be replaced and rectified at all areas, damages been observed at all doors and cabinets at a higher rate.

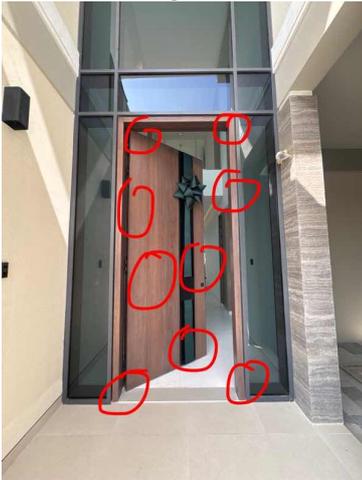
74 + 29/11/2024 Not attributed No deadline Not completed

Damaged and scratched wood frames, to be replaced and rectified at all areas, damages been observed at all doors and cabinets at a higher rate.

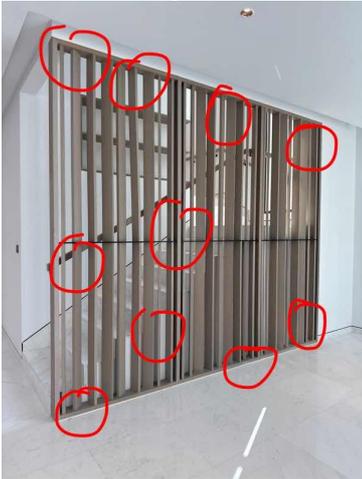
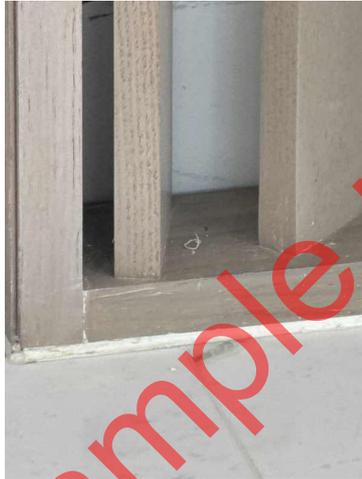
99 + 29/11/2024 Not attributed No deadline Not completed

Damaged and scratched wood frames, to be replaced and rectified at all areas, damages been observed at all doors and cabinets at a higher rate.

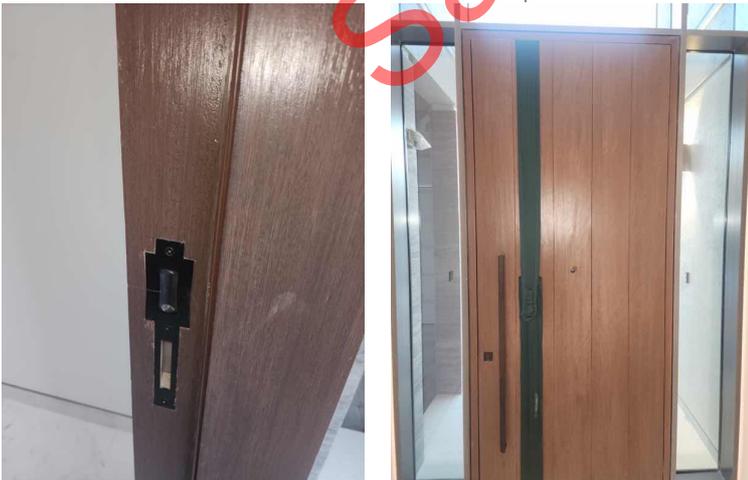
142 + 05/12/2024 Not attributed No deadline Not completed

Main entrance door scratched and does not keep closed unless it is closed with a key

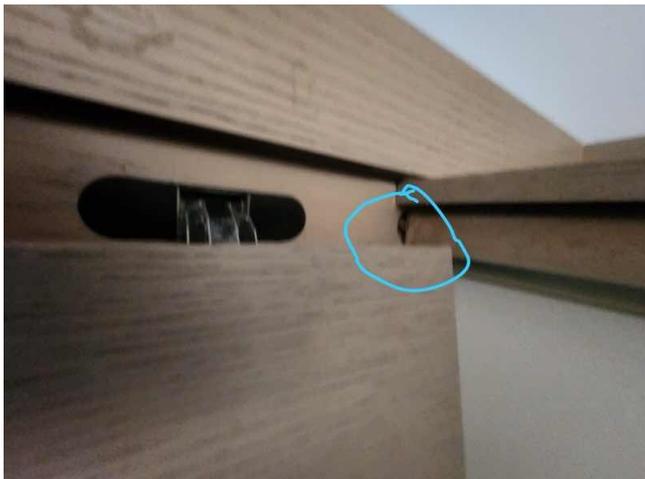
164 + 05/12/2024 Not attributed No deadline Not completed

Guest bedroom downstairs - door to bathroom: scree is used as workaround to keep in balance the above door part

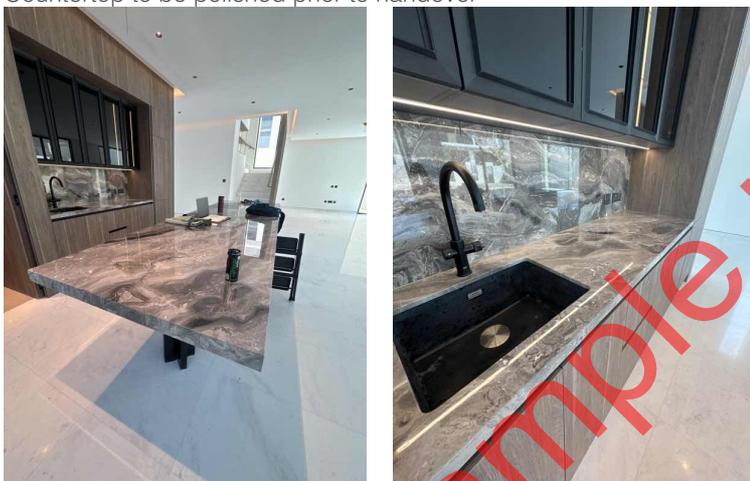
88 + 29/11/2024 Not attributed No deadline Not completed

Countertop to be polished prior to handover

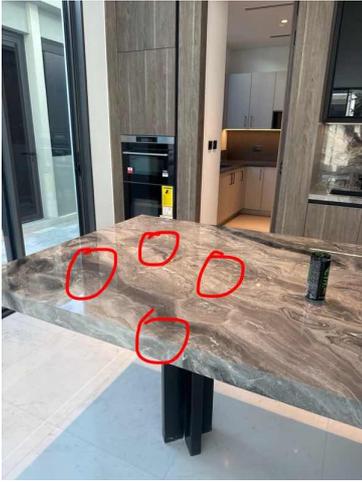
104 + 29/11/2024 Not attributed No deadline Not completed

Damaged and scratched marble top to be replaced.

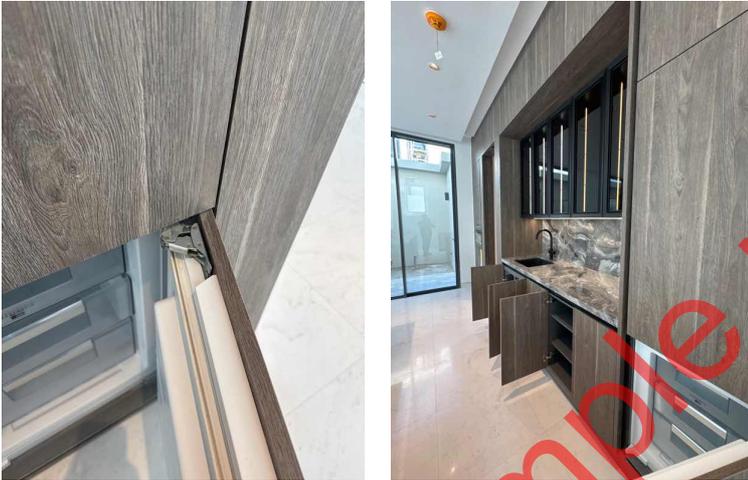
105 + 29/11/2024 Not attributed No deadline Not completed

All hinges to be checked movement is not smooth

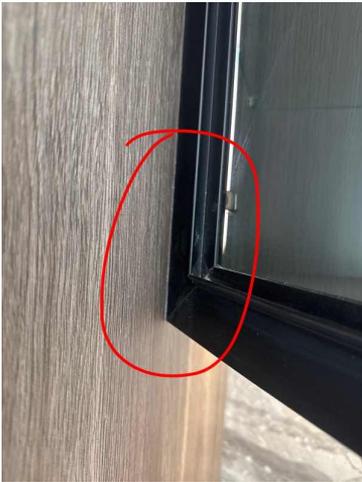
109 + 29/11/2024 Not attributed No deadline Not completed

Frame alignment to be rectified all of the cabinets hinges are loose and touching other elements when opening

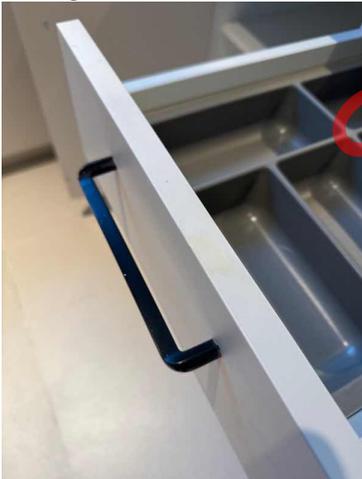
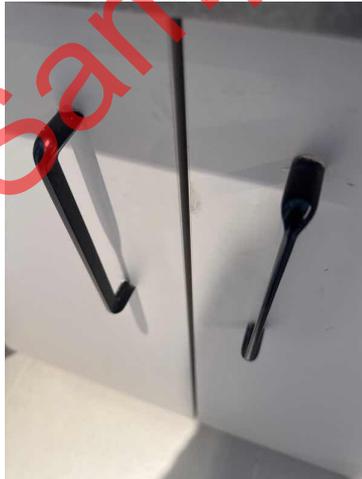
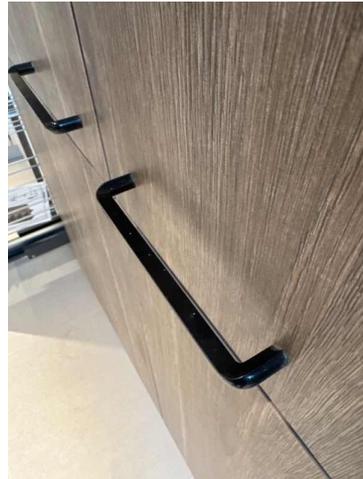
113 + 29/11/2024 Not attributed No deadline Not completed

Damage and scratches on all cabinet handles to be replaced

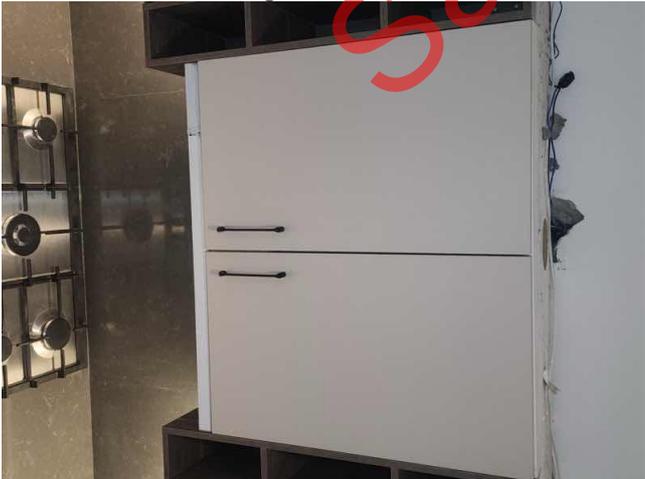
166 + 05/12/2024 Not attributed No deadline Not completed

Kitchen hood not working

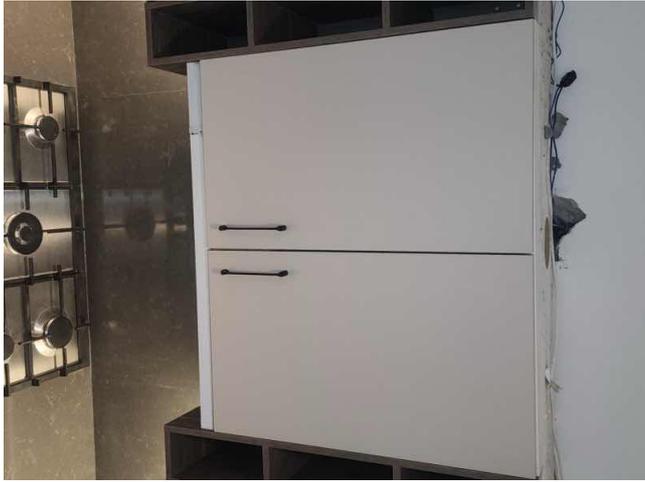
167 + 05/12/2024 Not attributed No deadline Not completed

Kitchn Lose Wires and Hole in the Wall Above Hood

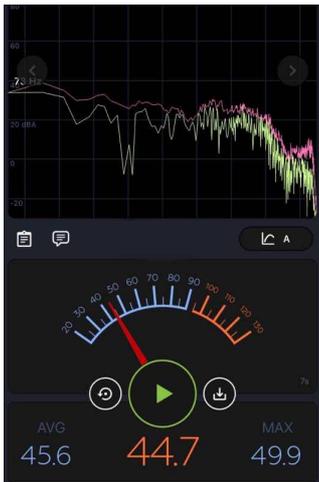
2 + 29/11/2024 Not attributed No deadline Not completed

Noise levels for various areas are identified across the unit. Levels of 45 decibels are the average with max level identified around 55 for certain areas. No level of 70 decibels is identified for all areas which lead to hearing loss on the long term.

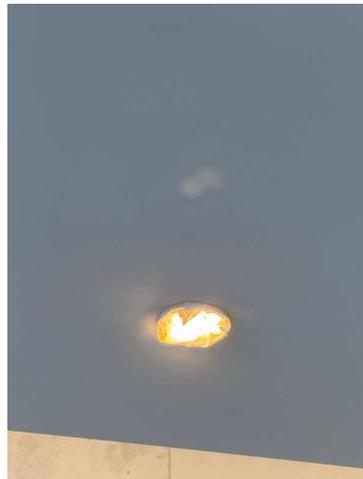
13 + 29/11/2024 Not attributed No deadline Not completed

Masking tape to be removed from all areas

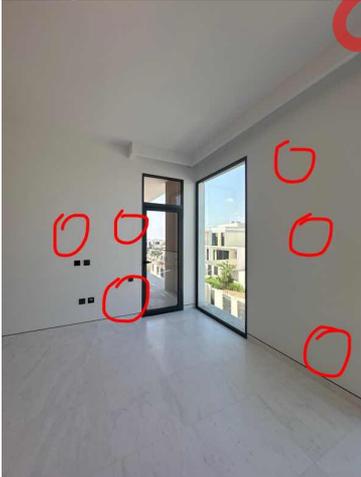
68 + 29/11/2024 Not attributed No deadline Not completed

Damages on the wall, a final layer of paint to be applied.

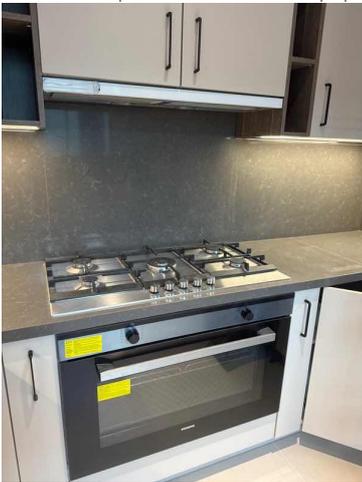
114 + 29/11/2024 Not attributed No deadline Not completed

Excessive paint on kitchen equipment to be removed

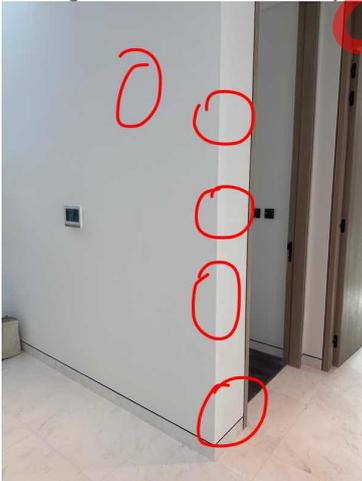
125 + 29/11/2024 Not attributed No deadline Not completed

Damages on the wall, a final layer of paint to be applied.

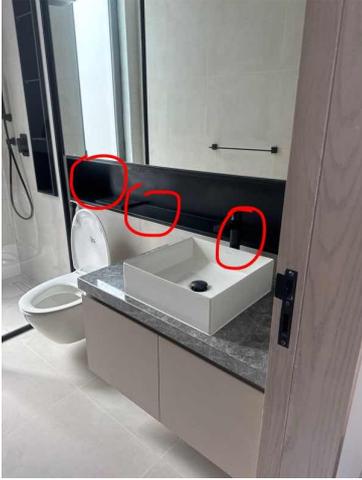
129 + 29/11/2024 Not attributed No deadline Not completed

Damages on the wall, a final layer of paint to be applied.

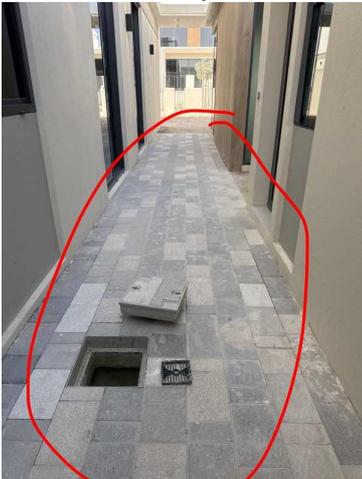
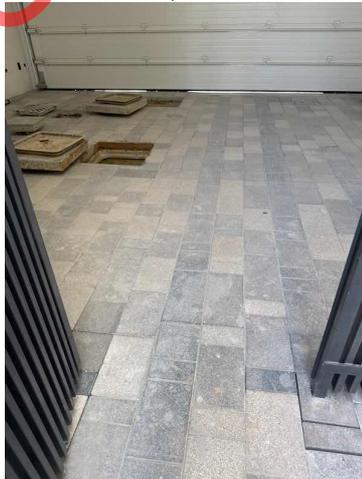
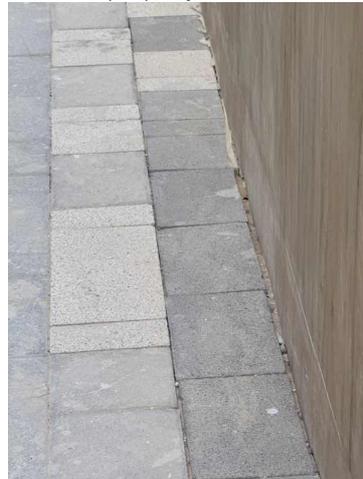
76 + 29/11/2024 Not attributed No deadline Not completed

All interlock is wavy and not leveled to be removed put on a same level and filled properly

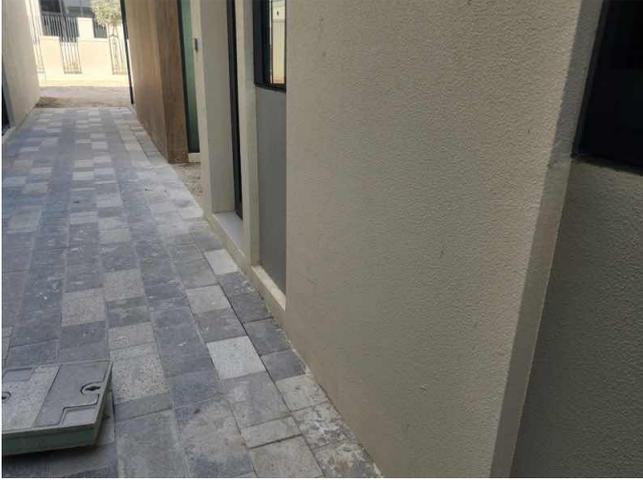
160 + 05/12/2024 Not attributed No deadline Not completed

Uneven, uneven gaps in the interlock cladding outdoors. Dirty and with no sloping towards edges.

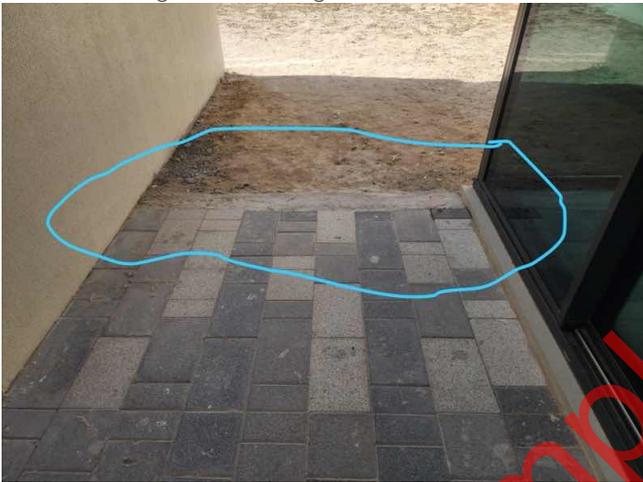
168 + 05/12/2024 Not attributed No deadline Not completed

Stone Cladding Concrete Edge is Eroded and Not Even

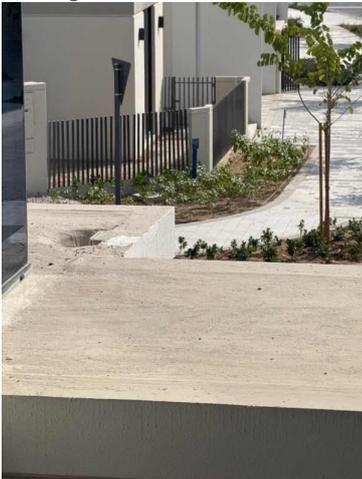
38 + 29/11/2024 Not attributed No deadline Not completed

Damages and scratches, to be replastered and a final layer of paint to be applied.

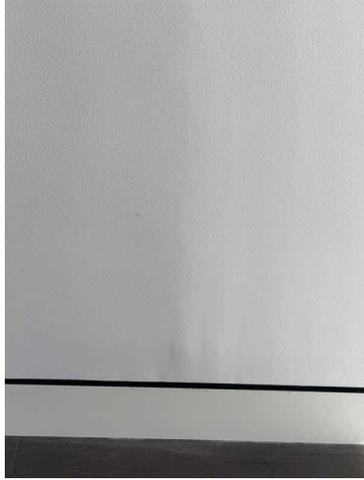
40 + 29/11/2024 Not attributed No deadline Not completed

Damages and scratches, to be replastered and a final layer of paint to be applied.

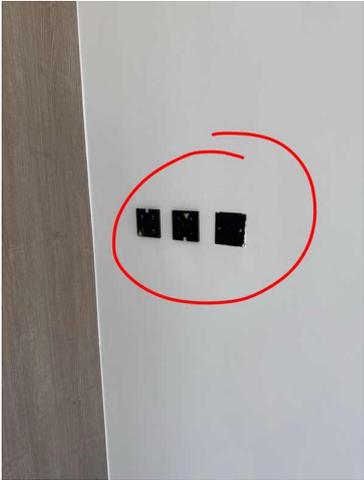
61 + 29/11/2024 Not attributed No deadline Not completed

Damages and scratches, to be replastered and a final layer of paint to be applied.

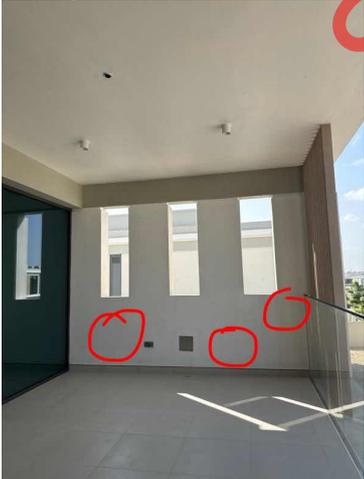
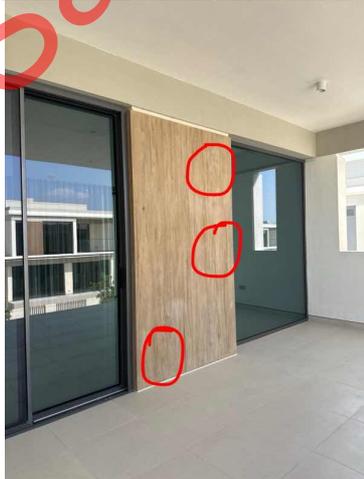
65 + 29/11/2024 Not attributed No deadline Not completed

Damages and scratches, to be replastered and a final layer of paint to be applied.

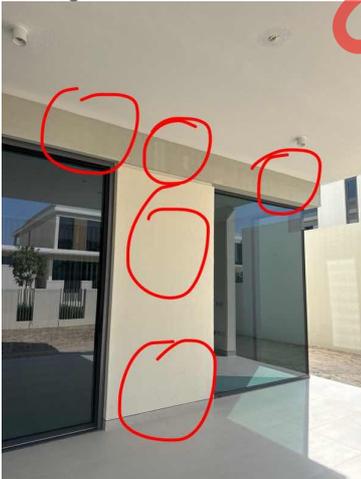
87 + 29/11/2024 Not attributed No deadline Not completed

Damages and scratches, to be replastered and a final layer of paint to be applied.

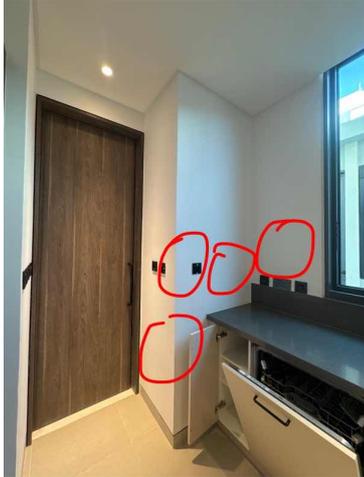
112 + 29/11/2024 Not attributed No deadline Not completed

Damages and scratches, to be replastered and a final layer of paint to be applied.

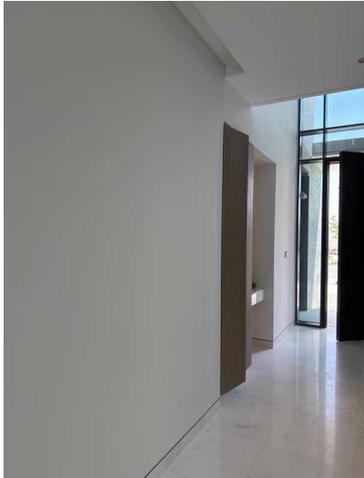
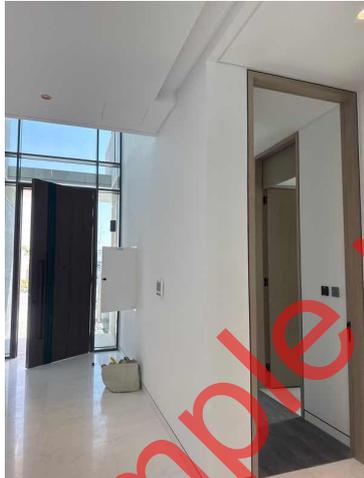
119 + 29/11/2024 Not attributed No deadline Not completed

Plaster to be smoothed out and a new fresh layers of paint to be applied afterwards.

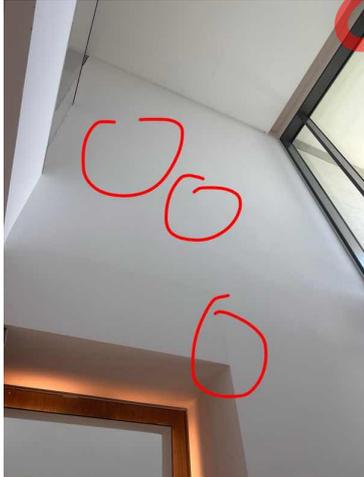
123 + 29/11/2024 Not attributed No deadline Not completed

Hairline cracks been identified at multiple locations, to be rectified.

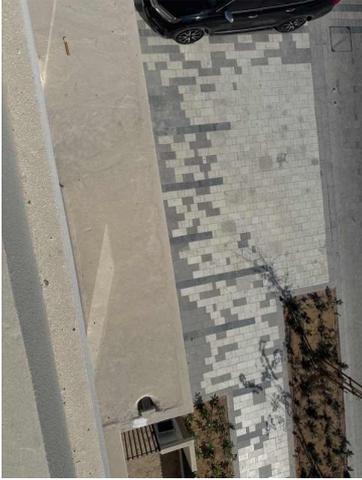
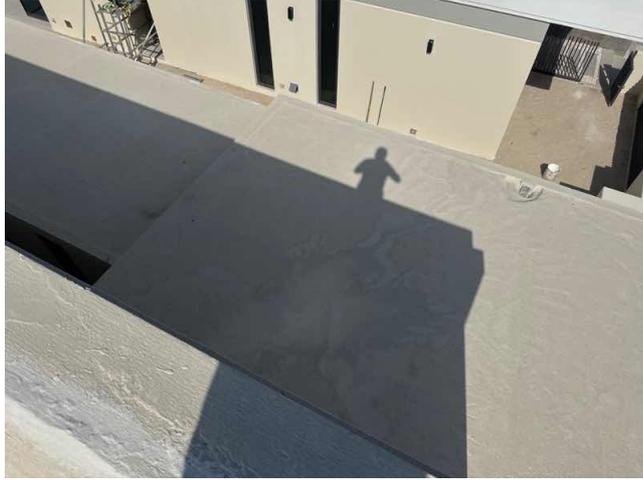
139 + 29/11/2024 Not attributed No deadline Not completed

Poor plaster, finishing off tops of garage and extensions to be redone

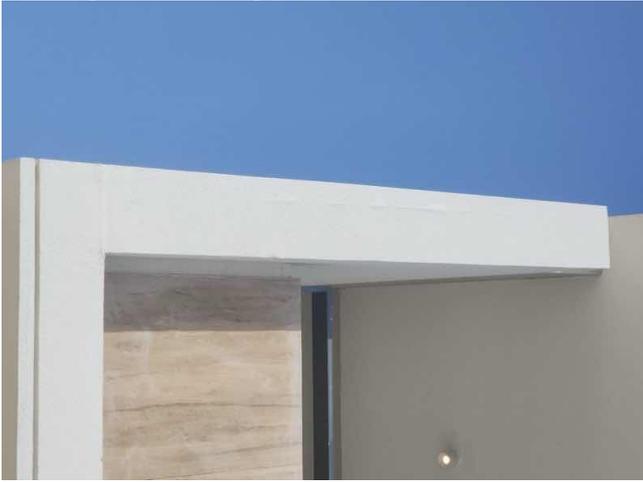
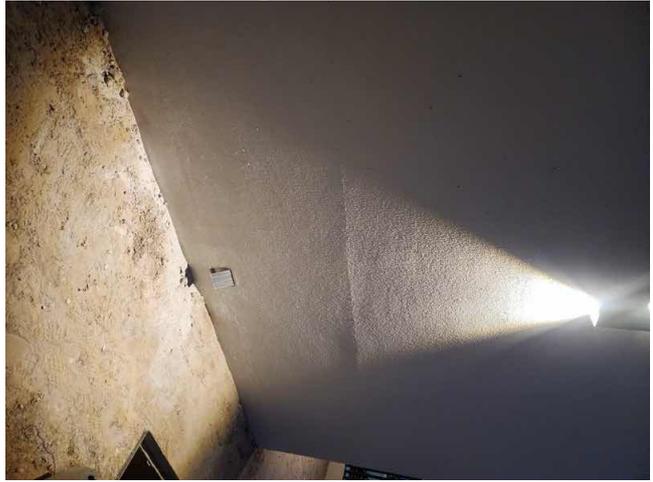
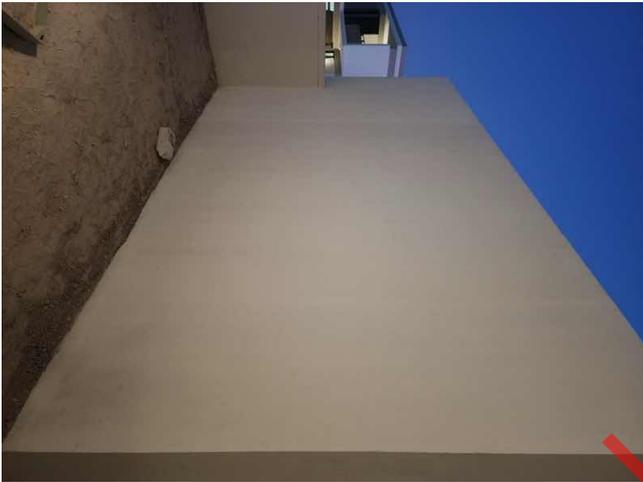
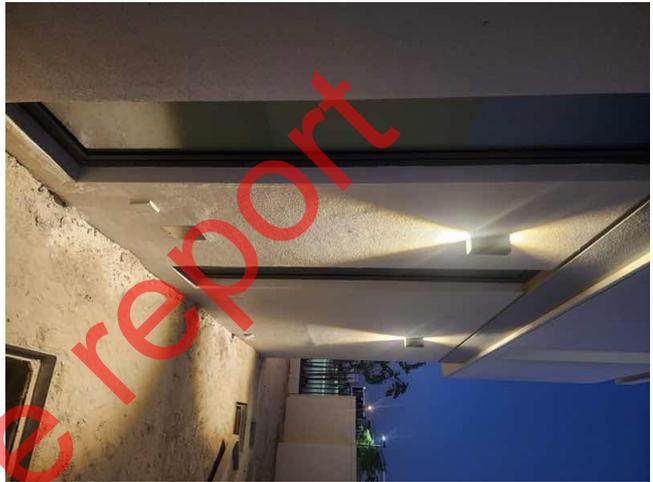
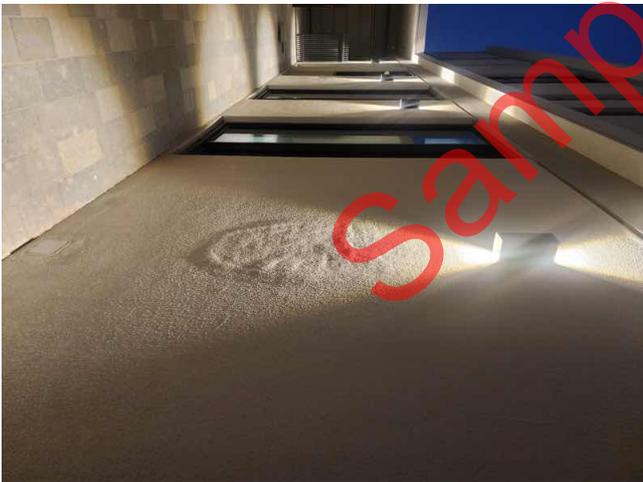
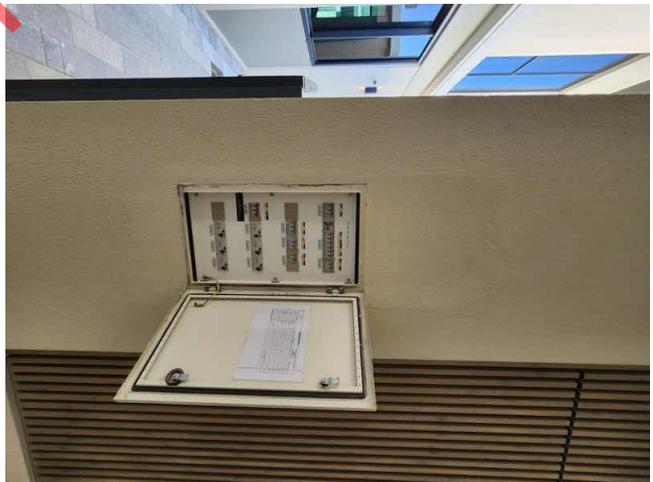
170 + 05/12/2024 Not attributed No deadline Not completed

Bubbling and exfoliating paint are all over the house. Look at these pictures with the light on them.

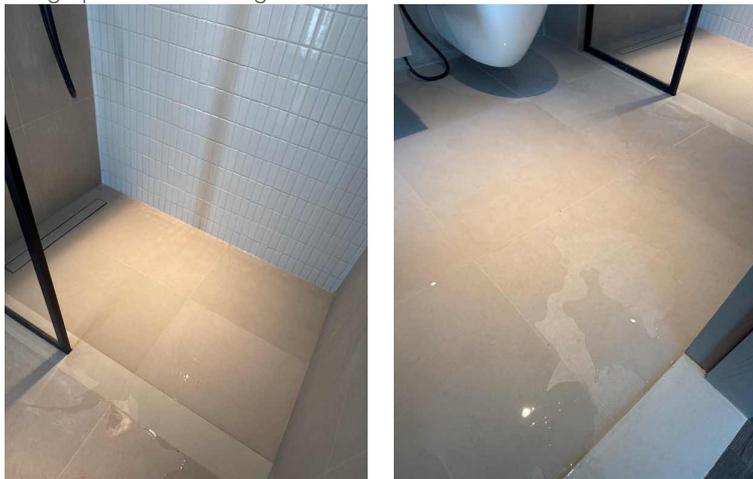
18 + 29/11/2024 Not attributed No deadline Not completed

Water not draining, to be checked for blockage.  
A high pressure flushing to be conducted to all drain holes.

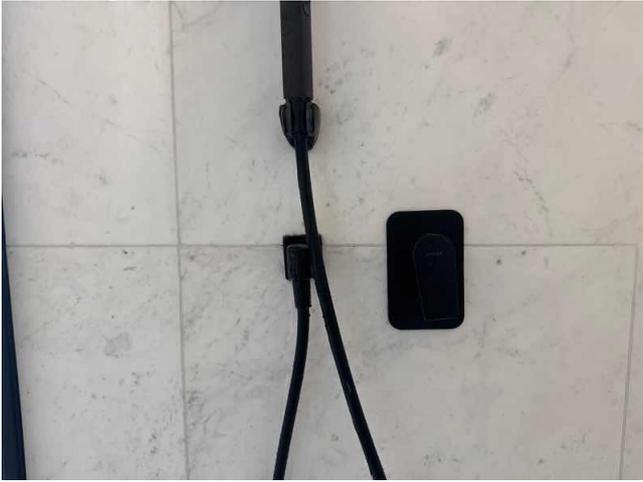
22 + 29/11/2024 Not attributed No deadline Not completed

Fixture alignment to be rectified

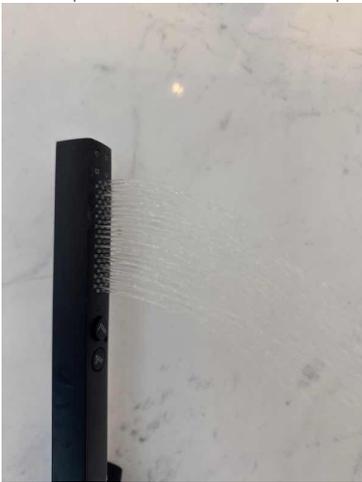
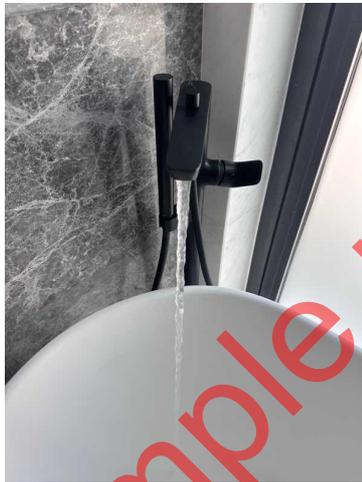
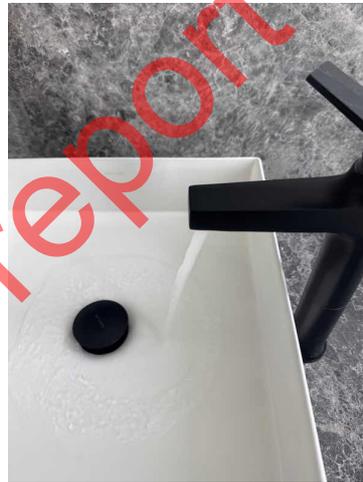
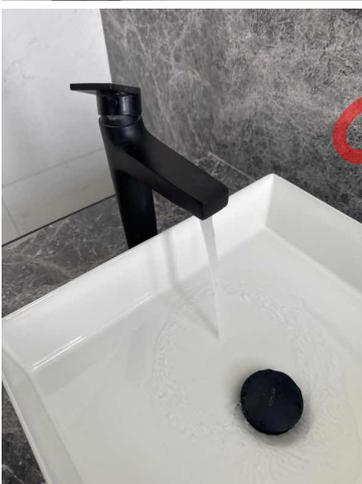
23 + 29/11/2024 Not attributed No deadline Not completed

Water pressure at outlets is as per normal levels.

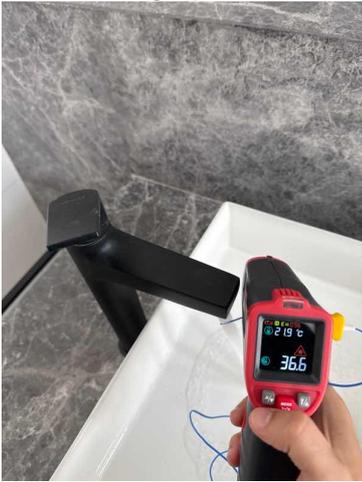
24 + 29/11/2024 Not attributed No deadline Not completed

Hot water to achieve 40-45 degrees Celsius at all taps in the unit, thermostat and piping to be checked, thermostat and heater commissioning report to be issued.

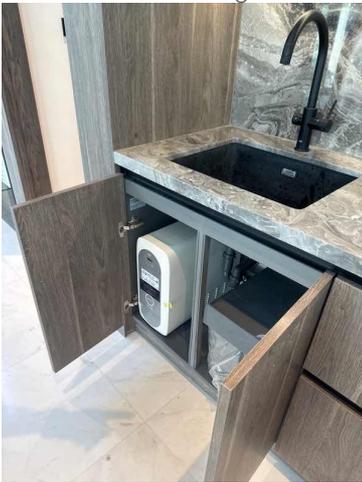
108 + 29/11/2024 Not attributed No deadline Not completed

Water filter not working.

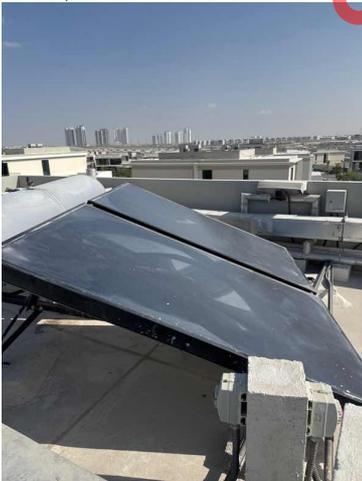
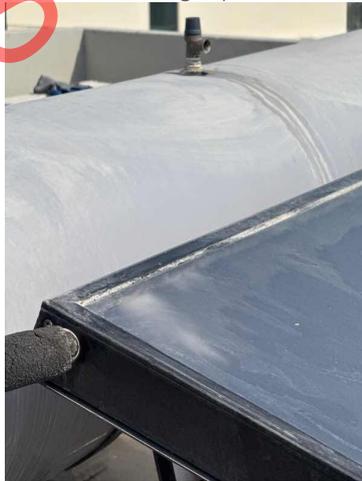
133 + 29/11/2024 Not attributed No deadline Not completed

Solar panels to be cleaned inside out, commissioning report and warranty documents to be provided.

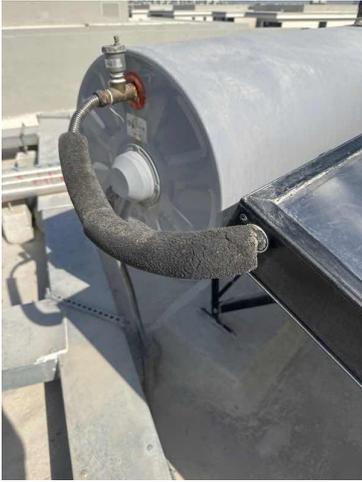
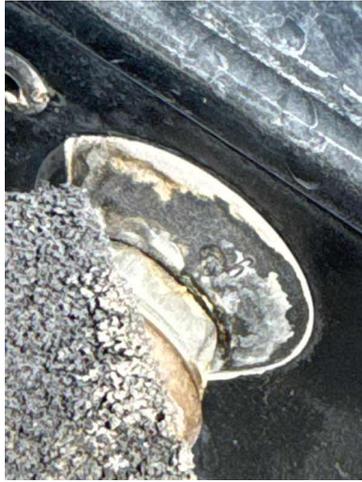
134 + 29/11/2024 Not attributed No deadline Not completed

Exposed parts of piping to be insulated and sealed with foam and covering sleeve.

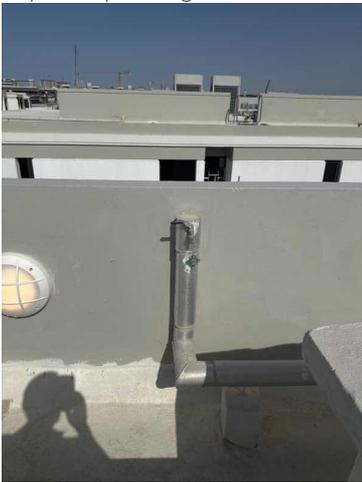
138 + 29/11/2024 Not attributed No deadline Not completed

Tap not operating.

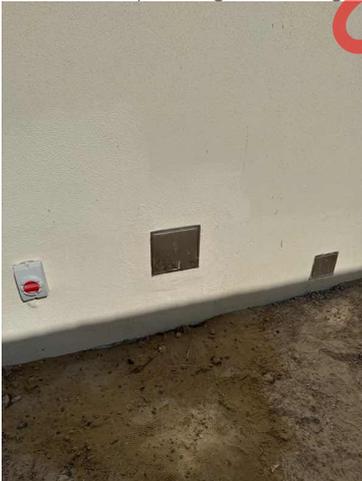
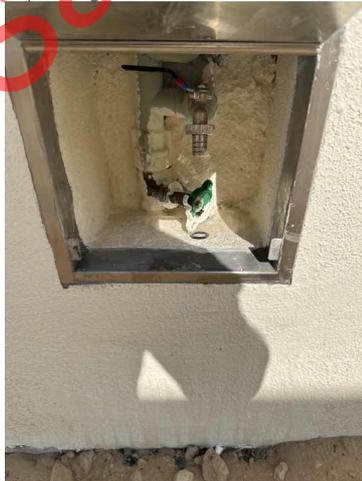
140 + 29/11/2024 Not attributed No deadline Not completed

Faucet not operating on closing and opening

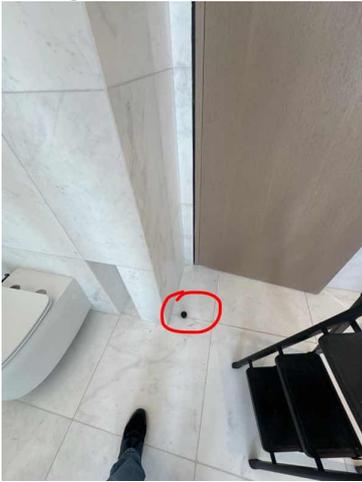
4 29/11/2024 Not attributed No deadline Not completed  
Damaged tile , to be replaced.

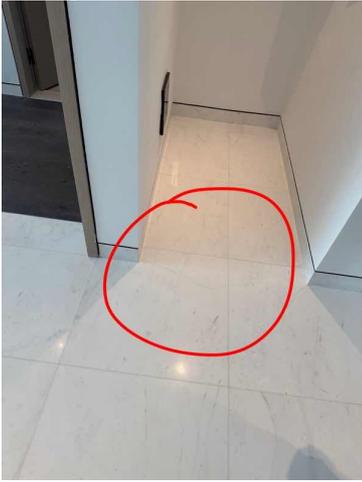
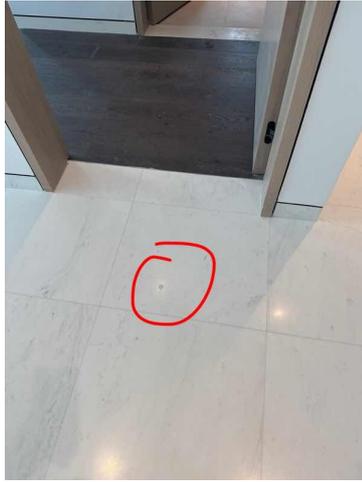
33 + 29/11/2024 Not attributed No deadline Not completed

Damaged tile , to be replaced.

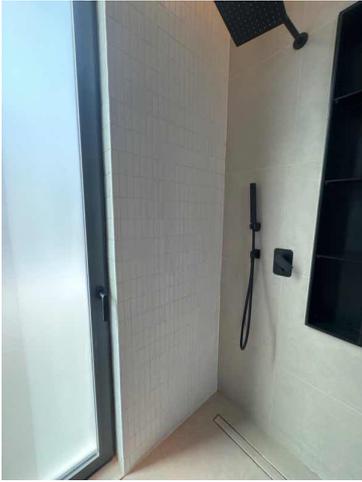
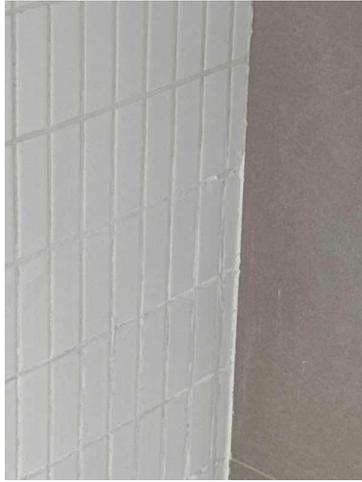
45 + 29/11/2024 Not attributed No deadline Not completed

Grouting to have a consistent and matching color at all areas.

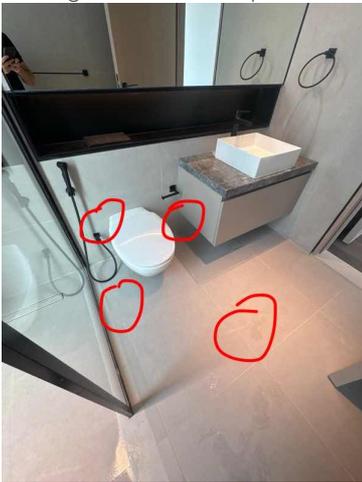
46 + 29/11/2024 Not attributed No deadline Not completed

Damaged tile , to be replaced.

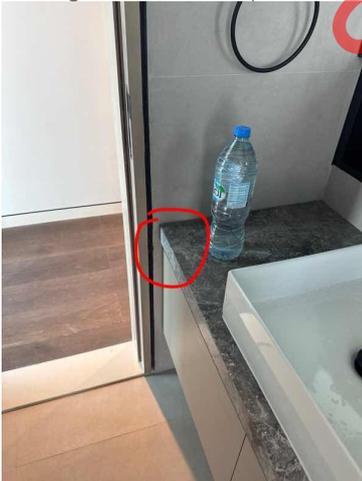
52 + 29/11/2024 Not attributed No deadline Not completed

Damaged tile , to be replaced.

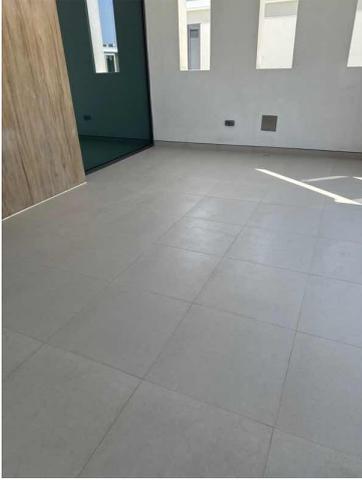
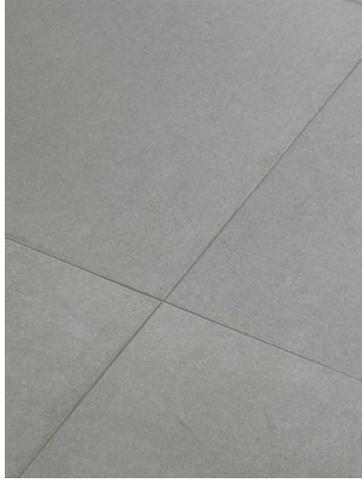
63 + 29/11/2024 Not attributed No deadline Not completed

Grouting to have a consistent and matching color at all areas.

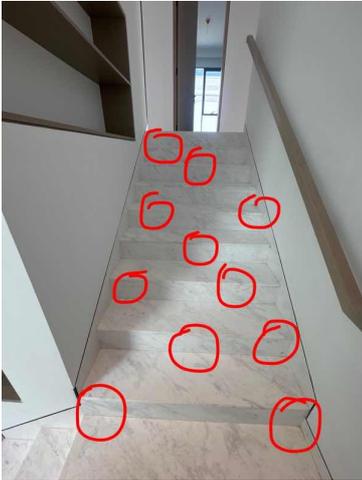
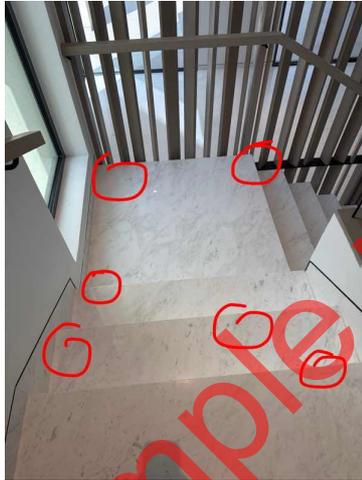
70 + 29/11/2024 Not attributed No deadline Not completed

Damaged tile , to be replaced.

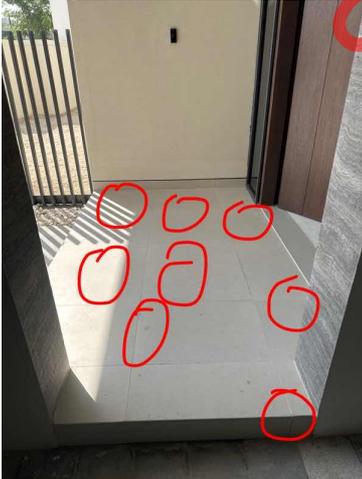
75 + 29/11/2024 Not attributed No deadline Not completed

Damaged tile , to be replaced.

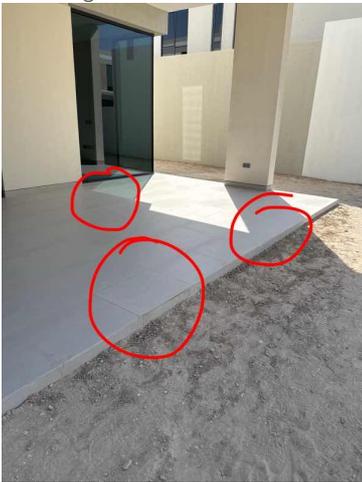
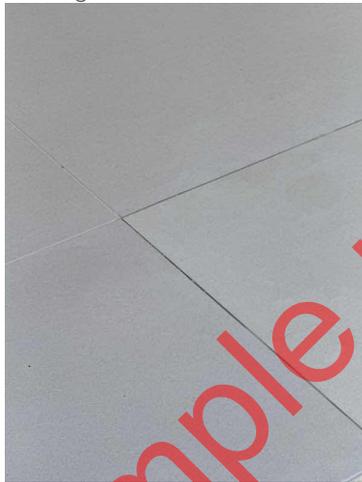
86 + 29/11/2024 Not attributed No deadline Not completed

Grouting to have a consistent and matching color at all areas.

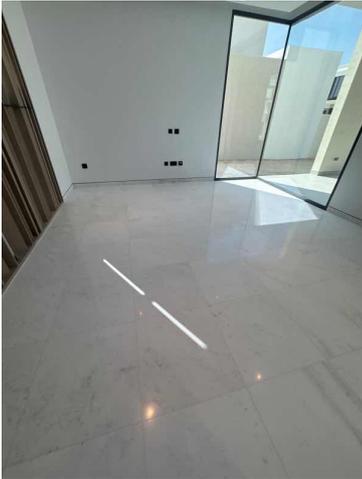
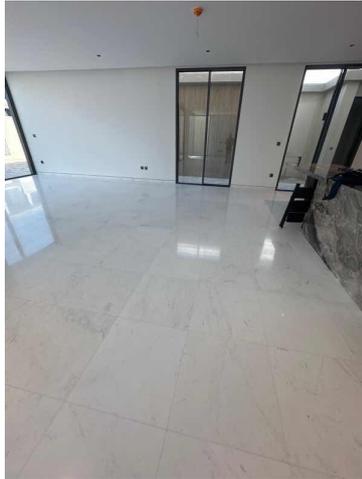
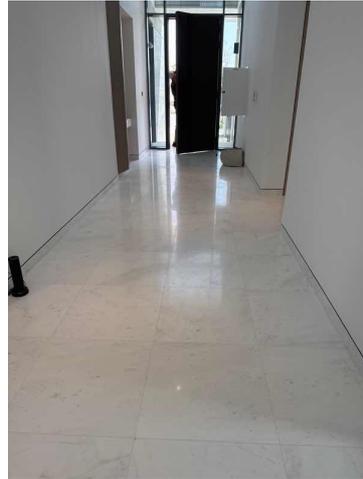
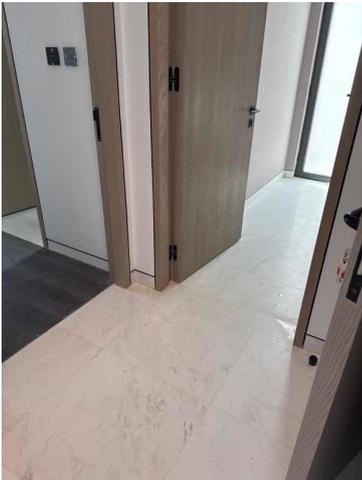
94 + 29/11/2024 Not attributed No deadline Not completed

Professional scrubbing of all floors to be done after all works completed.

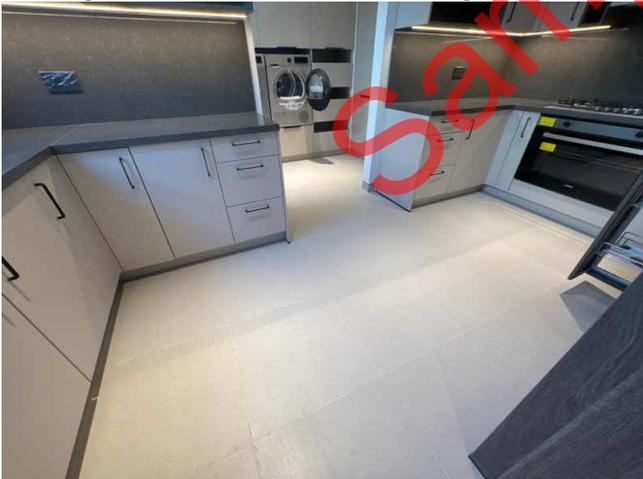
111 + 29/11/2024 Not attributed No deadline Not completed

Grouting to have a consistent and matching color at all areas.

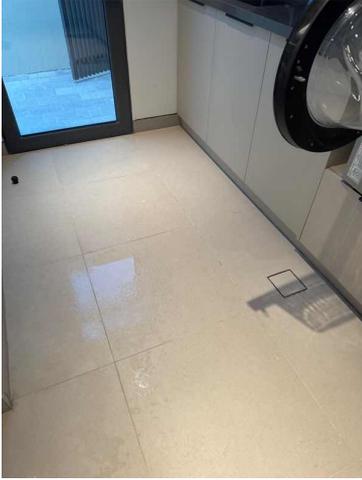
115 + 29/11/2024 Not attributed No deadline Not completed

Grouting to have a consistent and matching color at all areas.

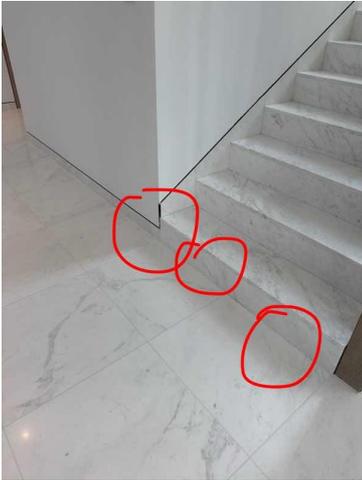
118 + 29/11/2024 Not attributed No deadline Not completed

Damaged tile , to be replaced.

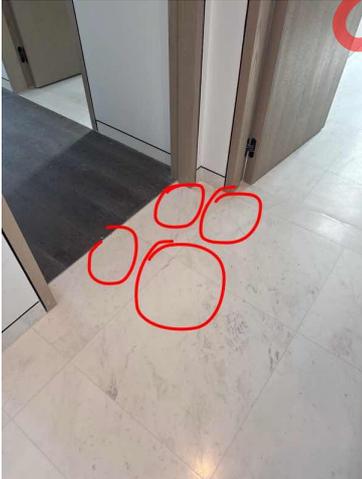
121 + 29/11/2024 Not attributed No deadline Not completed

Damaged tile , to be replaced.

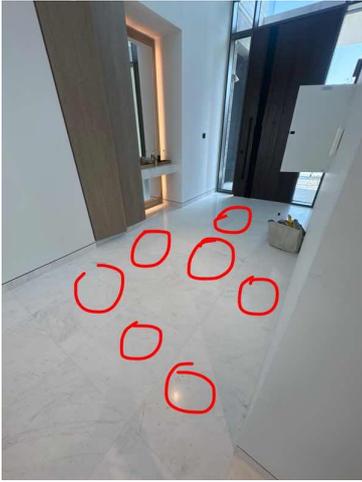
124 + 29/11/2024 Not attributed No deadline Not completed

Damaged tile , to be replaced.

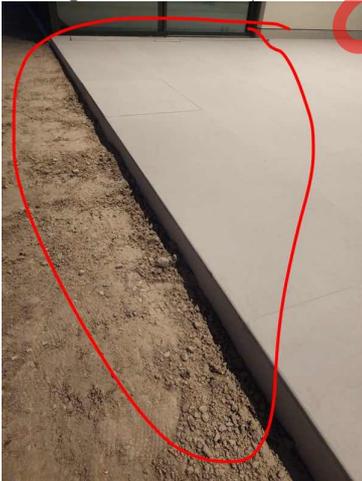
147 + 05/12/2024 Not attributed No deadline Not completed

Damaged tile , to be replaced.
