**RAMI**  
Property  
Inspections

## Property Inspection Report

# VILLA

Description	Client : Dubai 0000
Address :	Dubai
Generated on	- 10/12/2024
Stages	- Comprehensive Handover Snagging
Building trades	<ul style="list-style-type: none"><li>- About</li><li>- Air conditioning</li><li>- Aluminium joinery</li><li>- Bathroom Accessories, interiors and Fittings</li><li>- Electricity</li><li>- General Works</li><li>- Glass</li><li>- Gypsum &amp; Acoustic Ceiling</li><li>- Humidity</li><li>- Interior joinery</li><li>- Kitchen</li><li>- Noise Level</li><li>- Paint</li><li>- Paving</li><li>- Plaster</li><li>- Plumbing and heating</li><li>- Thermography</li><li>- Tiling, Wooden Floorings and stairs.</li><li>- Water Networks</li><li>- Water/ Moisture Intrusion</li></ul>
Stakeholders	
Drawings	- 2024-11-29 (Comprehensive Handover Snagging)

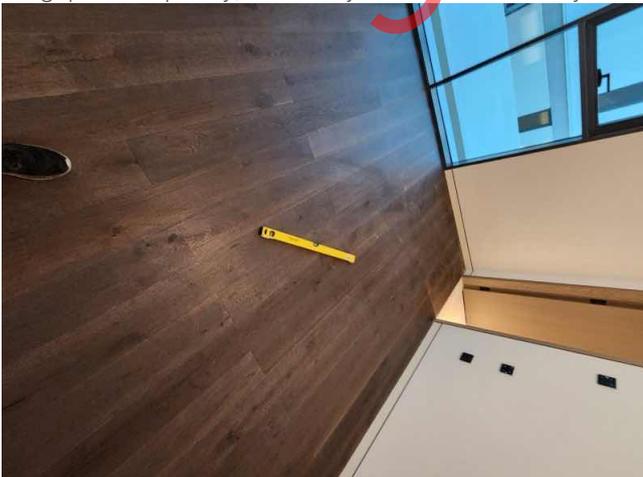
158 + 05/12/2024 Not attributed No deadline Not completed

Bedroom Facing Annex - Uneven and Bubbly Flooring next to Bathroom Door and in the Middle of the Room. Engineered wood tile gaps are squeaky, not evenly installed and bubbly.

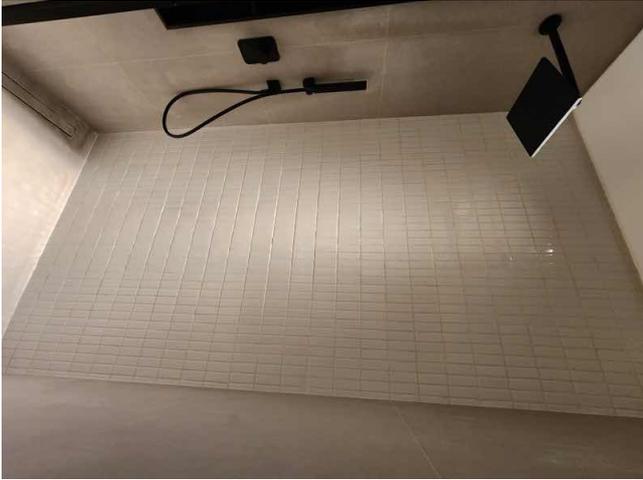
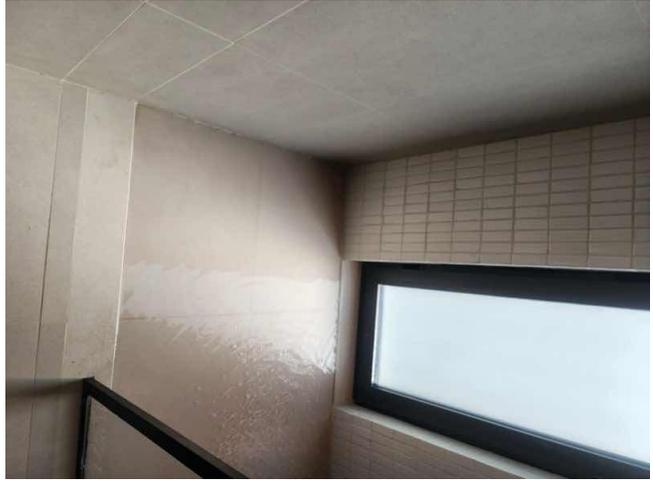
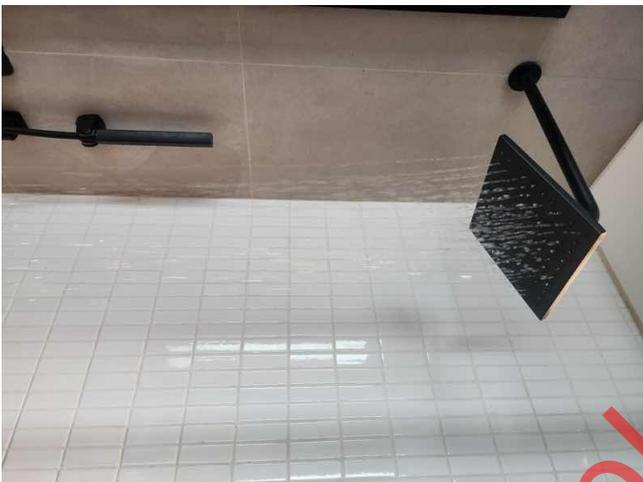
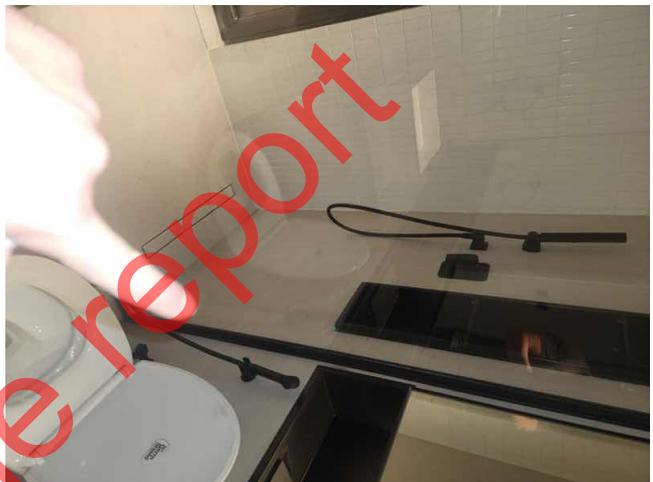
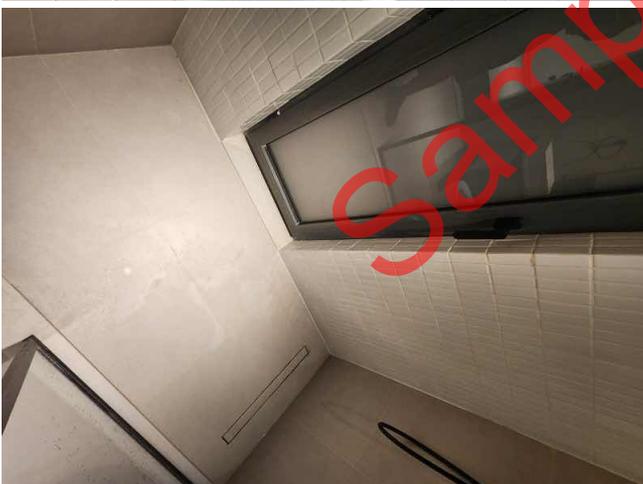
159 + 05/12/2024 Not attributed No deadline Not completed

General comment: White rectangular wall tyles in all villa and annex bathrooms are not installed evenly with different tile levels and uneven edges.

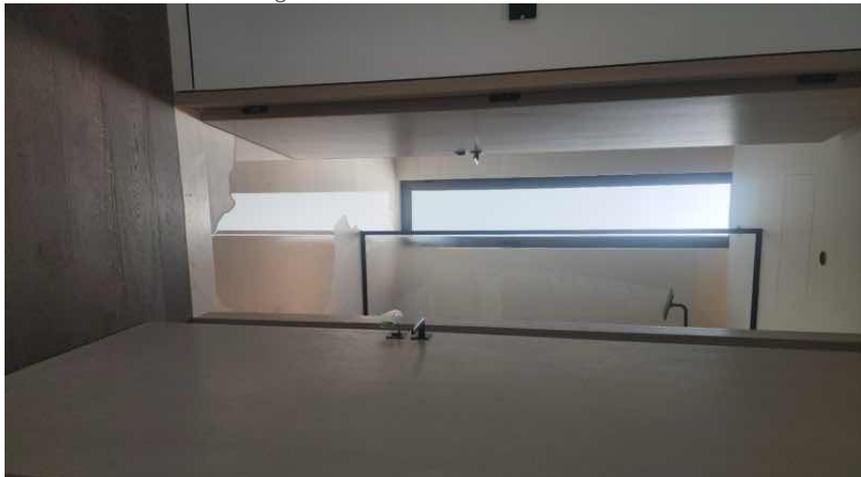
174 + 05/12/2024 Not attributed No deadline Not completed

Bedroom 1st Floor Street Facing Right Side (when facing the street) - Shower No Slope Led to Water Cumulation until the Room after 3 minutes of Running Shower

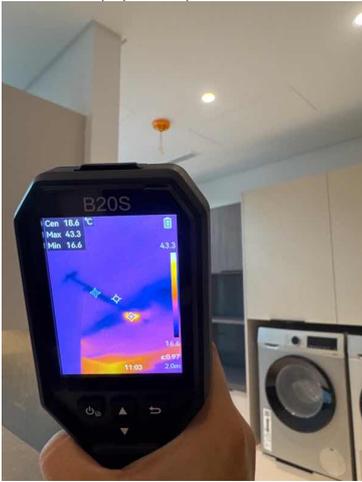
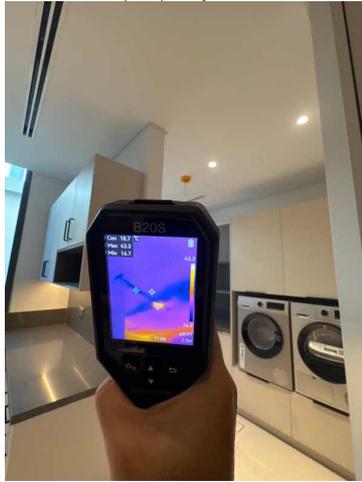
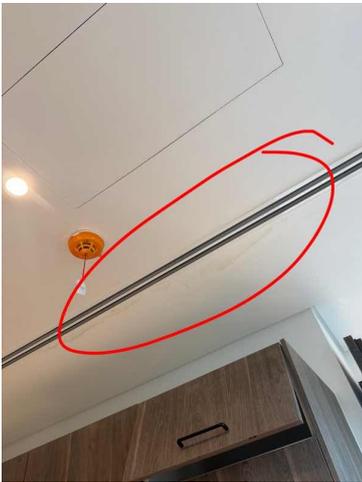
72    + 29/11/2024    Not attributed    No deadline    Not completed

Damp patches due to penetrating damps , all surrounding faulty gaps and cracks to be closed, walls and ceiling to be painted with damp proof paint and exterior areas to be properly coated.
